**SUBJECT: NUCLEAR PLANT WNP-2, OPERATING LICENSE NPF-21  
LICENSEE EVENT REPORT NO. 92-033**

Washington Nuclear Plant - Unit 2

IMPROPER SRV RESEAT PRESSURE AND REACTOR SCRAM

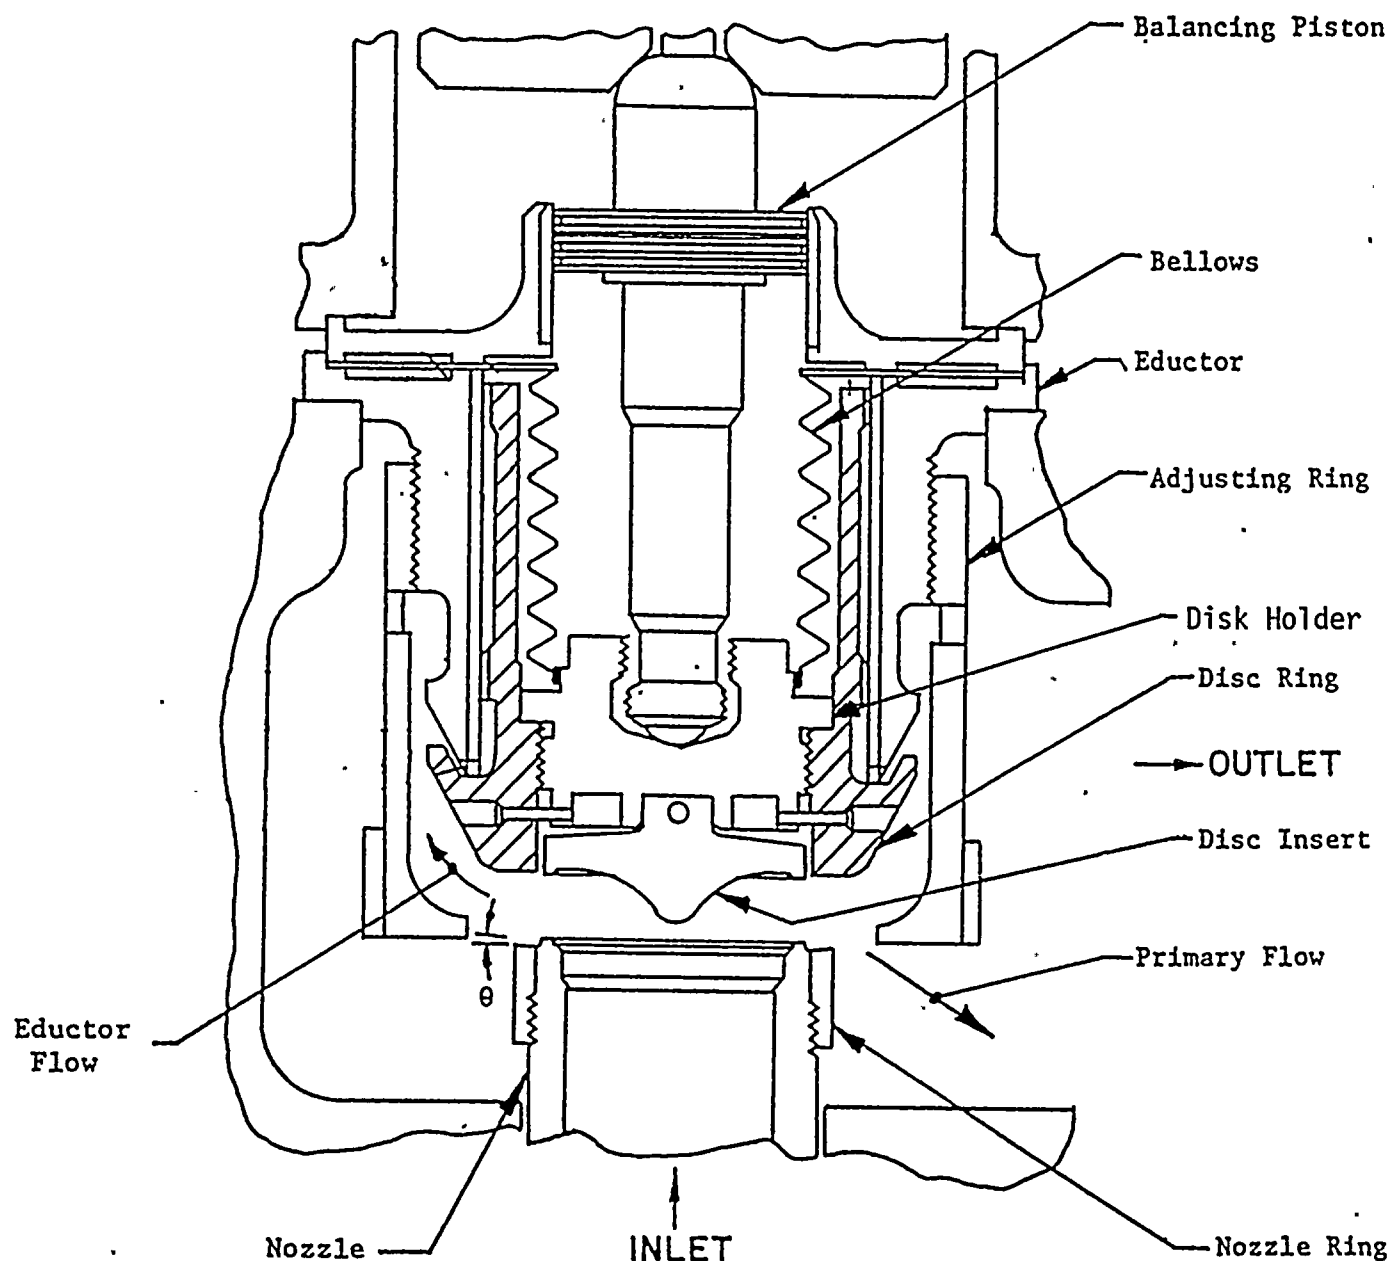
Figure 1

5. The valve nozzle ring and adjusting ring were checked for the proper settings (see Figure 1). There are 48 notches on the diameter of the adjustment ring; and the rings are cut at 12 threads per inch. There are thus 576 notches per inch of ring travel. There are 18 notches on the nozzle ring and it is cut at 16 threads per inch for a total of 288 notches per inch of ring travel.

The nozzle ring was found set at -40 notches versus the required -8. The nozzle ring is initially adjusted flush with the disk ring bottom and then adjusted down away from the disk ring the required number of notches.

The adjusting ring was found set at -350 notches instead of the required -450 notches. The bottom of the adjusting ring is initially aligned even with the bottom of the disk ring and is then lowered the required number of notches with the result that it slightly overlaps the nozzle ring. The adjusting ring is used to change the reseal pressure for the valve.

The failed valve was tested and the lift setpoint was verified to be correct. The valve was then disassembled and inspected. The inspection revealed that the nozzle ring was set at -6.5 notches instead of the required -8. Much more importantly, however, the disk ring diameter was verified to be oversized at 10.110". The required diameter for this part is  $10.0875 \pm 0.0005$ ". As is apparent from the tight tolerance restrictions, this dimension is critical in that it controls the flow of steam to areas above the disk holder and disk ring. The effect of reduced pressure above the disk ring on valve reseating performance during testing appears to be exaggerated at low steam pressures (less than the 1185 psig set pressure) due to the resultant reduced valve backpressure.

The nozzle ring and adjusting ring were reset.
