SUBJECT: NUCLEAR PLANT WNP-2, OPERATING LICENSE NPF-21  
LICENSEE EVENT REPORT NO. 92-032-01

Washington Nuclear Plant - Unit 2

**UNPLANNED MANUAL ACTUATION OF ESF COMPONENT DUE TO DECREASE IN REACTOR WATER LEVEL RESULTING FROM VOIDED FEEDWATER PIPING**

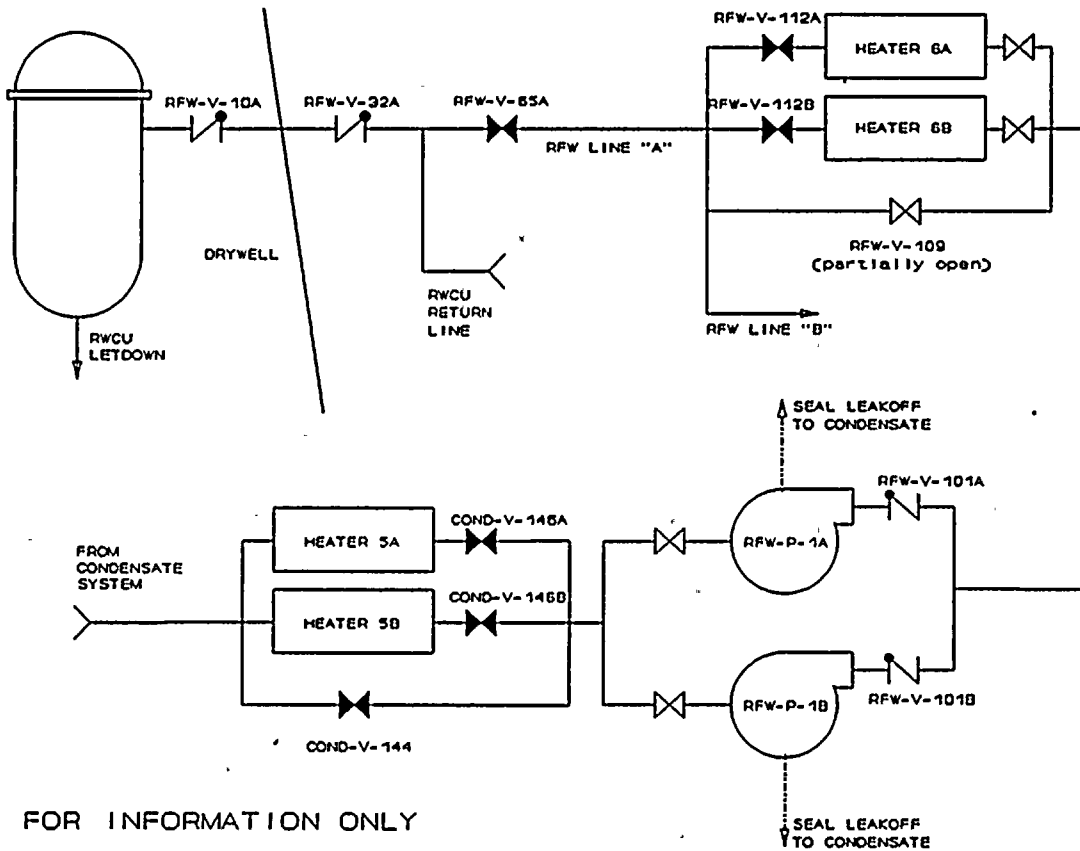
Feedwater System Valve Lineup

At the time of the event, a boundary had been established for work being performed on valve RFW-V-65A by closing valves located on the suction side of the feedwater pumps (COND-V-146A, COND-V-146B, COND-V-144). The boundary had been previously established at valves located closer to RFW-V-65A (RFW-V-112A, RFW-V-112B, RFW-V-109), but was expanded approximately 13 hours prior to the event as a result of unexpected, small reactor water level increases that were noted when RFW-V-65A was opened during the previous control room shift.

With the plant in the configuration previously described, it was possible for water trapped between RFW-V-65A and boundary valves located on the suction side of the feedwater pumps to drain into the condensate system via a flow path that existed through RFW-V-109, the feedwater pump discharge check valves (RFW-V-101A, and RFW-V-101B), and the feedwater pump seals.

The decrease in reactor vessel water level that occurred during this event was initiated when valve RFW-V-65A was opened. Opening RFW-V-65A caused RWCU return flow to be diverted from the reactor and into the voided section of feedwater piping. This resulted in annunciation of the RWCU high differential flow alarm, and caused reactor vessel level to decrease because RWCU letdown was still in progress.

During post-event investigation it was observed that RFW-V-109 required approximately 33 seconds to achieve full closure after displaying closed position indication. This is in excess of the 10 seconds assumed under the standard practice for throttle valve closure, and as a result, RFW-V-109 remained partially open when closed in this manner. Post-event examination of positioning for the closed limit switch on RFW-V-109 verified that it was set in accordance with motor operator data sheet specifications.

As further corrective action, the closed limit switch for RFW-V-109 was examined and verified to be set in accordance with data sheet specifications, and a caution tag has been placed on the handswitch for RFW-V-109 in order to advise operators that it requires more than 10 seconds to seat following receipt of closed position indication. Additionally, limit switch positions for motor operated valves with long stroke times that do not have a seal-in feature will be evaluated with respect to Operations practices. These valves will be provided with caution tags, as necessary, until the results of this evaluation can be implemented. Also, a description of this event will be incorporated into required reading for licensed operators. Stroke time evaluations and required reading are scheduled for completion by December 31, 1992.
