Subject: WNP-2, OPERATING LICENSE NPF-21
RESPONSE TO CONFIRMATORY ACTION LETTER

ROOT CAUSE ANALYSIS SUMMARY SHEET

Power Oscillation Event August 15, 1992

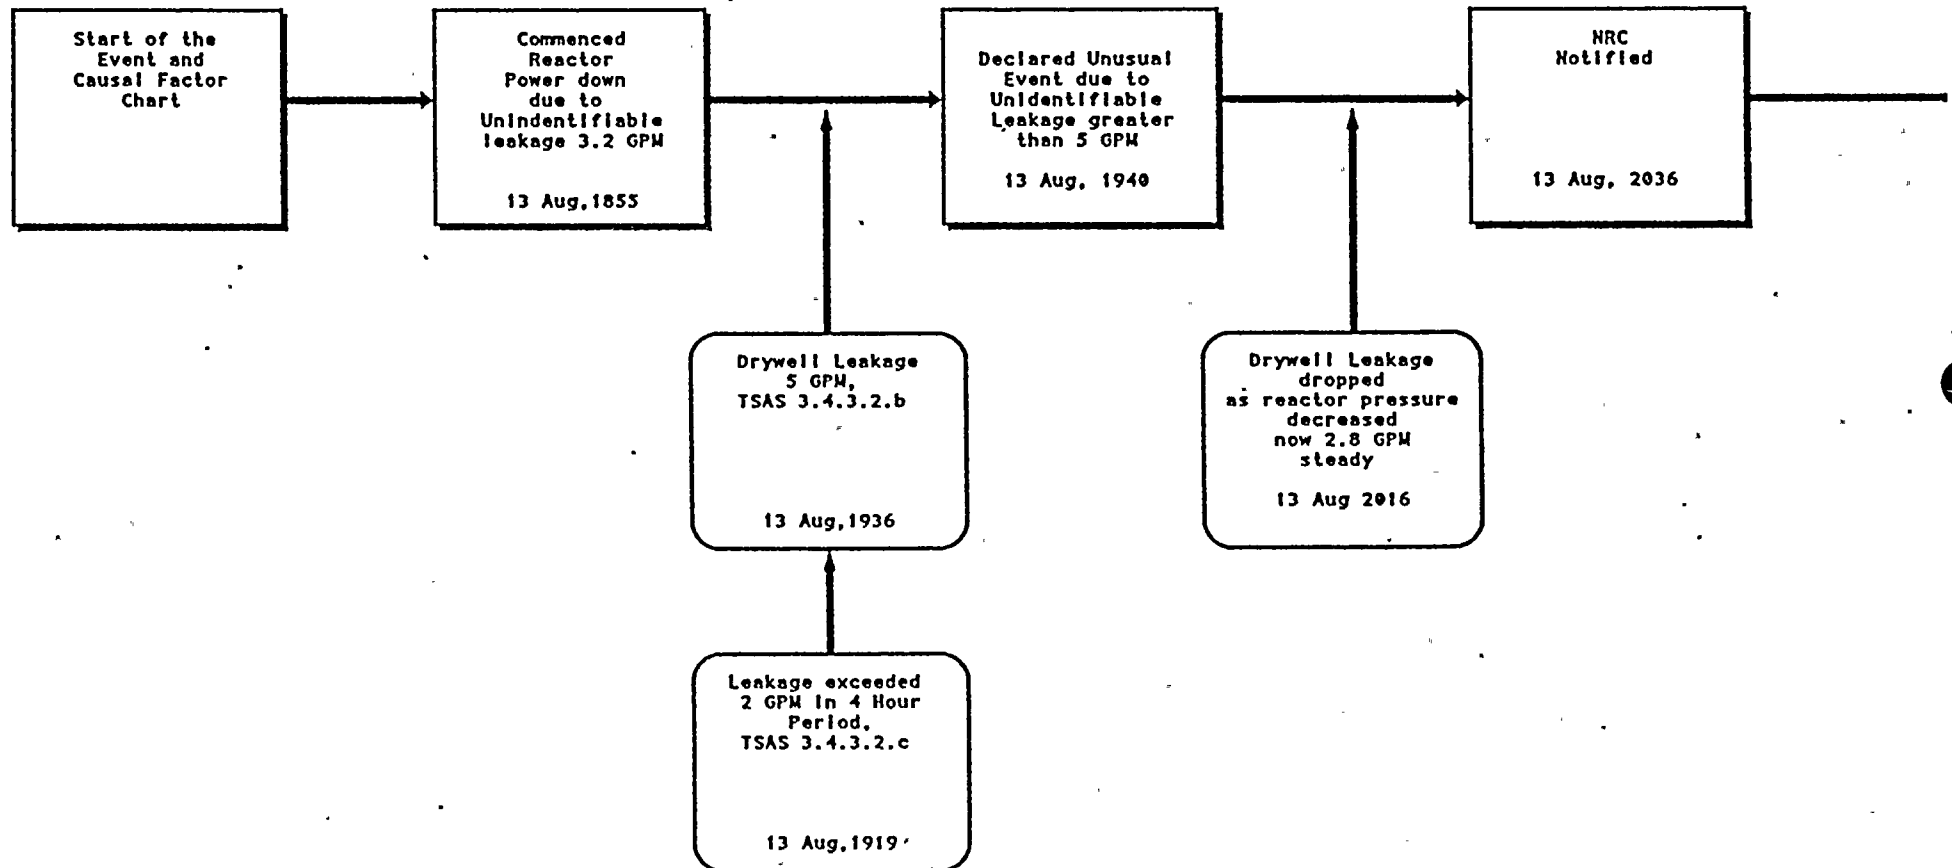
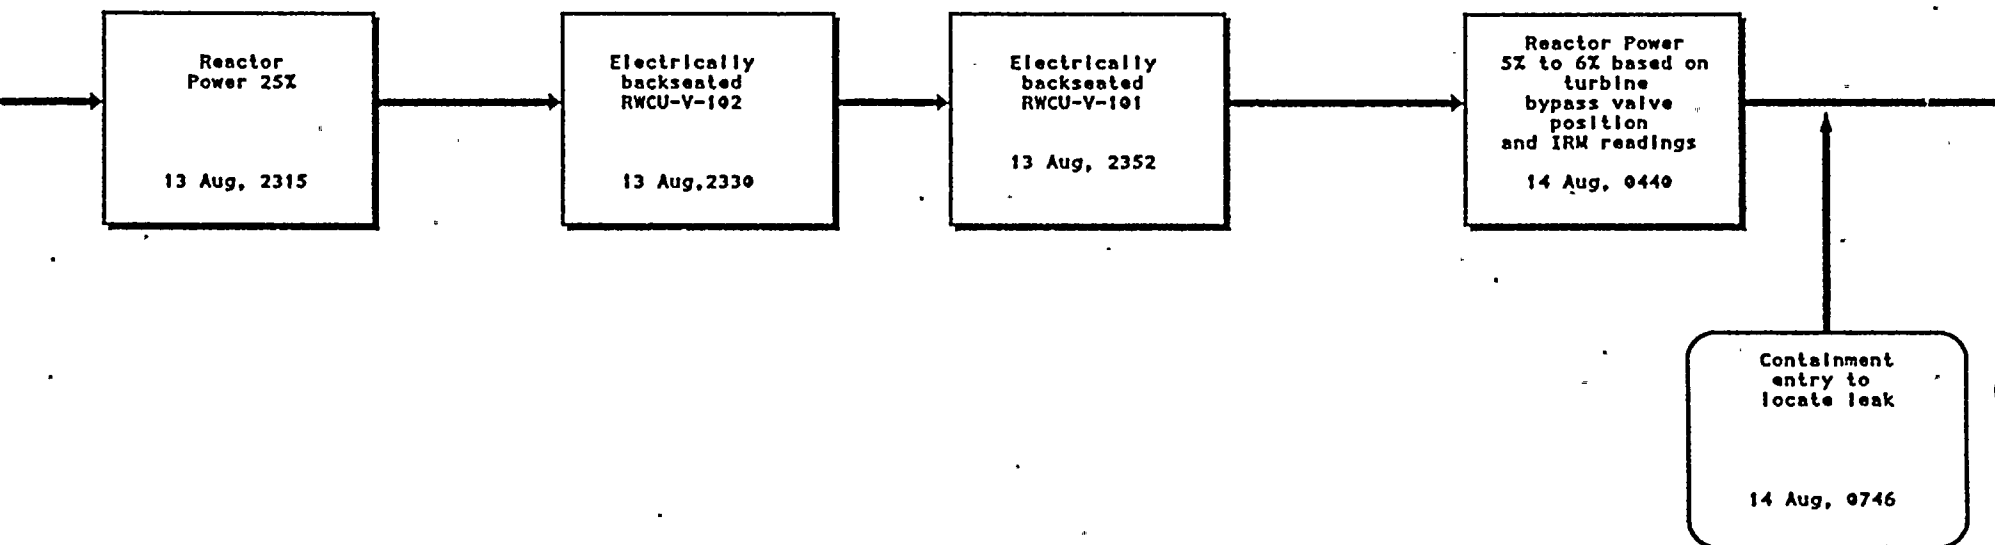
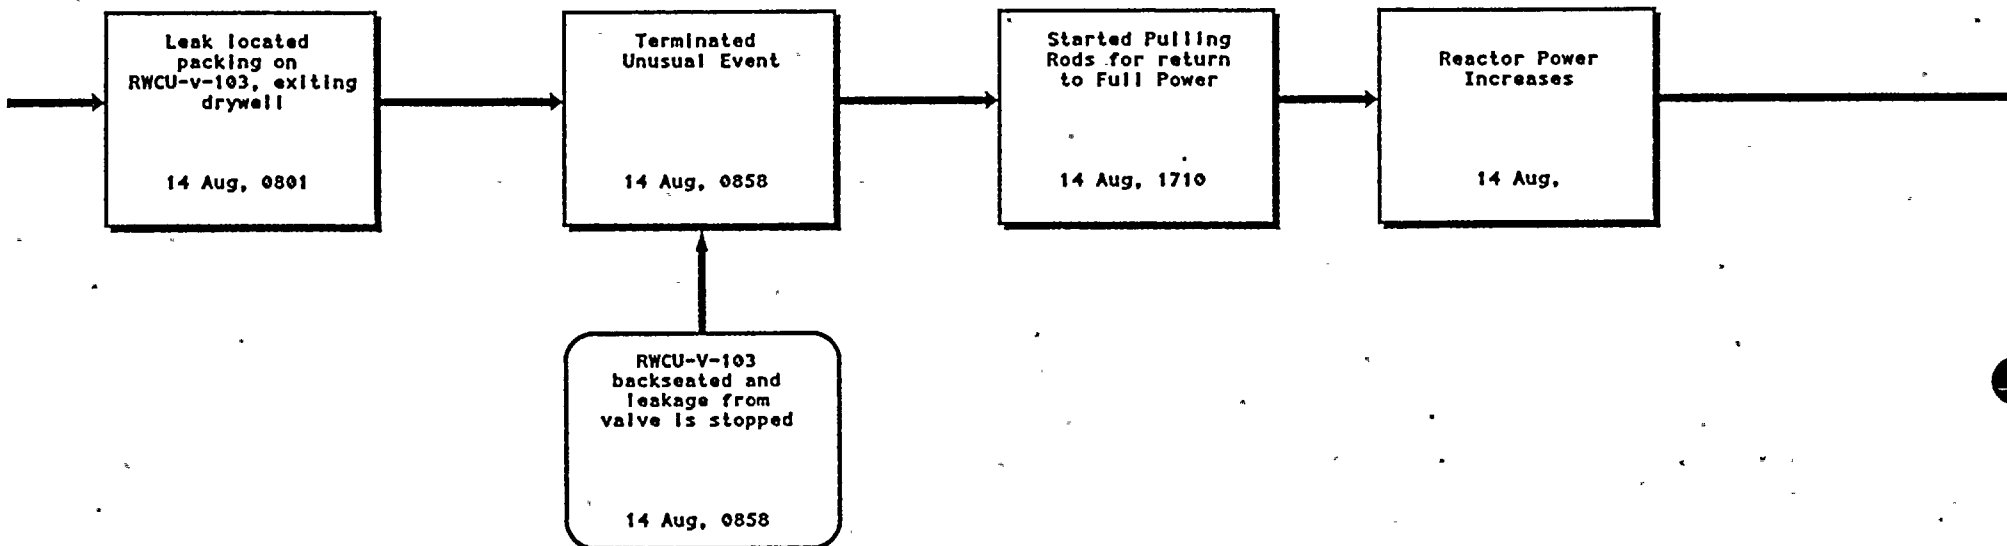
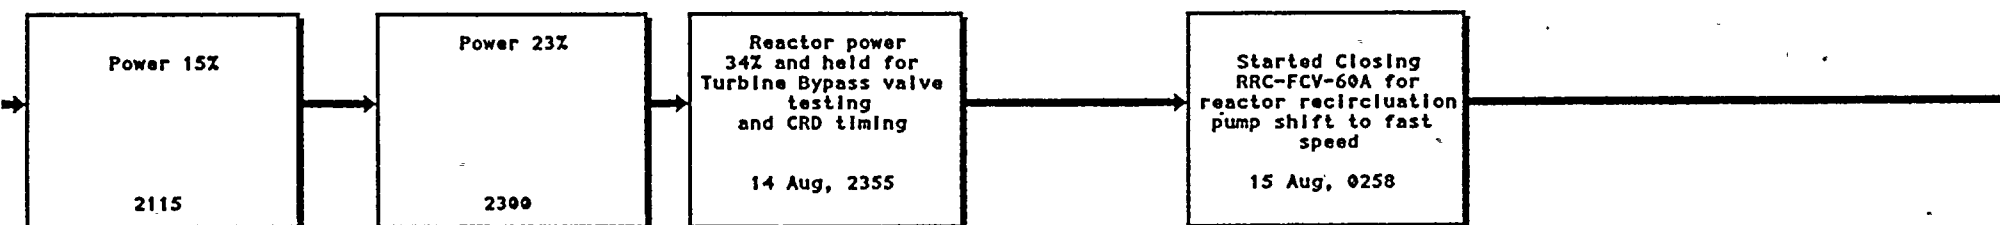
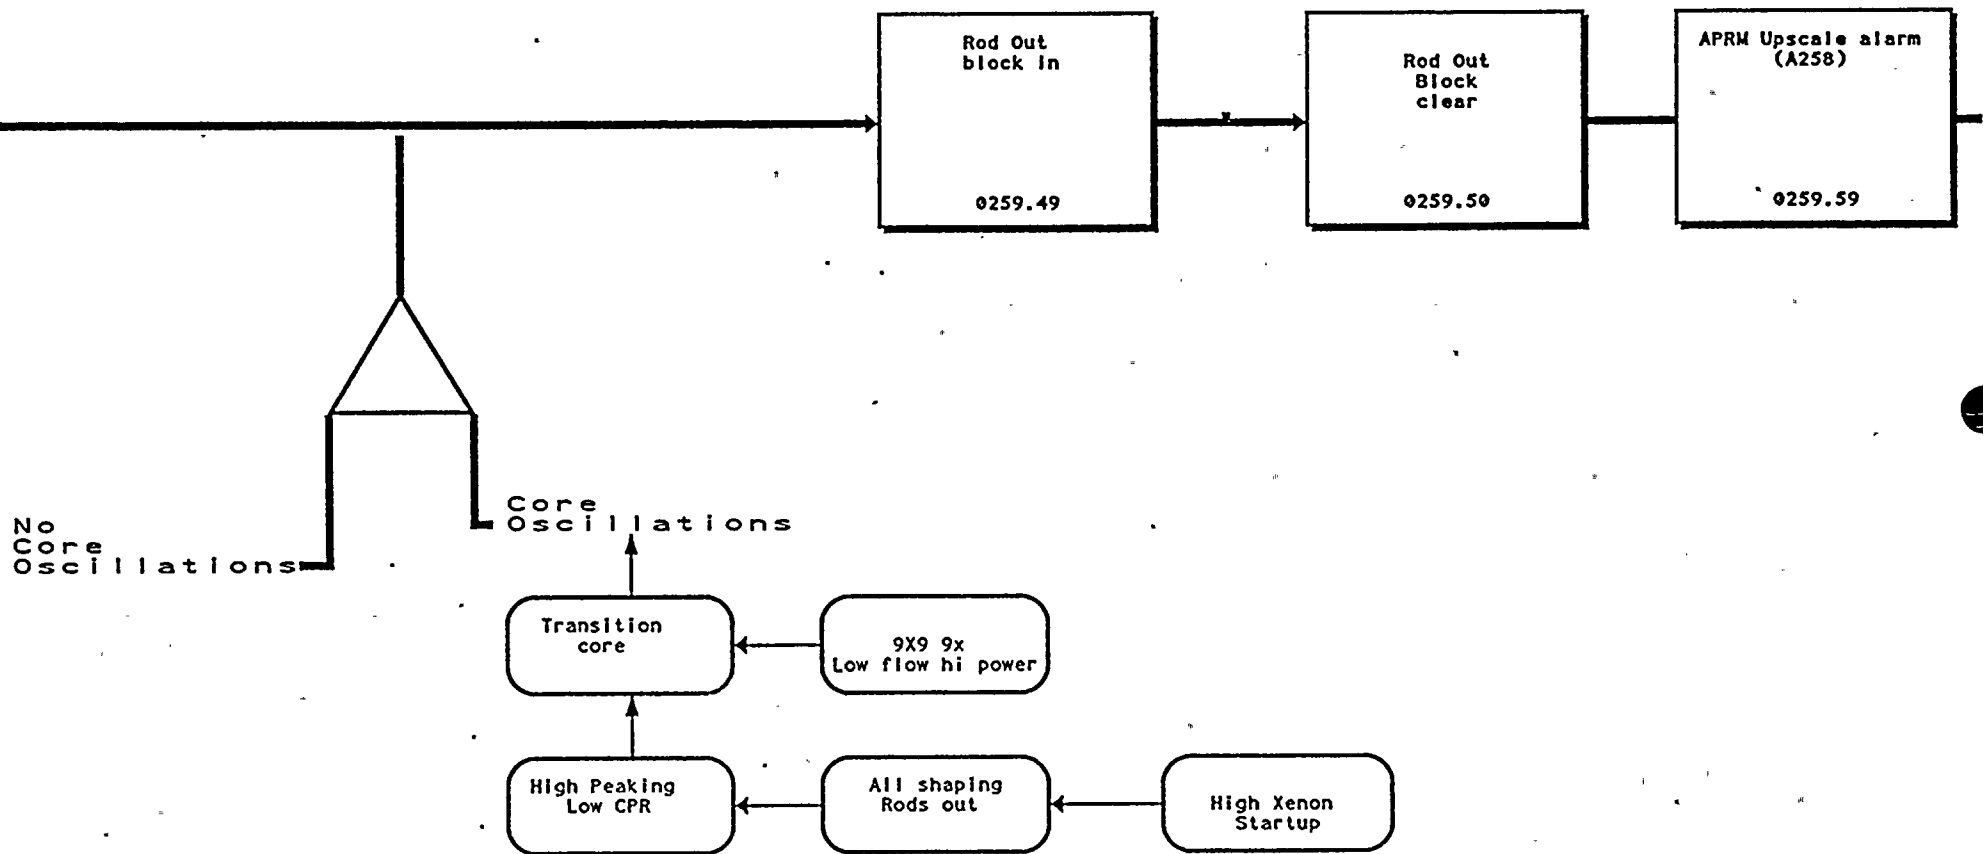
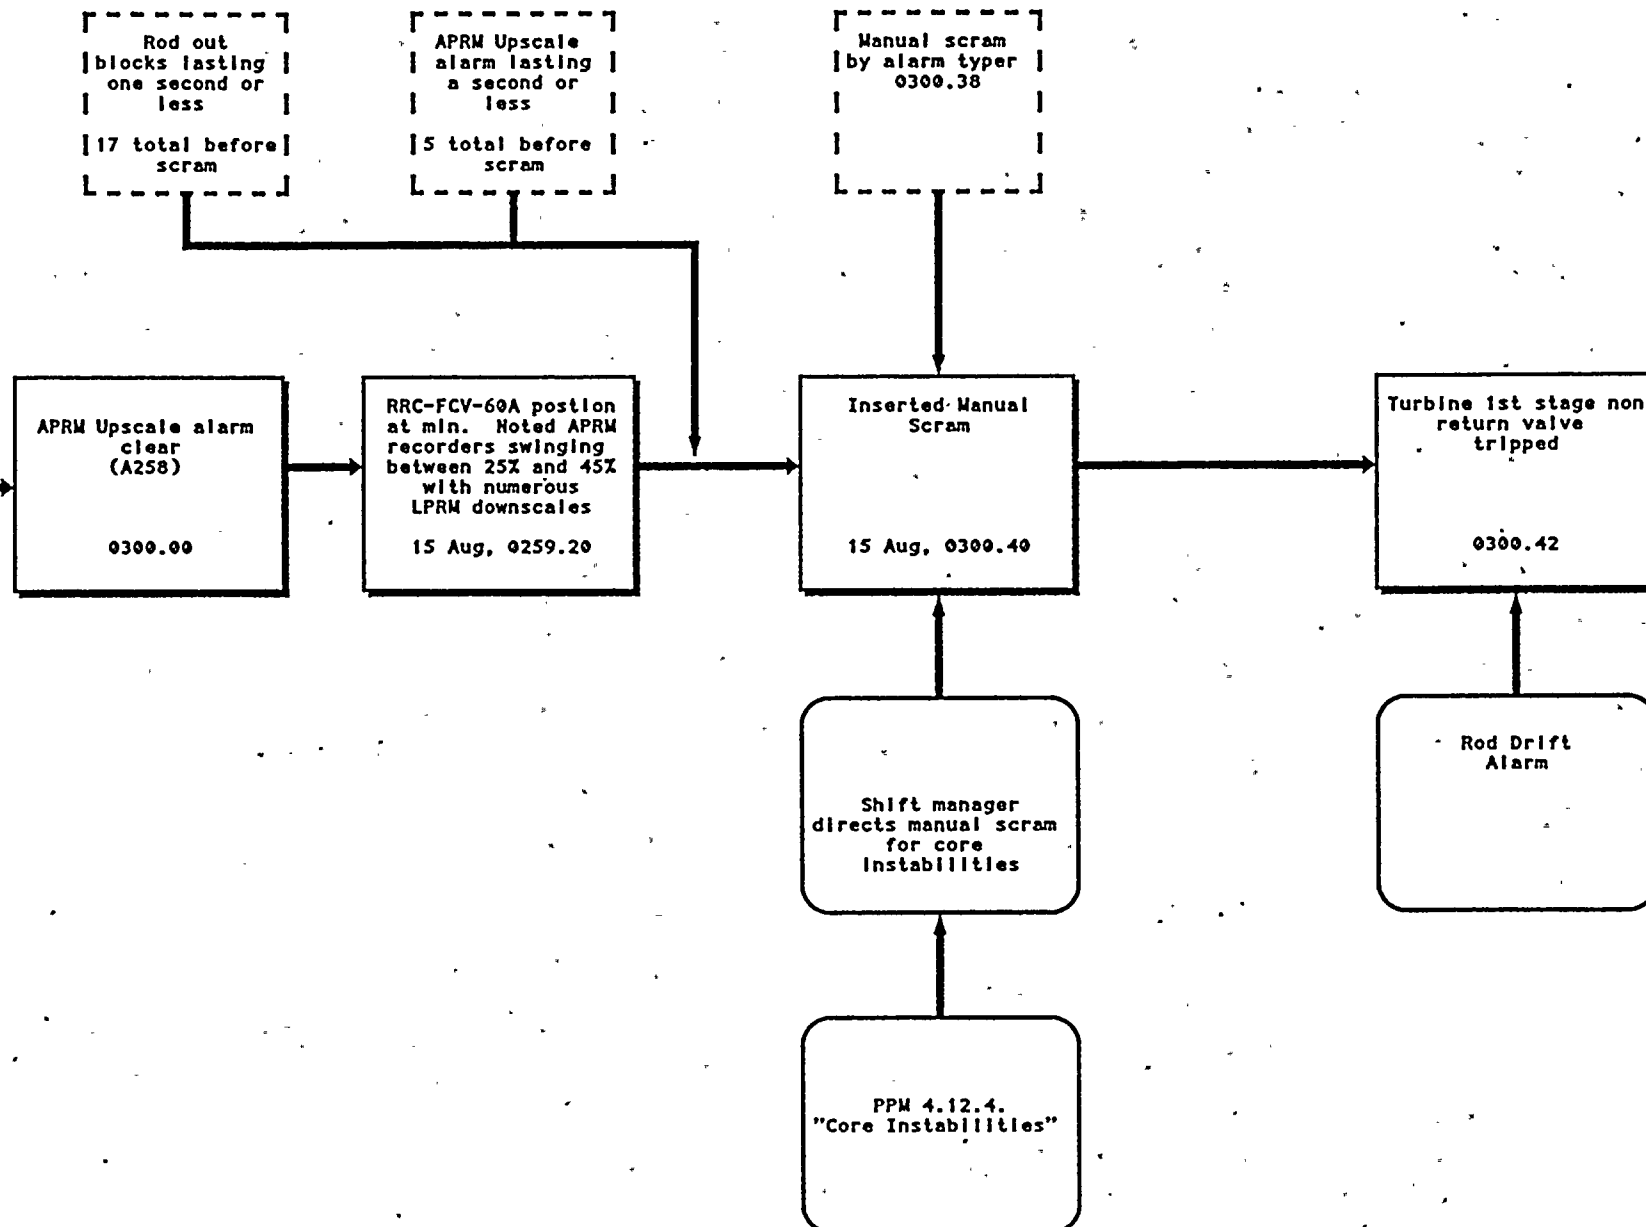
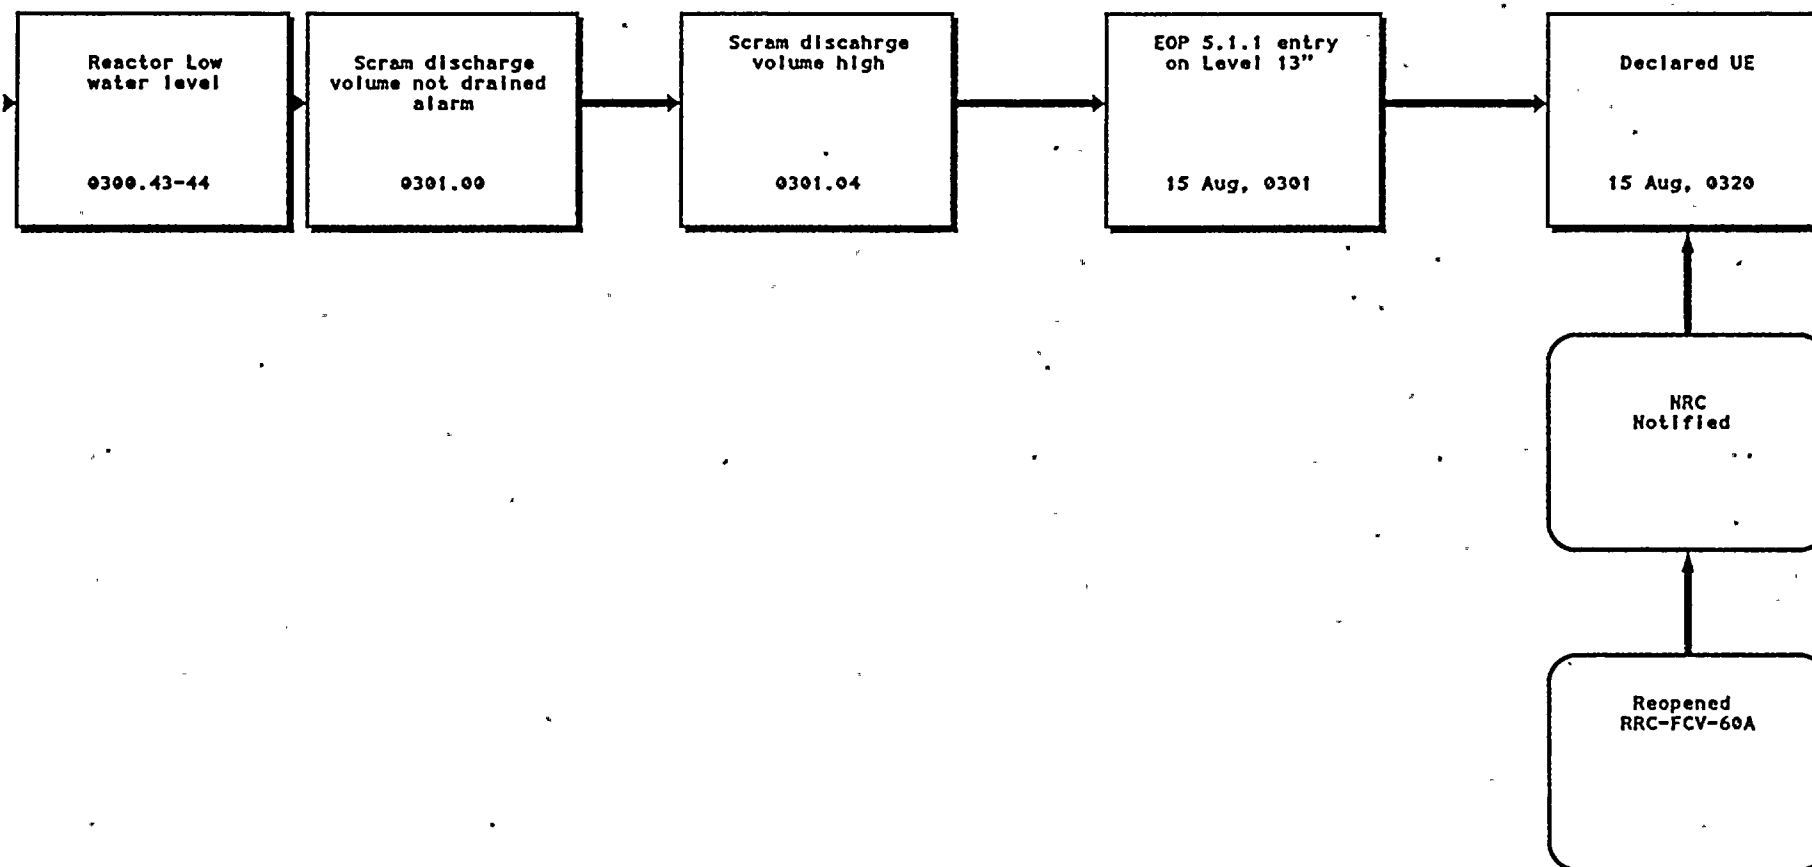
Reactor Power Oscillations

The pertinent sequence of events leading up to this power oscillation event were as follows (see attached Event and Causal Factor Chart). The unit was reduced in power from 100% to about 5% power starting at 1855 hours on August 13, 1992. This was due to unidentified drywell leakage of 5 GPM, in accordance with TSAS 3.4.3.2.b. This was to allow a drywell entry to locate and isolate the source of the leak. The leak was located on RWCU-V-103 as a failed packing and the valve was back seated to stop the leakage.

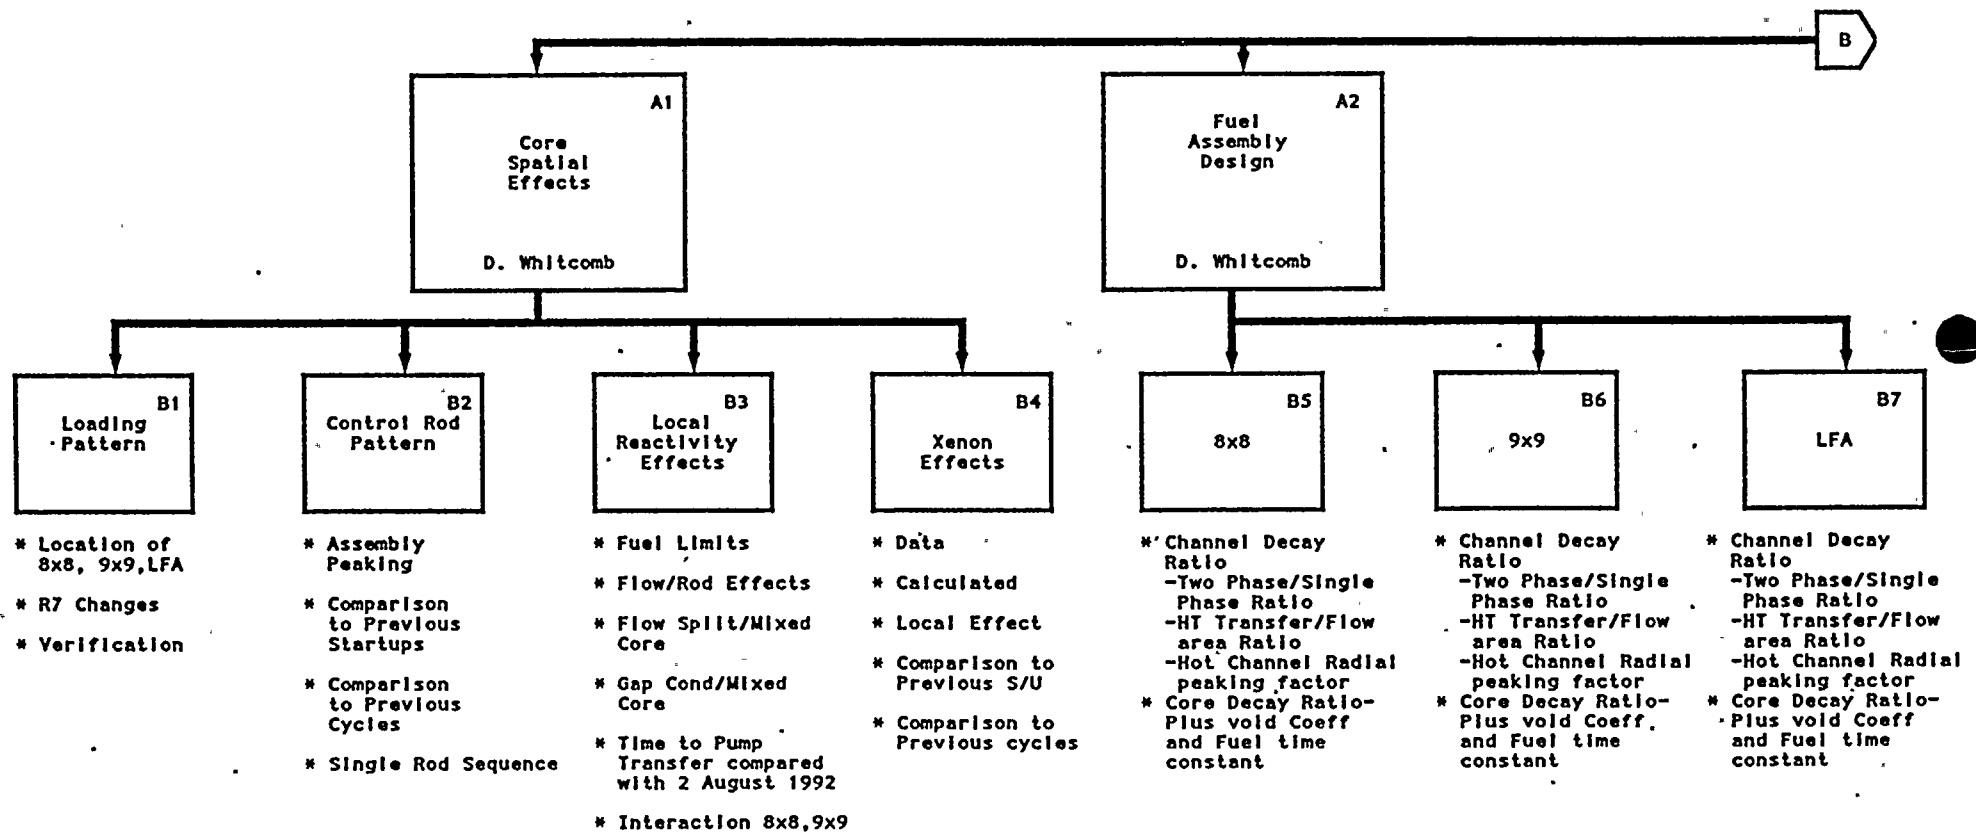
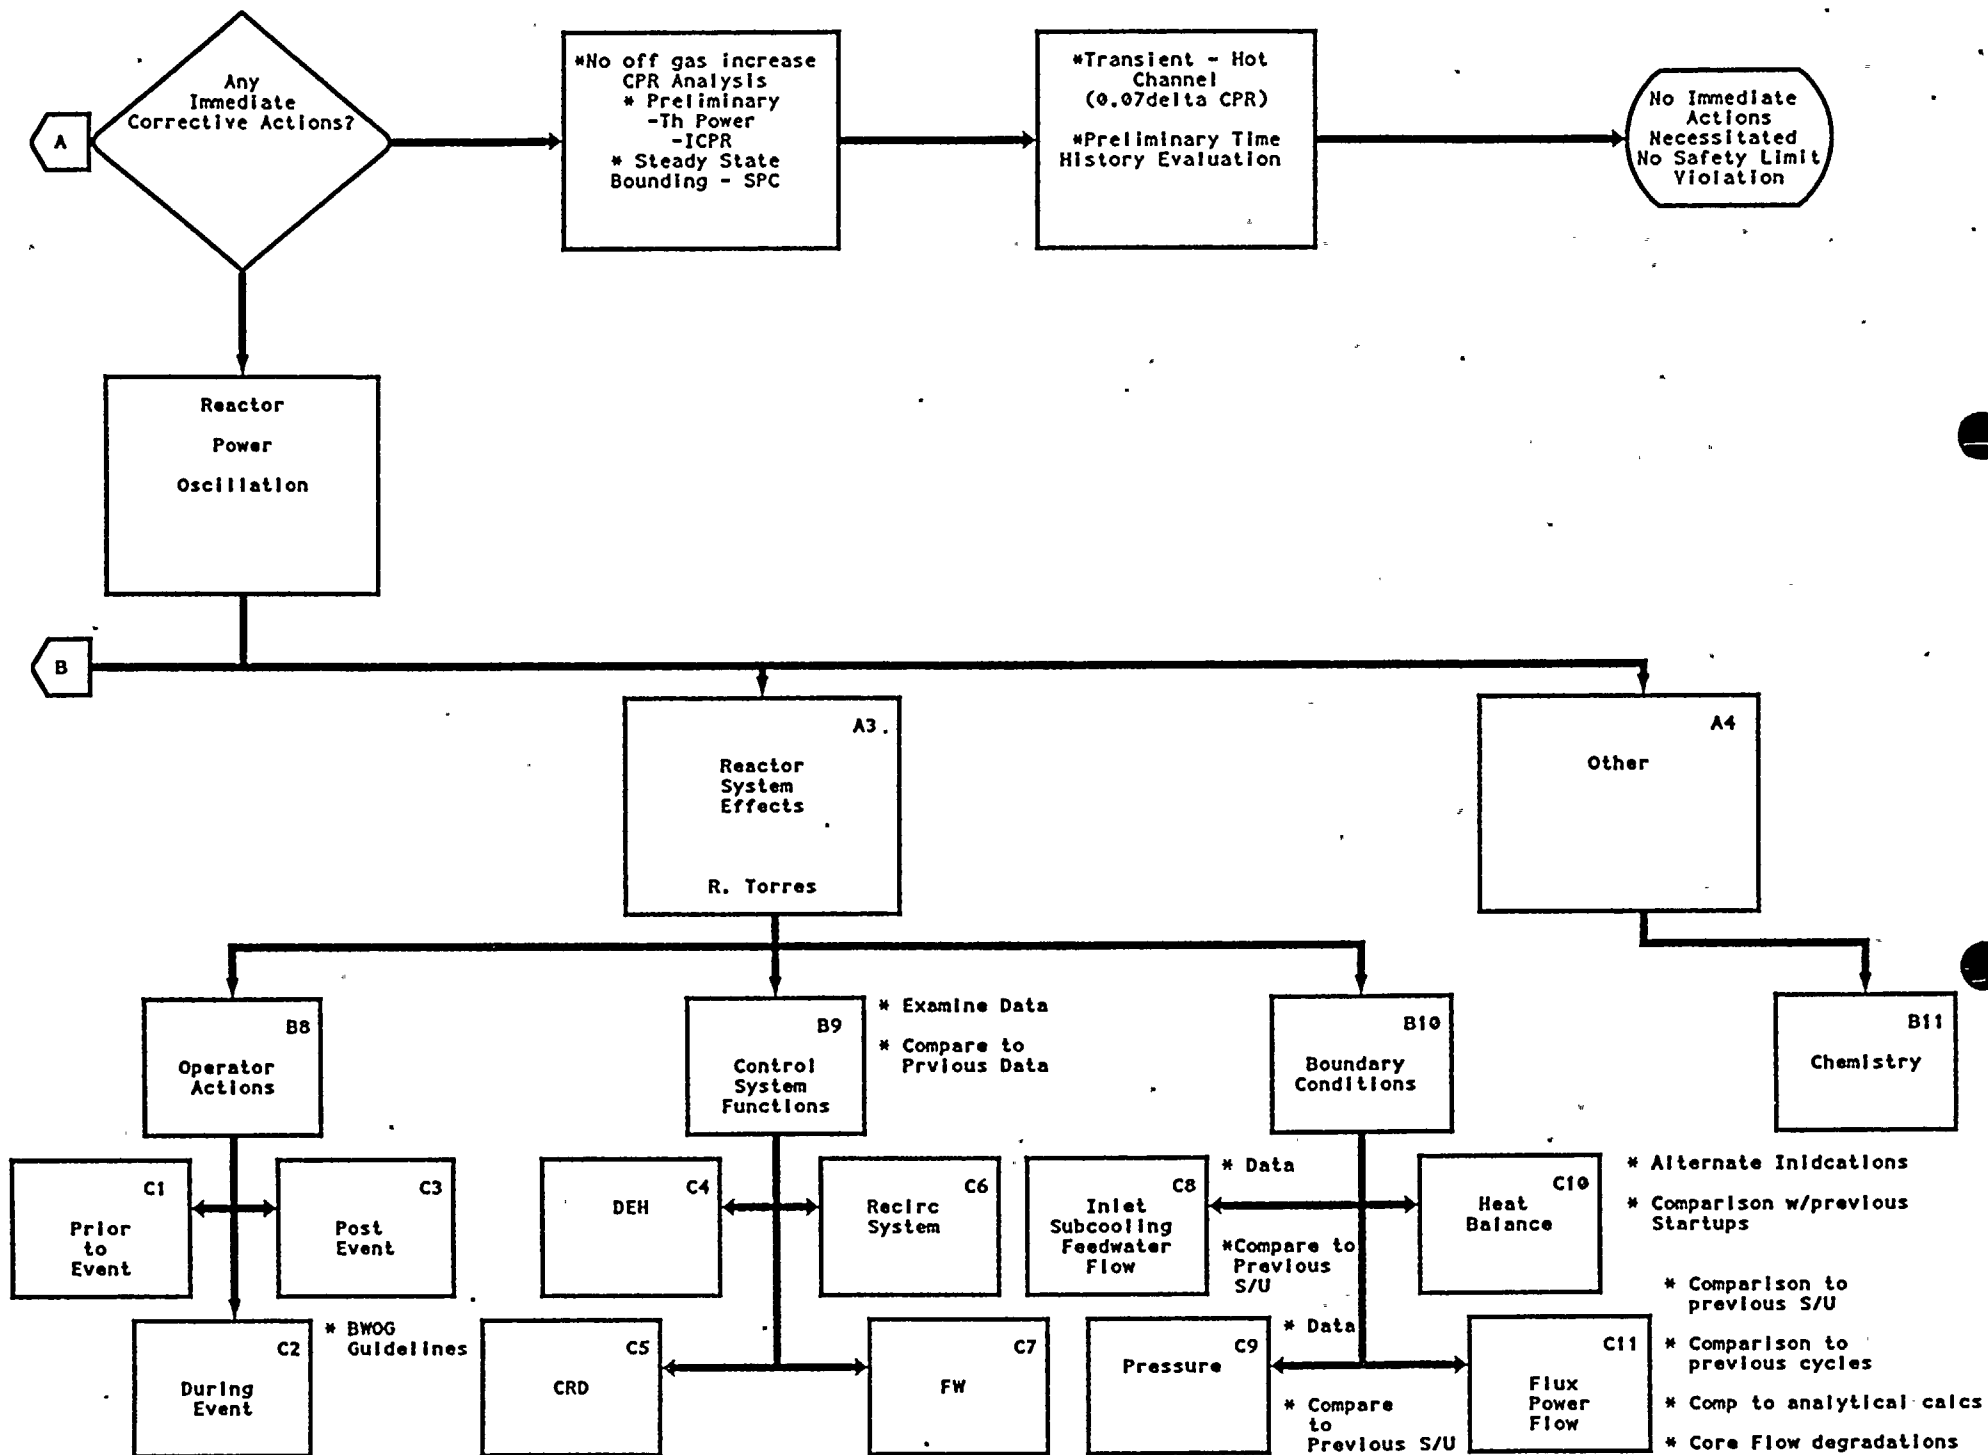
Immediately, an Incident Investigation Team was formed with a variety of team members from Supply System staff, General Electric, Siemens Power Corporation, and INPO (see attached letter dated August 15, 1992). The group's efforts to define the scope of their task resulted in a Fault Tree Analysis Plan to systematically define all possible sequences of events pertaining to power oscillations and investigate each one of these sequences thoroughly (see attached Fault Tree Analysis).

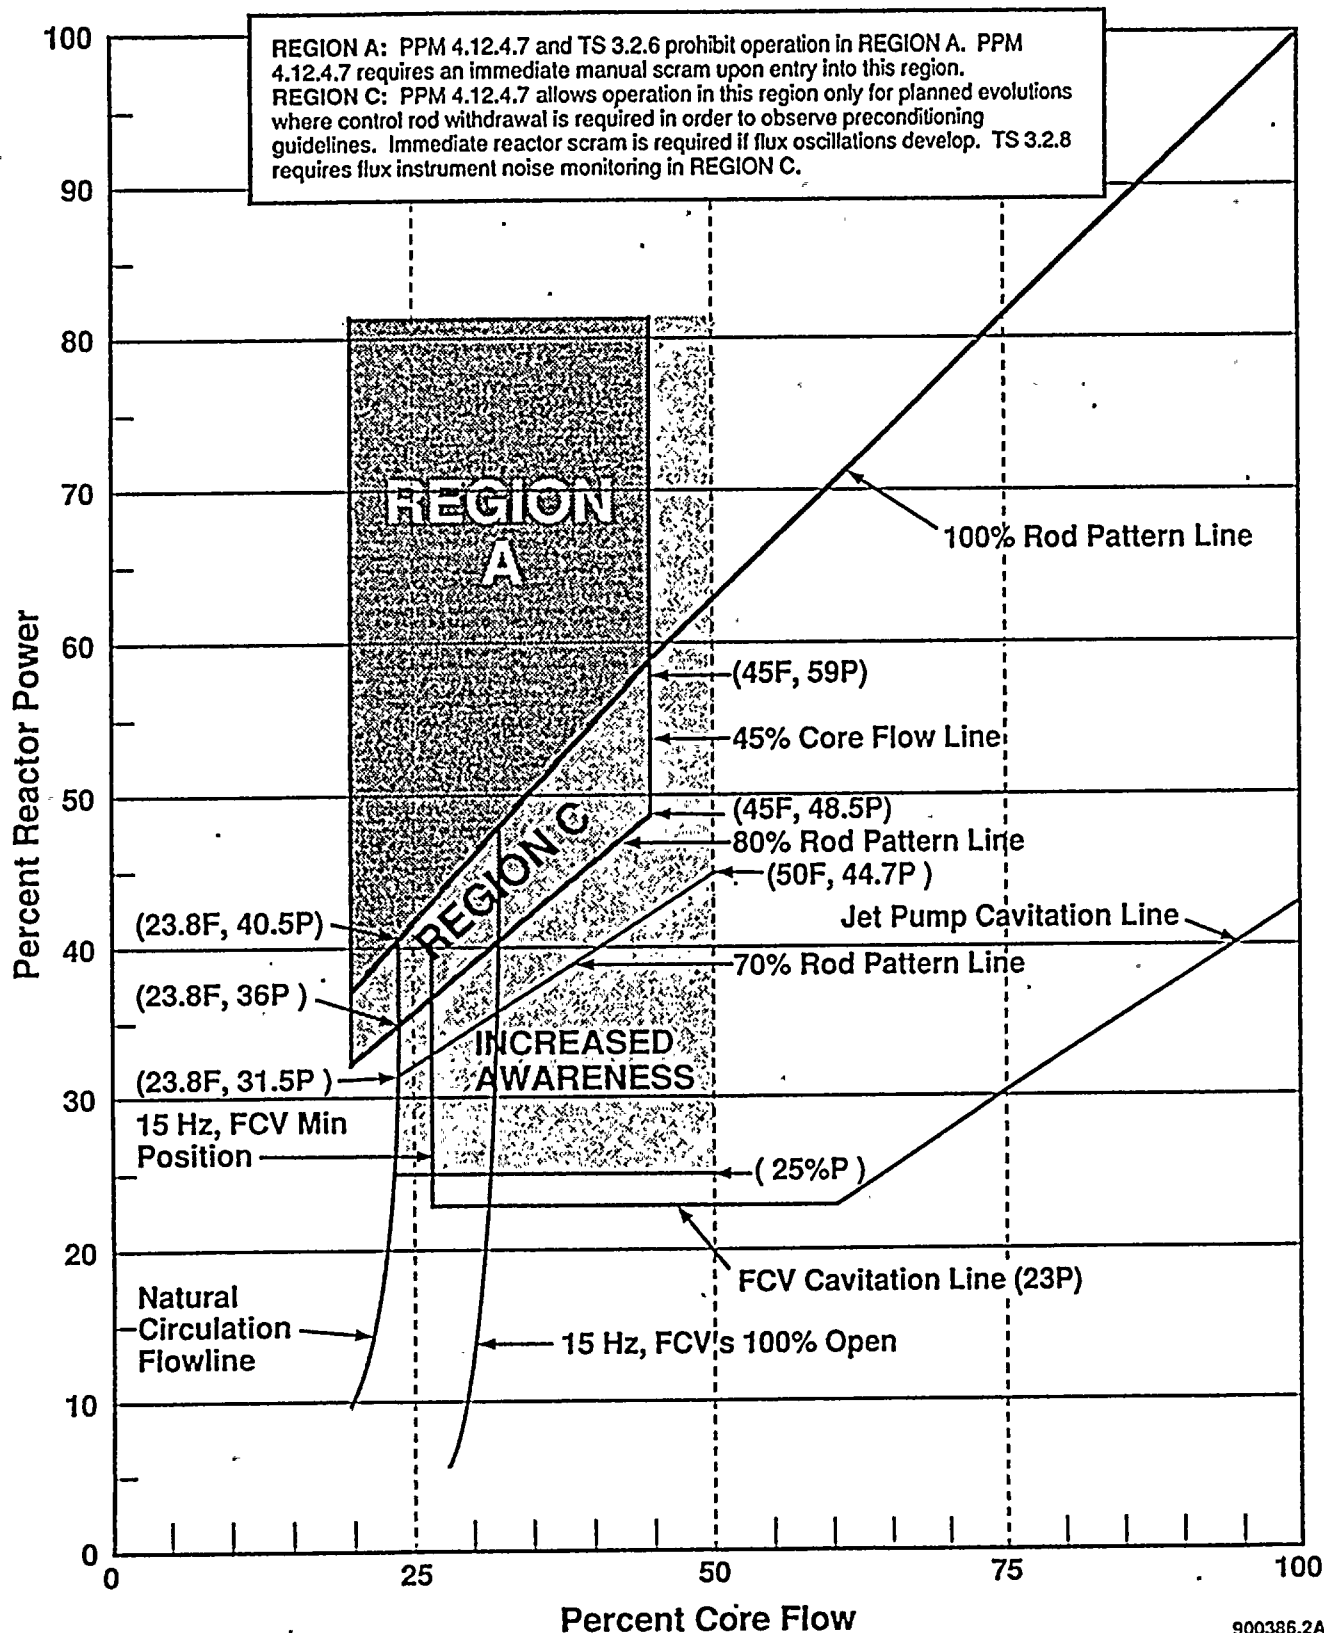
Two Loop Operation Plant 2 Operating Map

The above explanation describes the conditions which placed the core in the region of the Power to Flow Map that would increase the probability of a power oscillation. The events which led the STA and operators to place the core in this condition are as follows. The Xenon transient allowed the STA to proceed further into the "Pull Sheet" where the

These actions were implemented by procedural changes and training of personnel on these changes. The Power to Flow Map was revised to reflect these changes by designating an "INCREASED AWARENESS" region (see attached Power to Flow Map). BWROG Implementation Guidance for Stability Interim Corrective Actions have been implemented in Plant procedures and reinforced by training sessions and exam testing.
