LICENSEE EVENT REPORT (LER)

Washington Nuclear Plant - Unit 2

MANUAL REACTOR SCRAM DUE TO CORE INSTABILITY

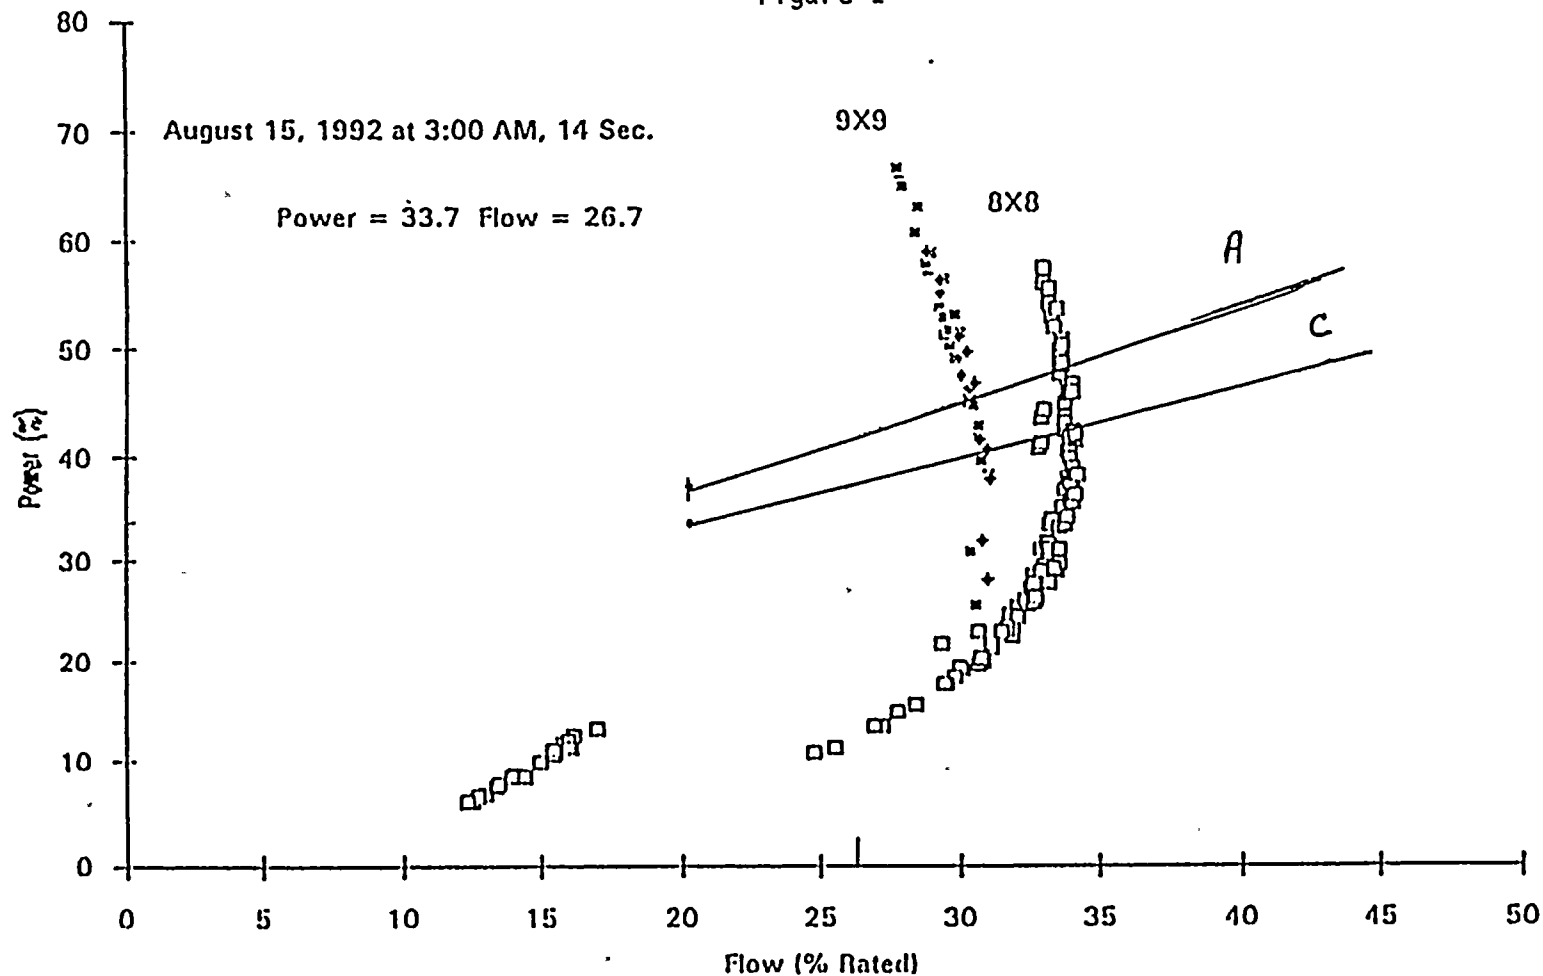
Figure 1

subsequently been determined that this resulted in a tendency toward thermal-hydraulic instability. As can be seen from the attached Figure 1, a significant number of 9x9 assemblies were operating at higher power and lower flow than the coresident 8x8 fuel. Thus, a number of individual subassemblies were actually operating in the region where instabilities can occur. Enough individual subassemblies reached the point of hydraulic instability and the overall core flux oscillations followed.

Power Flow - Individual Assemblies

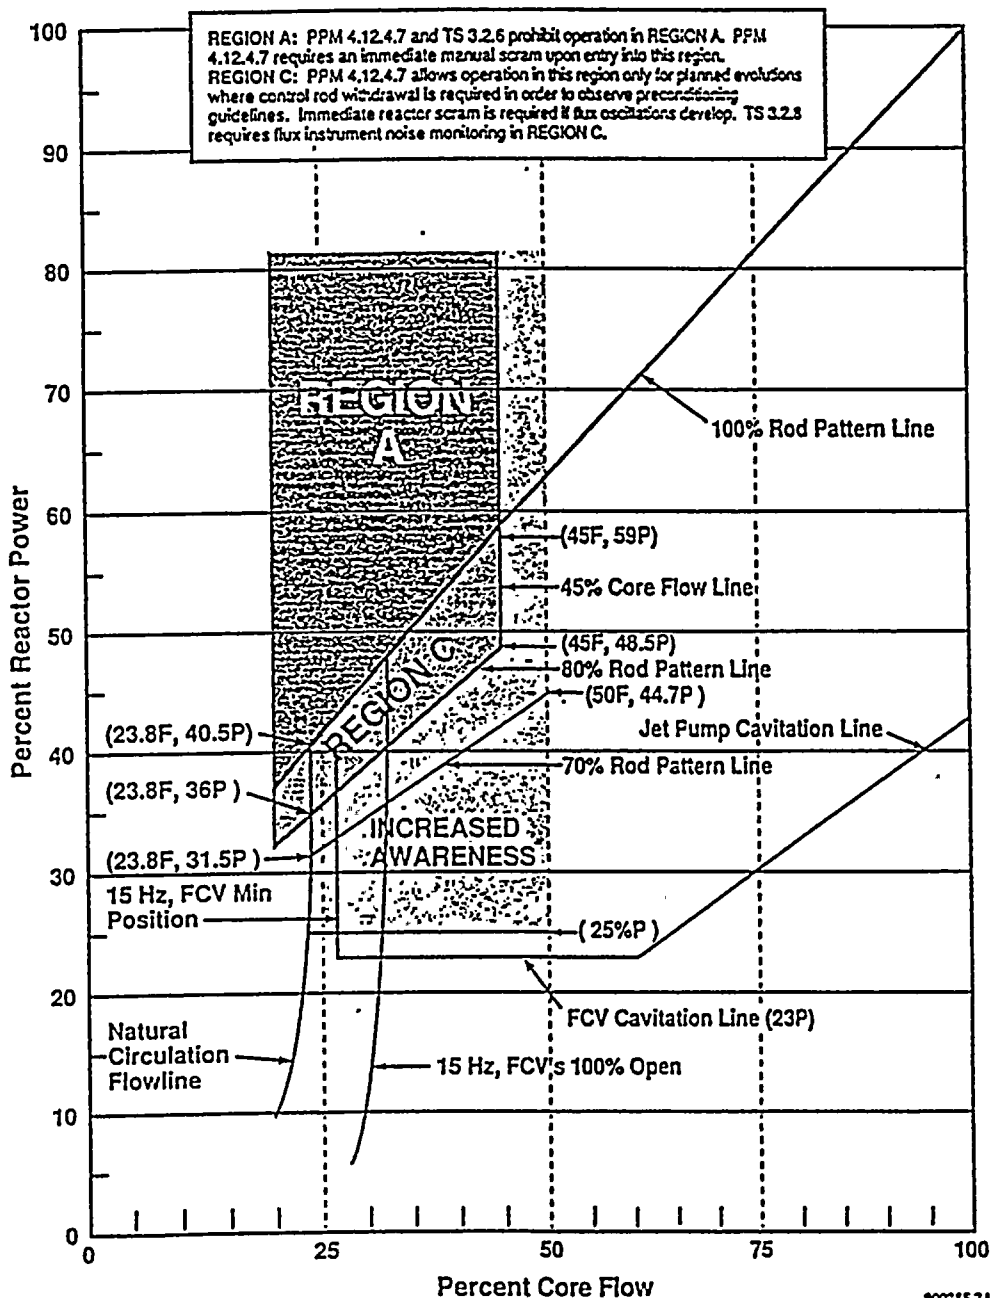
Figure 2

Two Loop Operation Plant 2 Operating Map

3. Procedures for monitoring power oscillations will require that the ANNA system be operable and in service from greater than 25% reactor power and less than 50% core flow (see attached Figure 2).
