SUBJECT: LER 92-039-00:on 920921,RWCS isolated on high differential flow while ROs were attempting to place filter-demineralizer RWCU-DM-1B back into service.Caused by inadequate mgt methods.Degraded equipment repaired & procedures updated.

**SUBJECT: NUCLEAR PLANT WNP-2, OPERATING LICENSE NPF-21  
LICENSEE EVENT REPORT NO. 92-039-00**

REACTOR WATER CLEANUP ISOLATION DUE TO HIGH DIFFERENTIAL FLOW

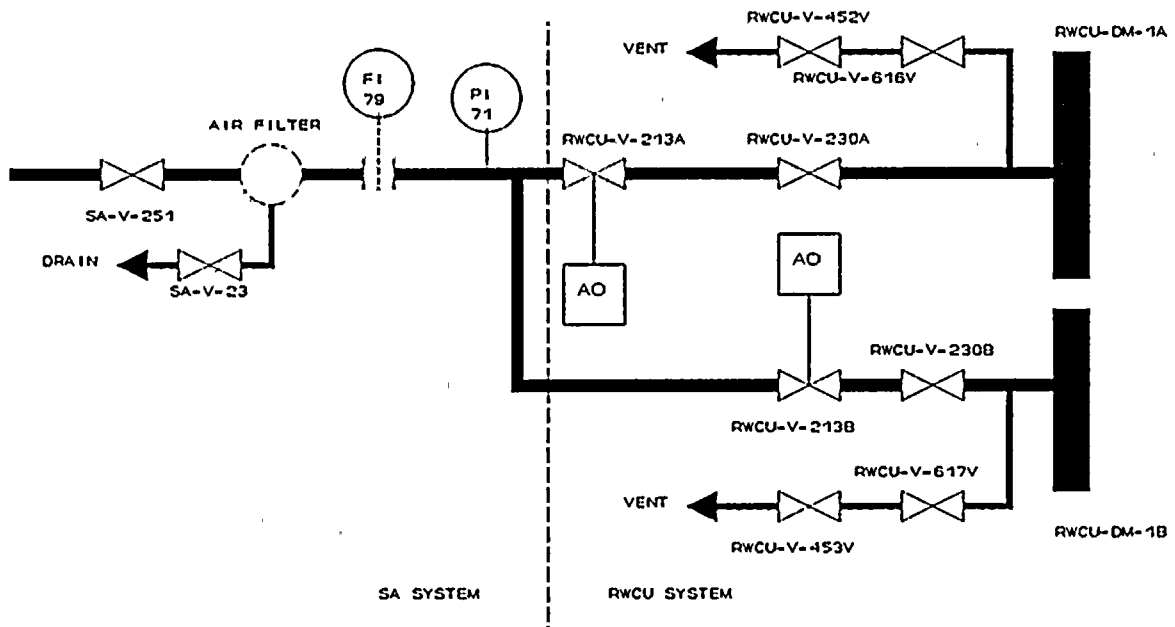
SA/RWCU AIR SURGE FLOW DIAGRAM

The air supply valve RWCU-V-213B has been leaking for approximately one and half years. The leak allowed air into RWCU-DM-1B following completion of the air surge step and during the filter regeneration process when the tank is at atmospheric pressure.

The crucial steps to prevent air from leaking into the demineralizer RWCU-DM-1B included closing SA-V-251 and opening the air filter drain valve SA-V-23. Opening the air filter drain valve was to depressurize the SA header downstream of SA-V-251 and upstream of RWCU-V-213B.

As a result of the leaking SA-V-251 and RWCU-V-213B valves, misalignment of the SA-V-3 and RWCU-V-230B valves created an air pocket in the RWCU-DM-1B tank. When bringing the F/D into service, the F/D inlet valve is opened to pressurize the F/D with the outlet valve closed. Normally there would be no flow of water into F/D tank because the tank would be vented and filled completely with water. In this case, because of the air pocket that had developed, water flowed into the tank when the F/D inlet valve was opened, compressing the air pocket to reactor pressure. The high differential flow condition occurred during the time the air pocket was being compressed.

1. Plant Procedures have been changed to clarify the required position of SA-V-23.
2. Internal leakage of RWCU-V-213B was corrected on or about October 17, 1992.

1. Correct the internal leakage of SA-V-251 by May 31, 1993.
2. Operations Management will re-emphasize procedural compliance with operating crews by November 30, 1992. The emphasis will indicate that the steps are to be completed prior to proceeding with the evolution. It is inappropriate to assume that a step has been performed without having personal knowledge of its correct execution.
3. Management expectations with regard to supervisory involvement in specific evolutions will be clarified by November 30, 1992.
4. Management will identify similar chronic problems and ensure the priority for resolution is commensurate with the problem's impact on Plant safety, availability and operation by November 15, 1992.
5. Management expectations will be formalized by November 30, 1992 with regard to Reactor Operator response to RWCU high differential flow conditions.
