SUBJECT: Suppls listed responses to NRC Bulletin 90-002, "Loss of Thermal Margin Caused by Channel Box Bow," effect on Cycle 9 operation. Requests NRC approval for plan to reuse channel boxes during Cycle 9.

Subject: **WNP-2, OPERATING LICENSE NPF-21  
RESPONSE TO NRC BULLETIN NO. 90-02: "LOSS OF THERMAL  
MARGIN CAUSED BY CHANNEL BOX BOW", EFFECT ON CYCLE 9  
OPERATION (TAC No. M82920)**

NRC INFORMATION NOTICE 92-74: POWER OSCILLATIONS AT WASHINGTON NUCLEAR POWER  
UNIT 2 ✓

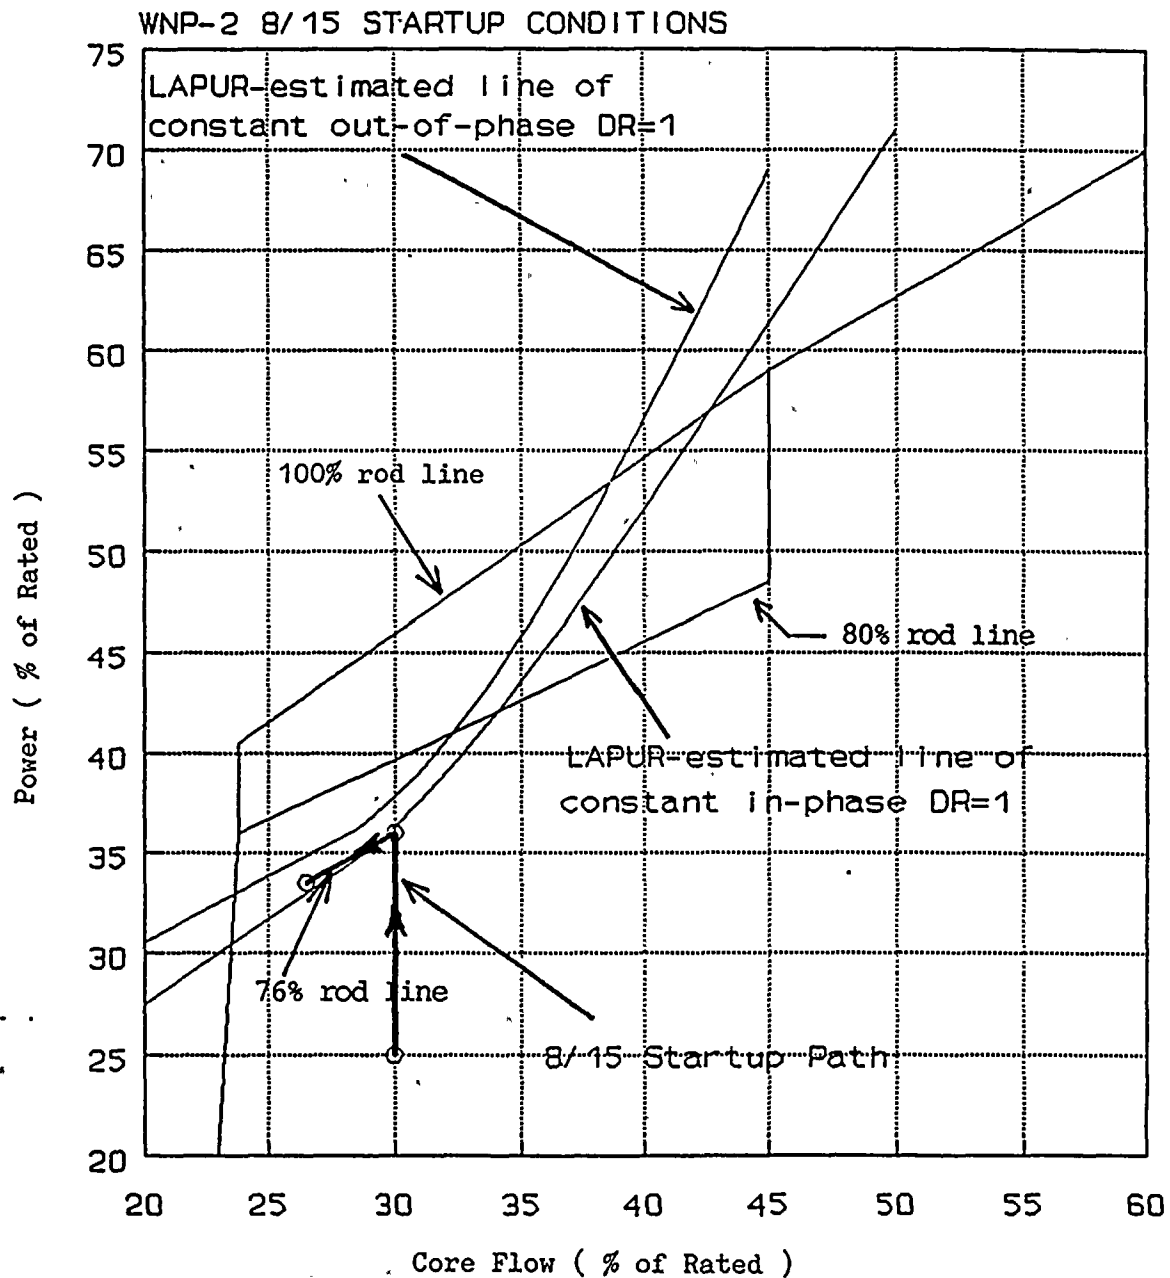
Figure 1. Best-estimate lines of constant decay ratio=1.0 for actual conditions of 8/15 event, assuming constant power distribution

After completing the tests, the operators continued the restart up the (approximately) 30-percent flow line to about 36-percent power (Figure 1). This is at a power above the recirculation pump cavitation region. The operators then began closing one of the two FCVs in preparation for shifting the associated recirculation pump to fast speed. During this change, in which power and flow decreased along the 76-percent rod line to a power/flow of about 34/27 percent, the operators observed power oscillations first on the average power range monitors (APRMs) and then by local power range monitors (LPRMs) downscale indications. Upon recognizing the power oscillations, the plant operators manually initiated a reactor scram. Post-event review indicated that the 2-second-period oscillations were in-phase (core-wide) and had grown to a peak-to-peak amplitude of about 25 percent of rated power. Most of the oscillation amplitude increase occurred in an interval of about 1 minute with the oscillations continuing at the limiting (maximum) amplitude for an additional minute before scram. The oscillations occurred while the reactor was operating at a power about 4 percent of rated power below the lower exclusion region boundary line (the nominal 80-percent rod line). During later review, the licensee found no indication that fuel had failed because of the event.

The NRC sent an Augmented Inspection Team (AIT) to the site to determine the possible causes and relevant facts of this event. The AIT concluded that the primary cause of the oscillations was very skewed radial and bottom peaked axial power distributions in the reactor (1.92 radial peaking factor and 1.62 core average axial peaking factor). These power distributions resulted from (1) the control rod pattern that the shift technical advisor selected for increasing the power and shifting the recirculation pump speed, and (2) the relationship of this control rod pattern to the specific WNP-2 cycle 8 core fuel loading configuration. These rod patterns were primarily directed towards achieving the target full power configuration and did not consider stability concerns.

The AIT also found, by analyses using the LAPUR code, that a contributor to the oscillations was the core loading, consisting of a mixed core with unbalanced flow characteristics between the new 9x9-9x fuel and the old 8x8 fuel. The analyses indicated that a full core of the 9x9-9x fuel would be significantly less stable than the old 8x8 fuel, and that the mixed core was less stable than a fully loaded core of either fuel type. The analyses also indicated that while the oscillations would be in-phase (core-wide), as observed in the event, the out-of-phase (regional) instability boundary would be very close to the in-phase boundary (Figure 1). The AIT found that small changes in operating conditions could have resulted in out-of-phase oscillations, which would have been more difficult for the APRM system to detect.

The licensee successfully restarted the unit after implementing the following restrictions for maintaining the limits on rod withdrawal patterns and power distribution in the low flow regions of concern.

- The licensee analyzed the control rod patterns for stability before startup, and the operator could not change these patterns without analysis and review.
- The calculated maximum total peaking factor was less than 3.4.

- The calculated core average axial peaking factor was less than 1.45.
- The Minimum Critical Power Ratio was greater than 2.2.
- The licensee analyzed the conditions at FCV closure and found a decay ratio of less than 0.5. The recirculation pump was shifted to fast speed with the reactor power less than 33 percent and the feedwater temperature greater than 146.1 °C (295 °F).
- The licensee continuously used the ANNA monitor when the reactor was operating above 25 percent power and below 50 percent flow.
