SUBJECT: LER 88-031-01:on 880902,determined that due to single failure CR HVAC sys could operate in recirculation mode. Caused by lack of communication between AE design groups.CR HVAC recirculation mode of operation analyzed.W/930212 ltr.

**SUBJECT: NUCLEAR PLANT WNP-2, OPERATING LICENSE NPF-21  
LICENSEE EVENT REPORT NO. 88-031-01**

# LICENSEE EVENT REPORT (LER)

TITLE (4)  
**SINGLE FAILURE COULD CAUSE CONTROL ROOM HVAC TO OPERATE IN AN UNANALYZED OPERATION MODE DUE TO DESIGN**

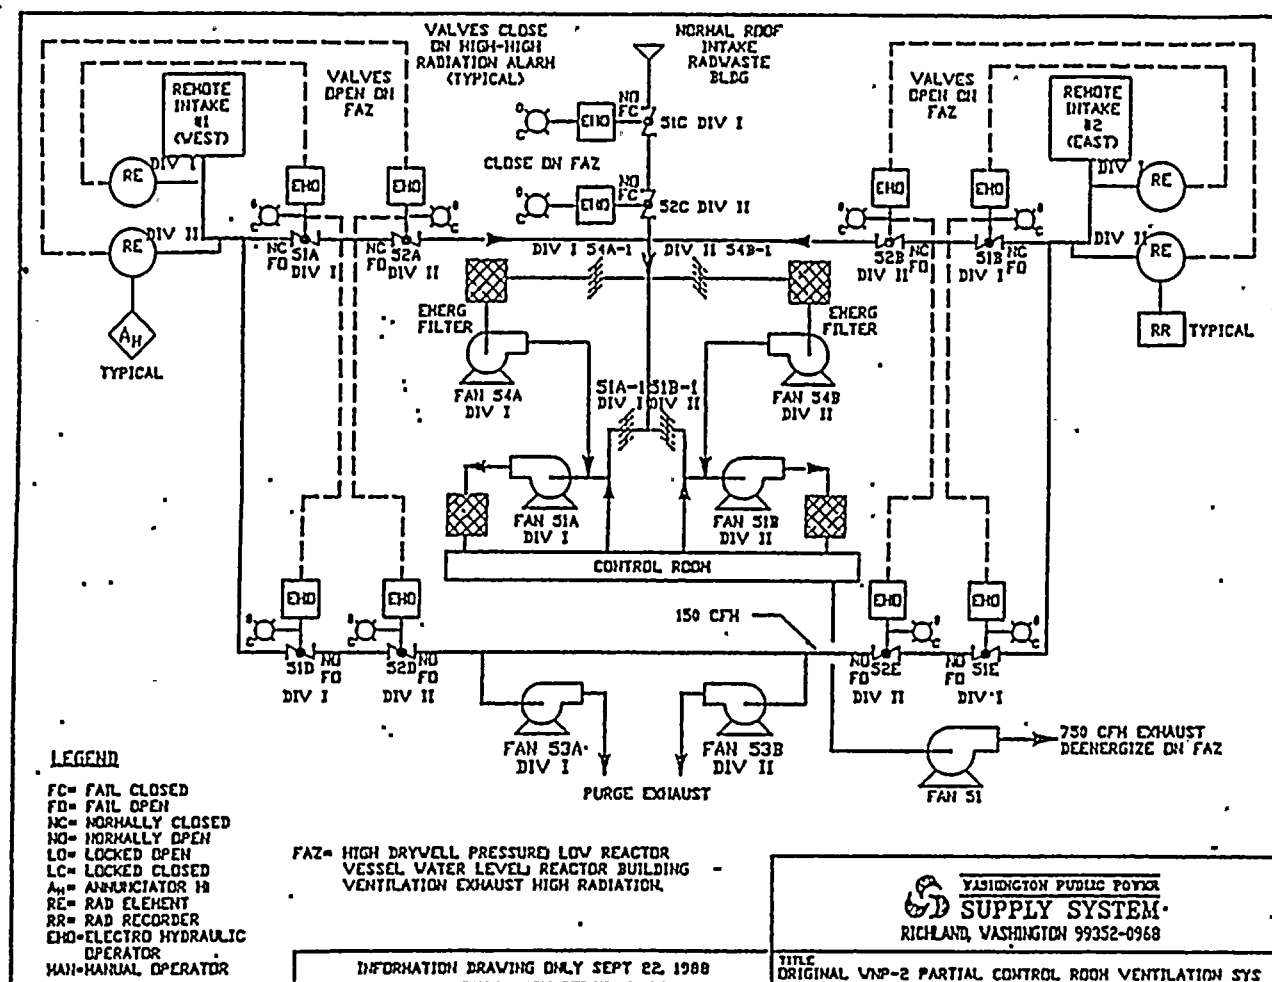
Figure 1 Pre-Event Control Room HVAC

The following brief description of the Control Room HVAC System (before modification) for normal operation and emergency operation during a Loss of Coolant Accident (LOCA) is presented to aid in understanding the event and the changes made to the system. Figure 1 is a partial diagram of the Control Room HVAC System prior to the event. The Control Room HVAC System consists of two redundant systems for both normal and emergency operation. During normal operation, 1000 cfm of fresh air from the normal roof intake Radwaste Building is mixed with 20,000 cfm of recirculated air (through fan 51A or 51B). Seven hundred and fifty (750) cfm is exhausted from the control room through fan 51 and the remaining 250 cfm pressurizes the control room and is exfiltrated. Also during normal operation, the remote air intake isolation valves (51A and B and 52A and B) are closed and the radiation monitor purge line valves (51D and E and 52D and E) are open with radiation monitor purge line fans 53A and B operating. During a LOCA when any of the following trip levels are reached 1) High drywell pressure ("F" signal), 2) Low low reactor water level ("A" signal) or 3) Reactor building ventilation exhaust high radiation ("Z" signal) the following actions occur:

- a) The normal roof intake Radwaste Building is isolated by closing valves 51C and 52C.

- b) The 750 cfm control room exhaust fan (51) deenergizes.
- c) The remote air intake isolation valves (51A, 51B, 52A, and 52B) open and the radiation monitor purge line isolation valves (51D, 51E, 52D and 52E) close. The remote air intake isolation valves and the radiation monitor purge line isolation valves are interlocked so when an intake line is opened the associated purge line is isolated.
- d) The control room emergency filtration system is automatically started and draws 1000 cfm of fresh air through the remote air intakes. This additional air, when added to the recirculated air, pressurizes the control room.

The event described in LER 88-005 was for leakage around the emergency filters in excess of the technical specification allowable limit. During the engineering evaluation committed to in LER 88-005 to determine the effect of the excess leakage on control room habitability, a design engineer determined that postulated single failures could cause some combination of remote air intake line isolation valves to fail to open or to reisolate and; thus, isolate both remote air intake lines. If this condition existed during LOCA conditions, the Control Room HVAC would be running in a recirculation mode only since the normal roof intake is also isolated. In the recirculation mode the 20,000 cfm would continue to be drawn from the control room and recirculated back to the control room; however, without the fresh air input the control room would not be pressurized. In a neutral pressure condition the inleakage to the control room would increase and this condition is not analyzed.
