SUBJECT: LER 93-006-00: on 930206, manual reactor scram initiated due to reactor recirculation pump trip while operating in area of increased awareness. Caused by component design parameter. RRC sys operating procedure changed. W/930308 ltr.

**SUBJECT: NUCLEAR PLANT WNP-2, OPERATING LICENSE NPF-21  
LICENSEE EVENT REPORT NO. 93-006**

Washington Nuclear Plant - Unit 2

**MANUAL REACTOR SCRAM INITIATED DUE TO REACTOR RECIRCULATION PUMP TRIP WHILE OPERATING IN THE AREA OF INCREASED AWARENESS**

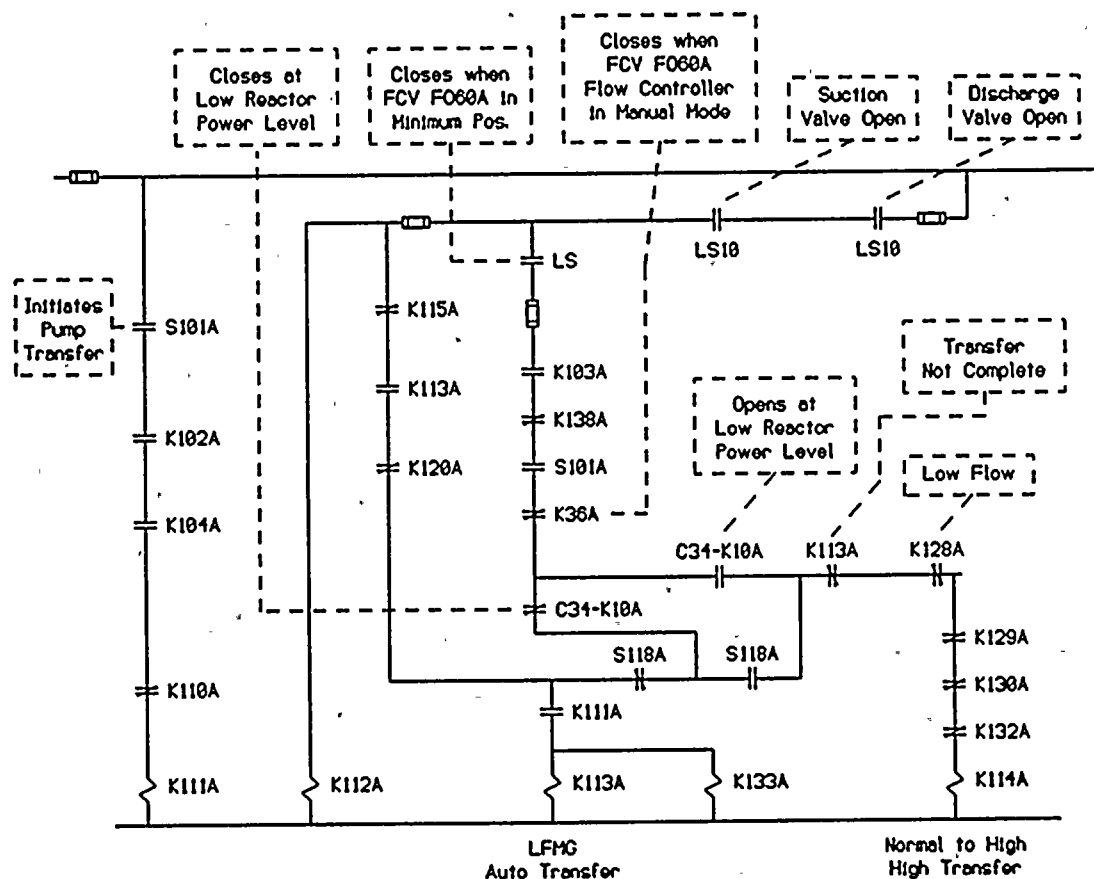
FIGURE 1

4. The pump start circuit is designed so that the relay C34-K10A selects the slow speed or high speed logic (see Figure 1). This relay only serves this function while the pump start switch S101A is held in the start position. Examination of the TDAS data indicated the operator held the switch in that position for about 12 seconds and that the breaker RRC-RPT-3A received the trip signal about four seconds after it closed. In order for the logic to cause this pump trip during the pump shift, the low feed flow signal must be received while the switch S101A is held in the start position, so as the time the switch is held in the start position increases the probability of receiving the spurious trip increases.

5. The circuitry design for transferring the pumps from slow to high speed has an unintended path resulting in tripping the 3A breaker if the attempt to shift the pumps is made at too low of a reactor power level. As installed, at a low power level as indicated by a low feed flow signal, the circuit will provide a path to seal in the logic for a slow speed start when the 3A breaker control switch S101A is held in the pump start position that causes the 3A breaker to open when the pump reaches 95% of rated speed. However, because of other components within the circuit, the actions taken to shift the pump to high speed also initiate interlocks that prevent connecting the pump to the LFMG. (The control switch for the RRC pump start is the breaker control switch for RRC-RPT-3A.) As designed, the status of the relay C34-K10A selects either the slow speed logic or the high speed logic. It was not intended, by the designer, for the shift to be attempted as near to the low flow condition as is currently required at WNP-2. The pump shift interlock to prevent high speed operation during low power and low feed flow conditions is provided with a 15 seconds time delay to avoid spurious signals resulting in pump trips.

1. The root cause of this event is that the risks and consequences associated with changes were not adequately reviewed or assessed. Instructions to allow bypassing the low feed flow pump start interlock while requiring a pump shift at a low power level were removed from the system operating procedure and additional restrictions in place to prevent core oscillations required the pump shift at low power levels.
2. A second root cause for this event has been categorized as a component not operated within the component design parameters in that the power level and feed flow conditions, at which the transfer to high speed was attempted, were not within the acceptable parameters to satisfy to logic circuitry.

1. The recirculation system operating procedure, PPM 2.2.1, was deviated to allow bypassing the pump start interlock C34-K10A contact during pump shift from slow to high speed.
