Subject: NUCLEAR PLANT WNP-2, OPERATING LICENSE NPF-21
LICENSEE EVENT REPORT NO. 93-017

Washington Nuclear Plant - Unit 2

FIRE DAMPER SEISMIC QUALIFICATION CONCERNS IDENTIFIED IN 1985 THROUGH 1987 WERE NOT REPORTED

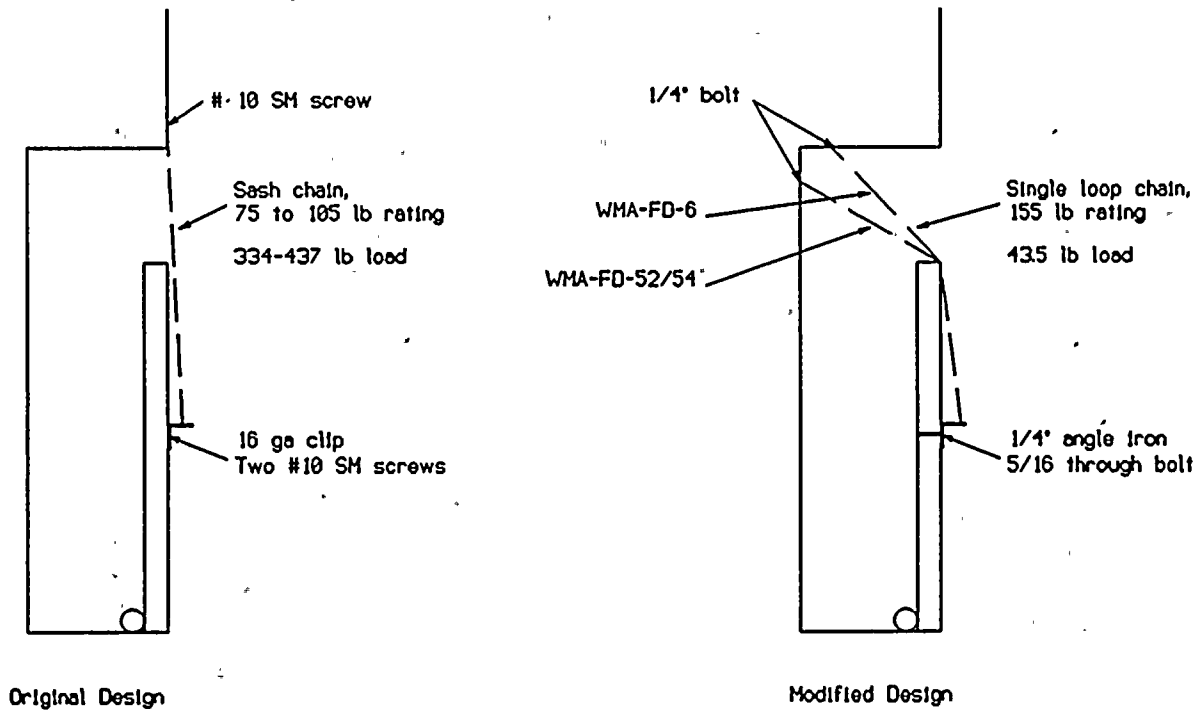
Sash type chains, "S" hooks, fusible links and chain end fasteners were used to hold fire dampers in the open position during normal operation. A failure of any of these components would cause the associated fire damper to close inadvertently. Based on the results of Calculation EQ-02-85-064004-01, the chains, end fastening clips and sheet metal screws for fire dampers WMA-FD-6, WMA-FD-52 and WMA-FD-54 could not be seismically qualified. The calculation concluded that the predicted seismic loading on the chains and fastening clips exceeded their rating, and they could fail during a seismic event. The fire dampers and associated hardware were supplied to WNP-2 by Ruskin Manufacturing between 1974 and 1975, and subsequently installed by Waldinger Corporation.

7. NCR 285-0543 was revised on April 30, 1987, to include sixteen trap door type fire dampers that had marginal or inadequate design. Calculation EQ-02-85-064004-01 determined that, of the sixteen fire dampers identified in the NCR revision, only WMA-FD-6, WMA-FD-52 and WMA-FD-54 had as-built configurations (see Figure 1) that could have failed during a seismic event. The seismic loading on the sash chains and chain end fastening clips exceeded their rating.

Though only three of the fire dampers were found to have a clearly inadequate design, approximately twenty-one fire dampers were modified in accordance with Basic Design Change (BDC) 02-86-0018 to include stronger chains, "S" hooks, fusible links and/or chain end fastening hardware. In some cases, the method of attaching the chain was also modified; see Figure 1 for example. These modifications were implemented under Maintenance Work Request (MWR) AU9856, and completed on June 3, 1987.
