SUBJECT: LER 91-017-01: on 910708, Auto start of emergency diesel generators occurred while on backfeed. Undervoltage initiated by a 500KV grid disturbance caused by personnel error & equipment design. Shutdown cooling restored. W/930609 ltr.

Subject: **NUCLEAR PLANT WNP-2, OPERATING LICENSE NPF-21
LICENSEE EVENT REPORT NO. 91-017-01**

LICENSEE EVENT REPORT (LER) TEXT CONTINUATION							
FACILITY NAME (1) Washington Nuclear Plant - Unit 2	DOCKET NUMBER (2) 0 5 0 0 0 3 9 7	LER NUMBER (8)			PAGE (3)		
		Year	Number	Rev. No.			
		9 1	0 1 7	0 1	2	OF	7
TITLE (4) AUTO START OF EMERGENCY DIESEL GENERATORS WHILE ON BACKFEED. UNDERVOLTAGE WAS INITIATED BY A 500 KV GRID DISTURBANCE. ROOT CAUSES ARE PERSONNEL ERROR AND EQUIPMENT DESIGN

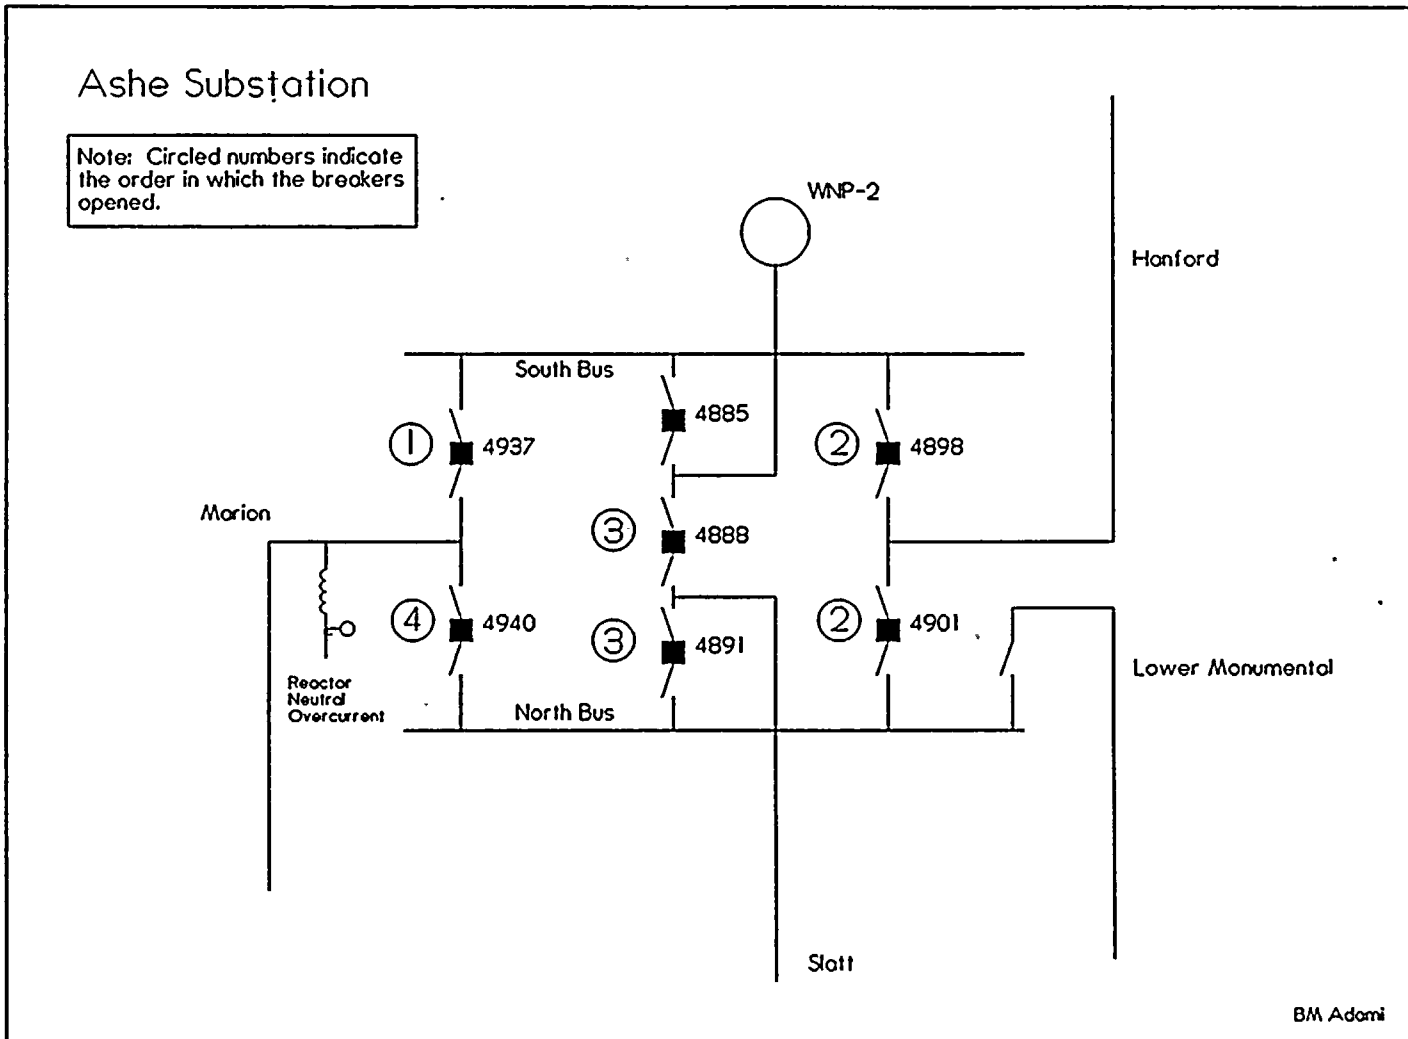
FIGURE 1

The disturbance was a ground fault on the Marion line feeding the substation. (See Figure 1 for schematic drawing of Ashe substation. The numbers in circles indicate the opening sequence for the substation breakers.) Misalignment of two protective relay selector switches at the substation precluded the BPA primary relays from immediately isolating the faulted line. The switches allowed breaker 4937 to open but not breaker 4940. Backup relaying (line relays) isolated the Hanford line (by opening breakers 4898 and 4901) and then the Slatt line (via breakers 4888 and 4891). Finally the fault was cleared when a neutral overcurrent relay timed out and opened breaker 4940. The fault was completely isolated in less than one second.

WNP-2 backfeed de-energized when the Slatt line isolated by opening breakers 4891 and 4888. Since the Hanford, Slatt and Marion line relays are not designed to trip breaker 4885, WNP-2 was left connected to the de-energized South bus through 4885. Breaker 4885 was not required to open to isolate the fault and did not open. Plant design includes logic for automatic transfer of station power from the off-site 500KV system to the 230 KV Startup transformer (TRS) in the event of a Main Generator trip. However, when the plant is in the 500 KV backfeed configuration, the Main Generator is out of service, and the logic is only actuated by faults on the power distribution system between WNP-2 and the Ashe substation. Since the electrical fault was isolated at the substation, auto-transfer to the Startup source did not occur by design. The resultant loss of power to critical plant buses was detected by undervoltage protective relays. The loss of voltage relay scheme then transferred Division 1 and 2 critical bus power to the Backup transformer (TRB) within four seconds. Concurrently, the loss of voltage relays started the Division 1 and 2 Diesel Generators. The High Pressure Core Spray (HPCS) Diesel Generator was out of service for maintenance at the time of the event.

BPA will implement modifications to: 1) automatically record relay selector switch activity; 2) annunciate and alert the substation operator if a relay selector switch is out of its normal position; and 3) color coding the selector switches to facilitate visual determination of their position.
