SUBJECT: LER 93-021-00: on 930514, CAC sys water accumulation & failure in standby SW sys due to inadequate original analysis of the sys design. No corrective actions required because CAC sys & primary containment not operational in Mode 5.W/930614 ltr.

Subject: **NUCLEAR PLANT WNP-2, OPERATING LICENSE NPF-21
LICENSEE EVENT REPORT NO. 93-021**

TITLE (4)
CONTAINMENT ATMOSPHERE CONTROL (CAC) SYSTEM WATER ACCUMULATION AND POTENTIAL CONTAINMENT BYPASS

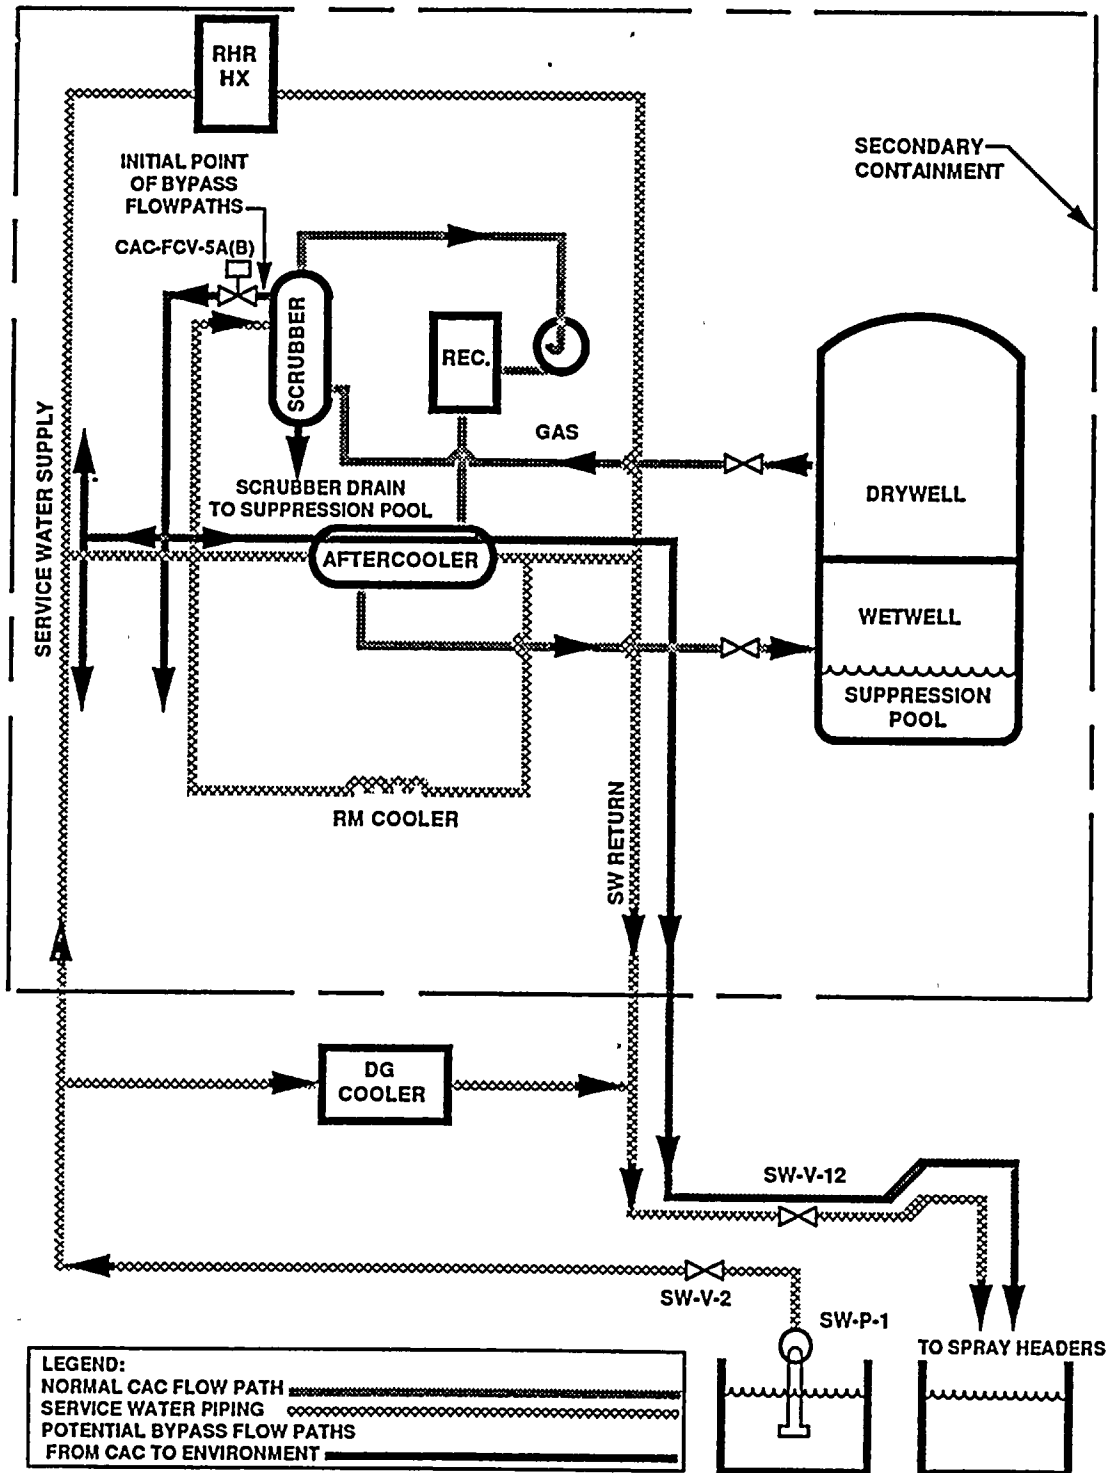
FIGURE 1: CONTAINMENT BYPASS: CAC TO SW SPRAY PONDS

Similarly, on June 2, 1993, at 1215 hours, with the reactor in Mode 5, an additional evaluation concluded that a post-LOCA Primary Containment gas-bypass of Secondary Containment (the Reactor Building) could occur through the CAC system. This problem was discovered by a Supply System engineer who was involved with the original SSFI and who was performing followup work on open Quality Finding Reports (QFRs). As previously mentioned, each CAC subsystem includes a scrubber [CAC-AW-1A(B)] that cools and removes impurities from the gas stream from Primary Containment before the gas enters the CAC blowers (see figure 1).

The safety-related Standby Service Water (SW) system supplies water to each scrubber from separate spray ponds located outside Secondary Containment. Each scrubber includes a flow control valve [CAC-FCV-5A(B)] which is remote-manually positioned from the main control room to control flow to the desired value. As designed, service water drains from the scrubbers to the Suppression Pool during CAC operation. However, in the event of a single failure of a Service Water pump (shaft shear, power loss, or equivalent), the SW system would drain and create a Secondary Containment bypass flowpath. The bypass flowpath would be from CAC piping conveying gas from Primary Containment to the scrubber, out of the SW-to-scrubber inlet piping, and through drained SW piping to the outside environment via the spray pond.

The root cause for the water accumulation problem and the Secondary Containment bypass problem in both CAC subsystems was inadequate original analysis of the system design to ensure the CAC system would serve its intended function. The design was less than adequate in that it failed to recognize and prevent a potential for accumulation of condensate in the piping containing the flow orifices and flow control valves. And although the CAC system was designed as an extension of Primary Containment to ensure no leakage from the CAC system boundary could occur during a LOCA, the original design analysis failed to identify the bypass of Secondary Containment in the event of a single failure in the SW system.

3. Plant operating procedures have been revised to provide instructions for tripping a CAC subsystem if its corresponding supply of service water becomes unavailable. Tripping the CAC system automatically causes the CAC system's containment isolation valves and scrubber-inlet flow control valves to close. This provides multiple barriers between Containment and the environment.
