LICENSEE EVENT REPORT (LER)

FACILITY NAME (1) Washington Nuclear Plant - Unit 2	DOCKET NUMBER (2) 0 5 0 0 0 3 9 7	PAGE (3) 1 OF 18
---	---	----------------------------

TITLE (4)
MANUAL REACTOR SCRAM DUE TO CORE INSTABILITY

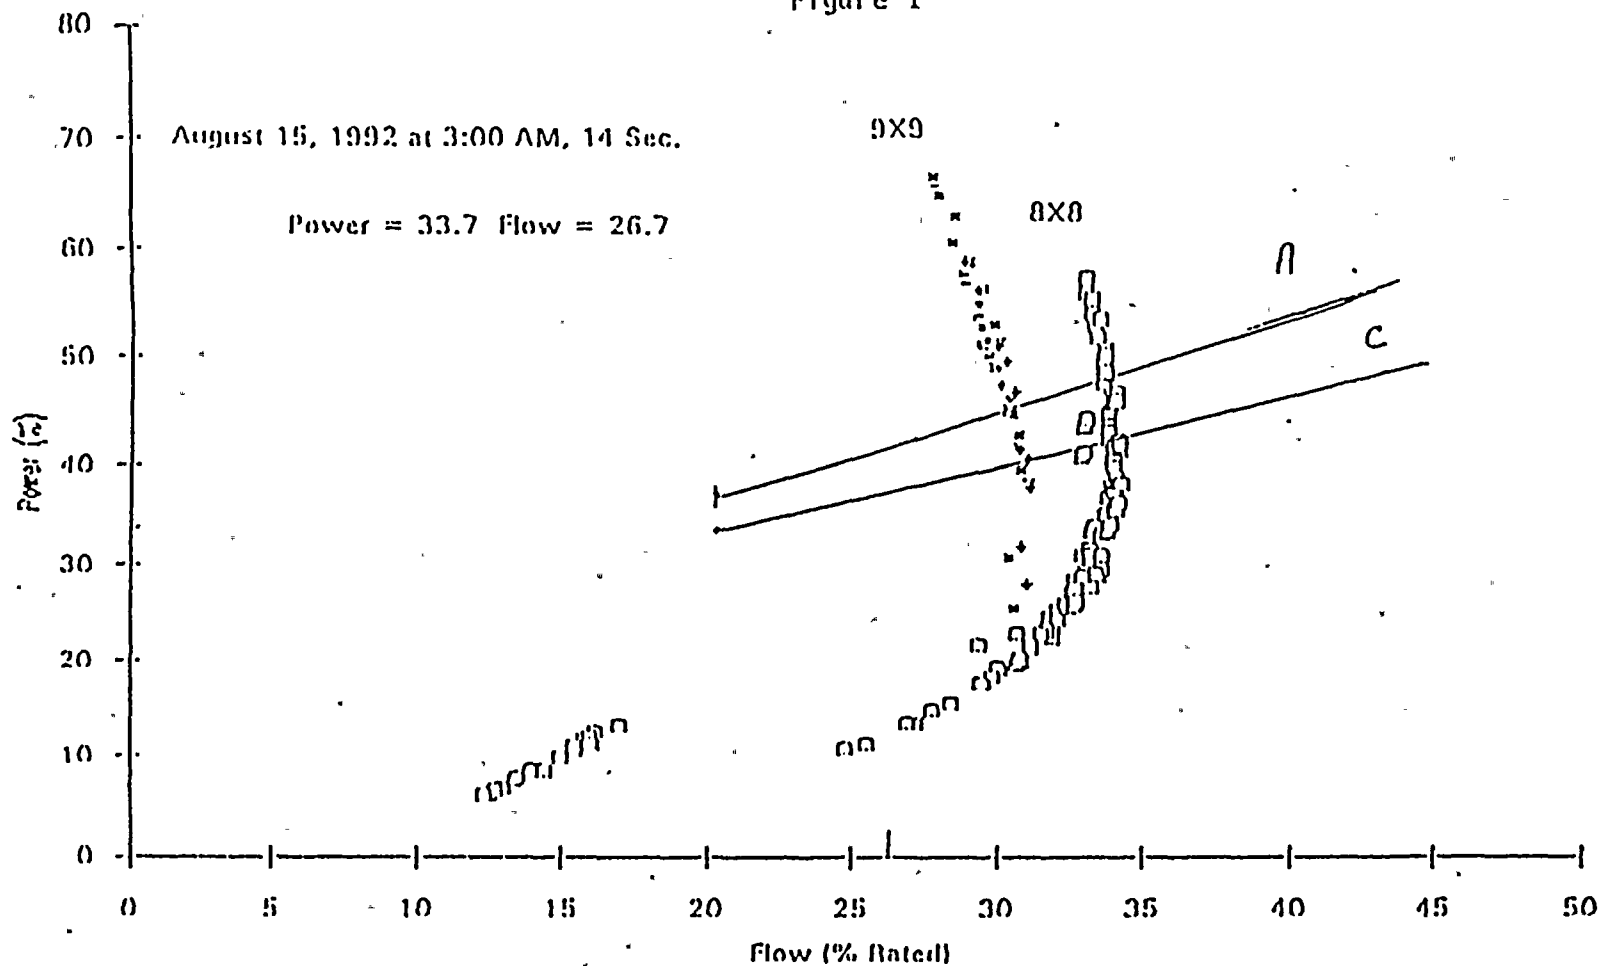
Figure 1

across them as compared to the 8x8 design. In Cycle 8, WNP-2 had about 26% of its core with 9x9 design and the remaining 74% of the core was 8x8 design including 12 LFAs. As can be seen from the attached Figure 1, a significant number of assemblies were operating at high power and relatively low flow. Thus, a number of individual assemblies were actually operating in the region where instabilities can occur. Enough individual assemblies reached the point of hydraulic instability and the overall core flux oscillations followed.

Power Flow - Individual Assemblies

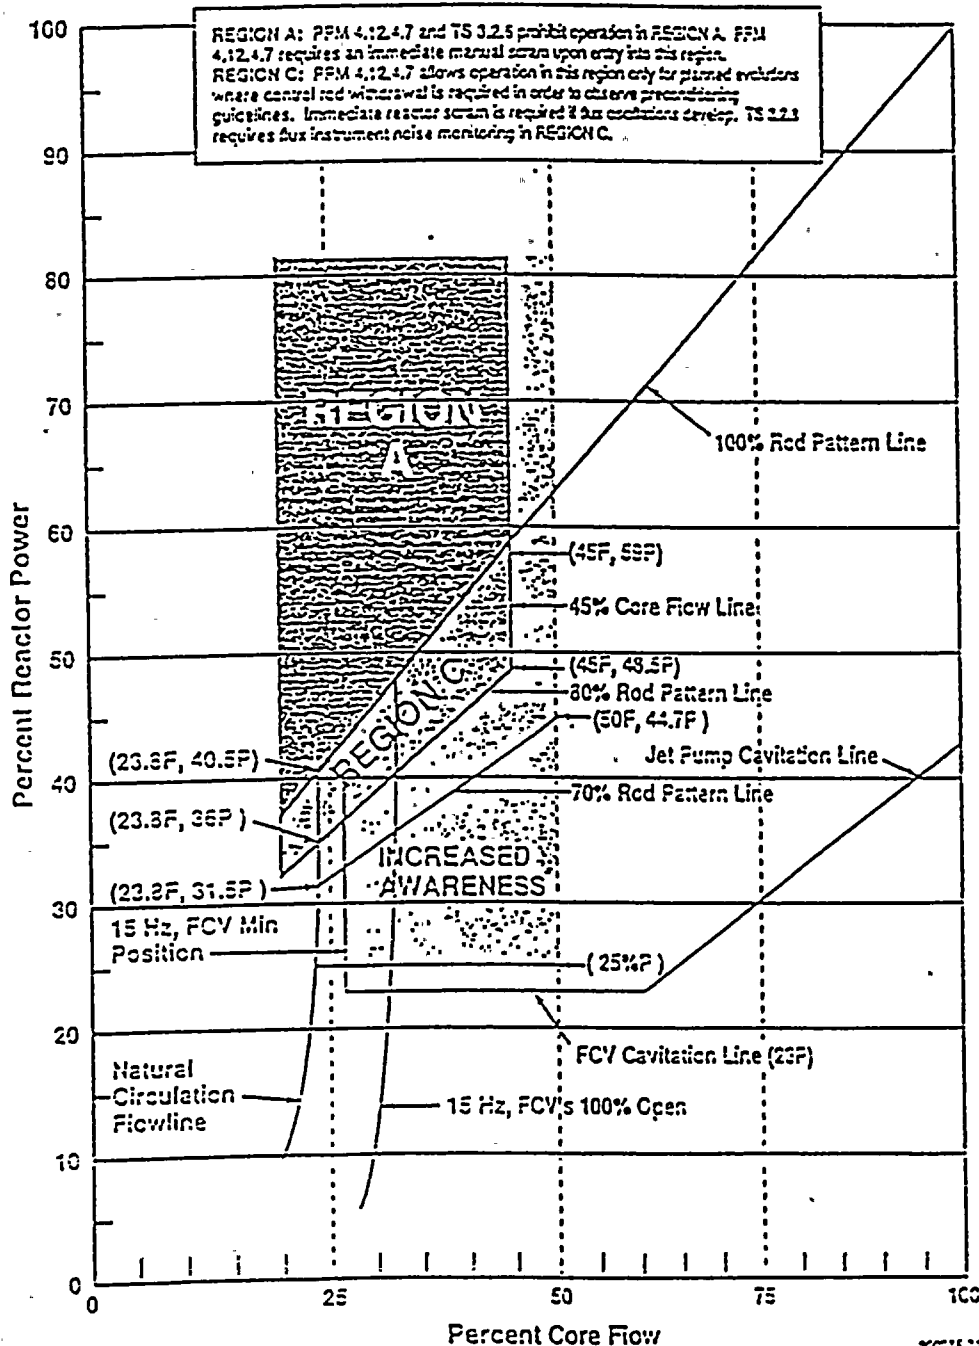
Figure 2

Two Loop Operation Plant 2 Operating Map

3. Procedures for monitoring power oscillations will require that the ANNA system be operable and in service from greater than 25% reactor power and less than 50% core flow (see attached Figure 2).

6. These actions were implemented by procedural changes and training of personnel on these changes. The Power to Flow Map was revised to reflect these changes by designating an "INCREASED AWARENESS" region (see attached Figure 2). BWROG Implementation Guidance for Stability Interim Corrective Actions have been implemented in Plant procedures and reinforced by training sessions and exam testing.
