Subject: NUCLEAR PLANT WNP-2, OPERATING LICENSE NPF-21
LICENSEE EVENT REPORT NO. 93-028-00

LICENSEE EVENT REPORT (LER)

FACILITY NAME (1) Washington Nuclear Plant - Unit 2	DOCKET NUMBER (2) 0 5 0 0 0 3 9 7	PAGE (3) 1 OF 10
---	--	-------------------------

TITLE (4)
FAILURE TO ANALYZE A HIGH ENERGY LINE BREAK LOCATED OUTSIDE PRIMARY CONTAINMENT

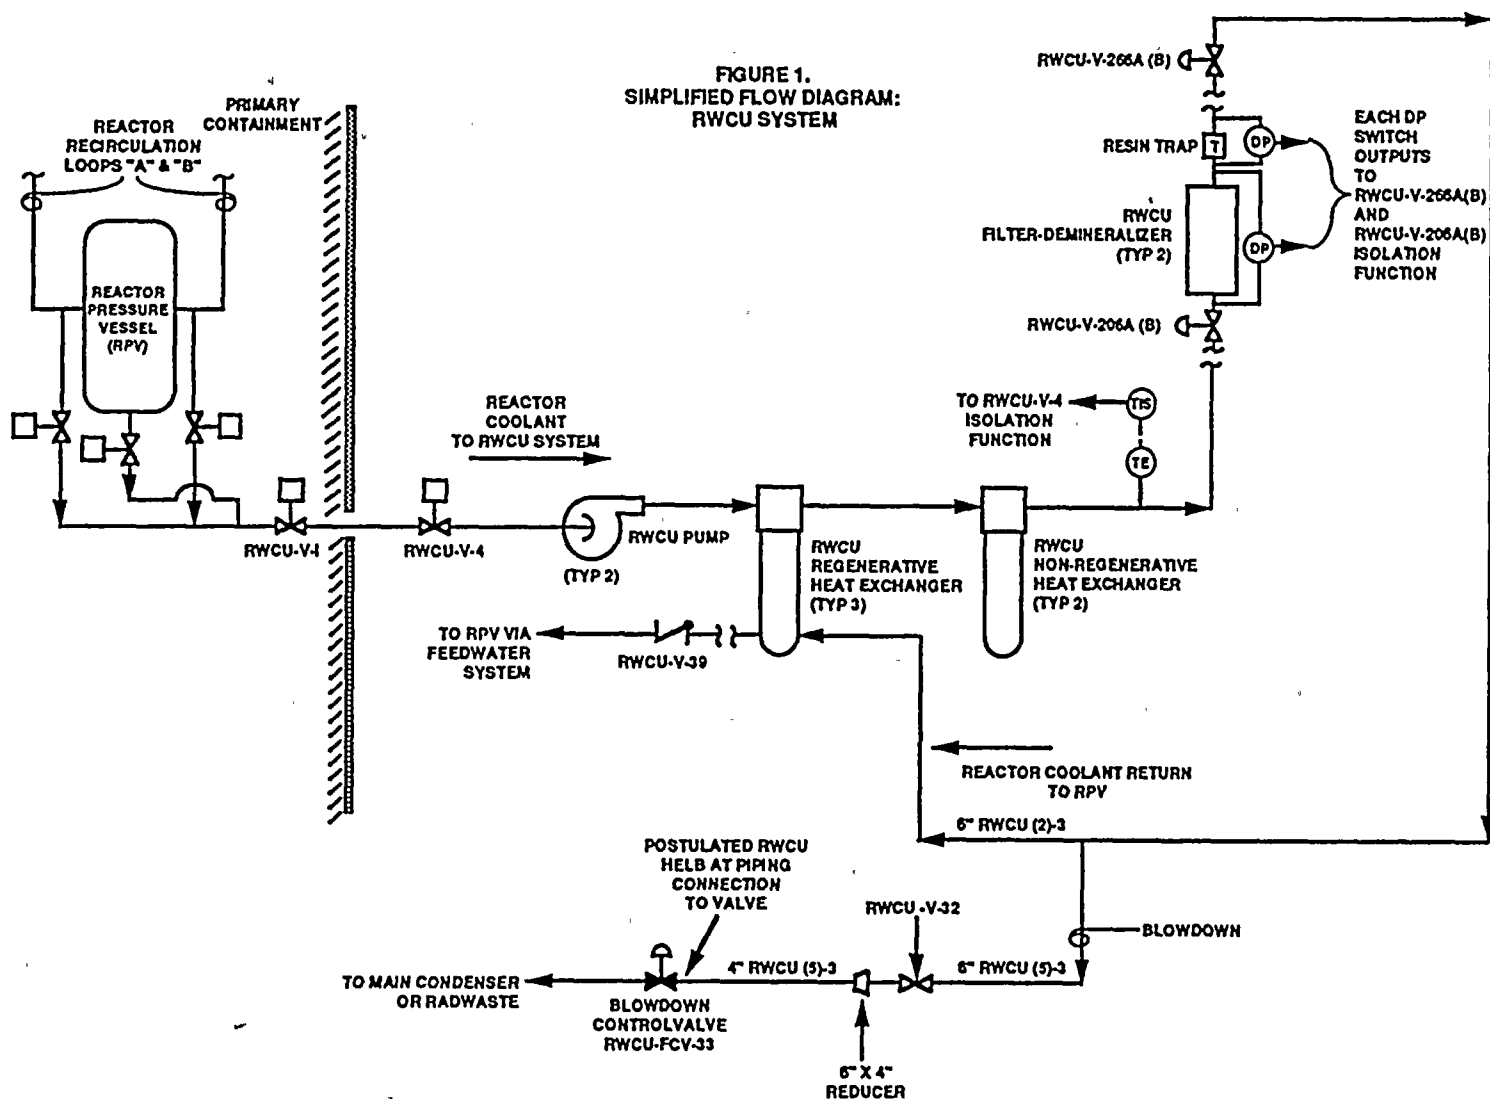
This HELB involves a postulated break in four-inch Reactor Water Cleanup (RWCU) system line RWCU(5)-3 (Figure 1). Specifically, this break is located at RWCU system blowdown flow control valve RWCU-FCV-33 and is open to Reactor Building floor elevation 501'. The postulated break location involves ASME Section III Class 3 piping. Postulated pipe break locations are based on guidelines provided by NRC Branch Technical Positions APCS 3-1 and MEB 3-1 (as described in FSAR 3.6.2.1). In part, for ASME Section III Class 3 piping, these guidelines require breaks to be postulated at terminal ends. For piping runs which are maintained pressurized for only a portion of the run, MEB 3-1 defines a terminal end as the piping connection at the first normally closed valve in the run. Accordingly, a break should be postulated at RWCU-FCV-33. During power operation, this line operates at primary coolant pressure at an approximate temperature of 125 degrees Fahrenheit.

4. Upon discovery of the unanalyzed HELB, engineering initiated an investigation to determine why the HELB was not evaluated. The investigation determined that the list of bounding HELBs used to analyze corresponding environmental effects was developed from an earlier list of bounding HELBs that omitted the postulated break in line RWCU(5)-3.

The root cause of this event was less than adequate design analysis and design analysis review by the architect engineer. The programmatic review performed by the Supply System determined that the architect engineer omitted the RWCU HELB from the list of bounding HELBs because the effects of the associated blowdown were incorrectly assessed. The architect engineer erroneously concluded that because water contained within this particular branch of piping was of moderate temperature, a postulated break at this location would have negligible environmental impact. However, the postulated RWCU HELB would cause a rapid increase in blowdown temperature until blowdown was terminated. The rapid increase in temperature would occur because the postulated break would significantly reduce the amount of water returning to the reactor via the shell-side of the regenerative heat exchanger RWCU-HX-1A(B,C). This would have the effect of removing the heat sink for water at reactor temperature entering the tube-side of the regenerative heat exchanger and thus causing a rapid increase in blowdown temperature. Because this list later formed the list of bounding HELBs subsequently analyzed for environmental effects, the mistake was carried forward to that analysis. Prior to initial plant startup, the Supply System overview of the architect engineer's work was not to the level of detail where this error would be discovered. There were no contributing causes to this event.

1. A review will be performed to ensure that other piping systems were not inadvertently omitted from consideration of HELB environmental effects. This review will evaluate the other piping systems eliminated from consideration by the architect engineer. This will be completed by June 1, 1994.
2. A request for permanent exclusion of the postulated RWCU(5)-3 line break based on the as-built stress analysis and recent nondestructive examination results will be submitted to the NRC by December 3, 1993.
