SUBJECT: LER 93-010-06:on 931104,TS surveillance improvement project identified nonconforming conditions.Caused by less than adequate barriers & controls for program changes & less than adequate test procedures.C/A listed.W/940211 ltr.

**Subject: NUCLEAR PLANT WNP-2, OPERATING LICENSE NPF-21, SUPPLEMENT  
(93-010-06) TO LICENSEE EVENT REPORT NO. 93-010**

TECHNICAL SPECIFICATION SURVEILLANCE IMPROVEMENT PROJECT IDENTIFICATION OF NONCONFORMING CONDITIONS

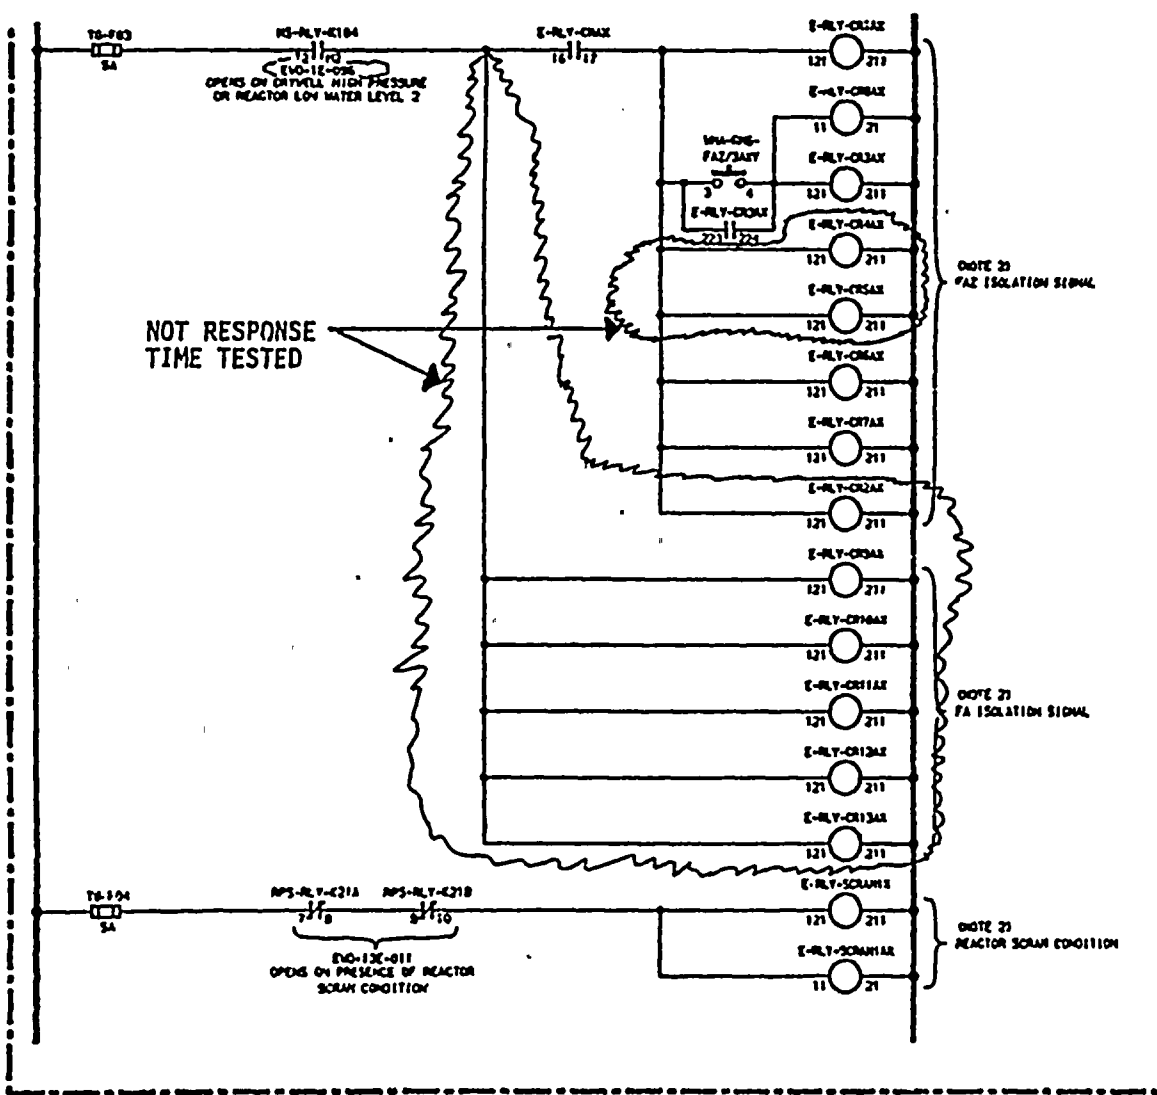
**ATTACHMENT 1**

EXCERPT FROM DRAWING EWD-108E-001  
"MISC EQPT SYS RELAY CABINET E-CP-RC/1 ISOLATION CONTROL RELAYS"

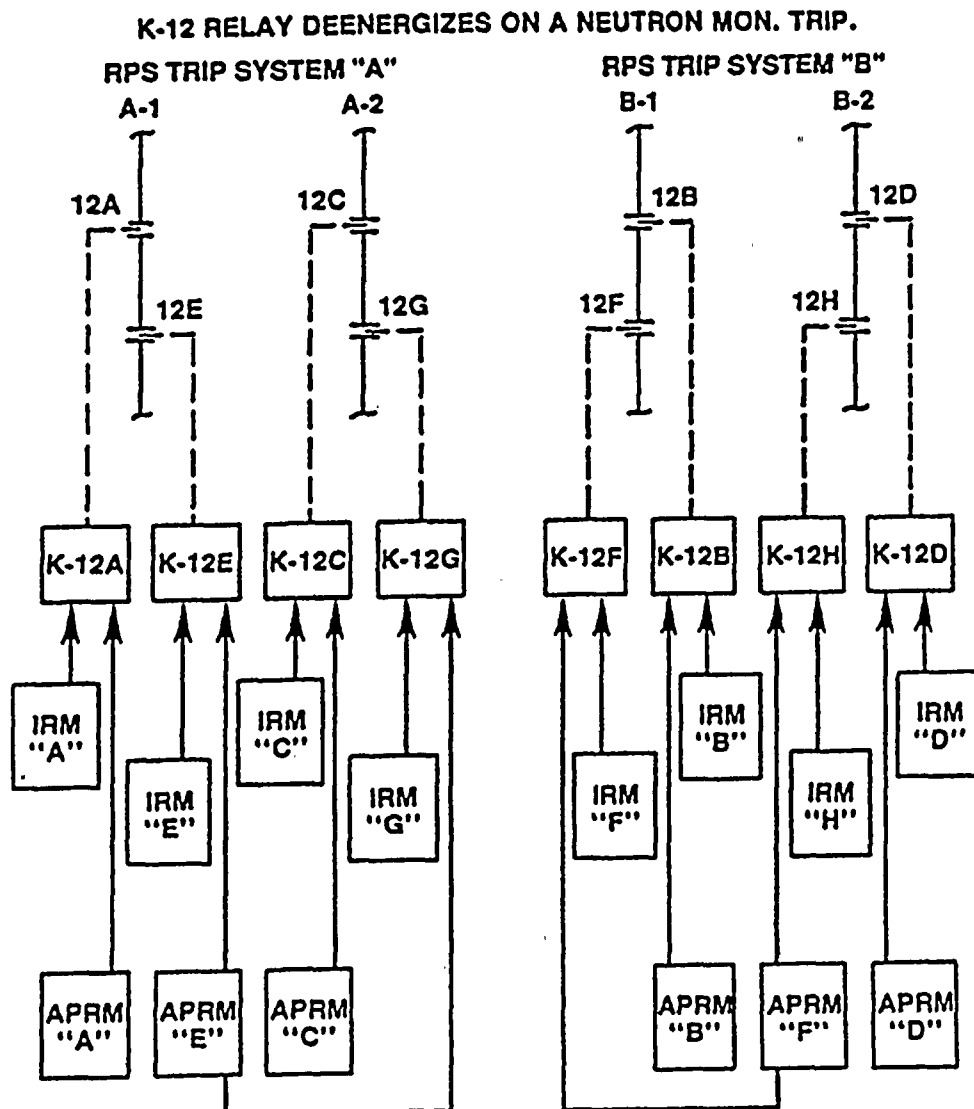
## ATTACHMENT 2

SIMPLIFIED APRM/IRM RPS TRIP LOGIC
