SUBJECT: LER 94-012-00: on 940623, discovered water in bottom of control room emergency filter unit WMA-FU-54B. Caused by leaky manual isolation valve. Revised deluge system valve station lineups. W/940722 ltr.

Subject: NUCLEAR PLANT WNP-2, OPERATING LICENSE NPF-21
LICENSEE EVENT REPORT NO. 94-012

| CONTROL ROOM EMERGENCY FILTER WMA-FU-54B INOPERABLE DUE TO LEAKING DELUGE SUPPLY ISOLATION VALVE | | | | | | | | | | | | | | | | | | | | | | | | | | | | | | | | | | | | | |

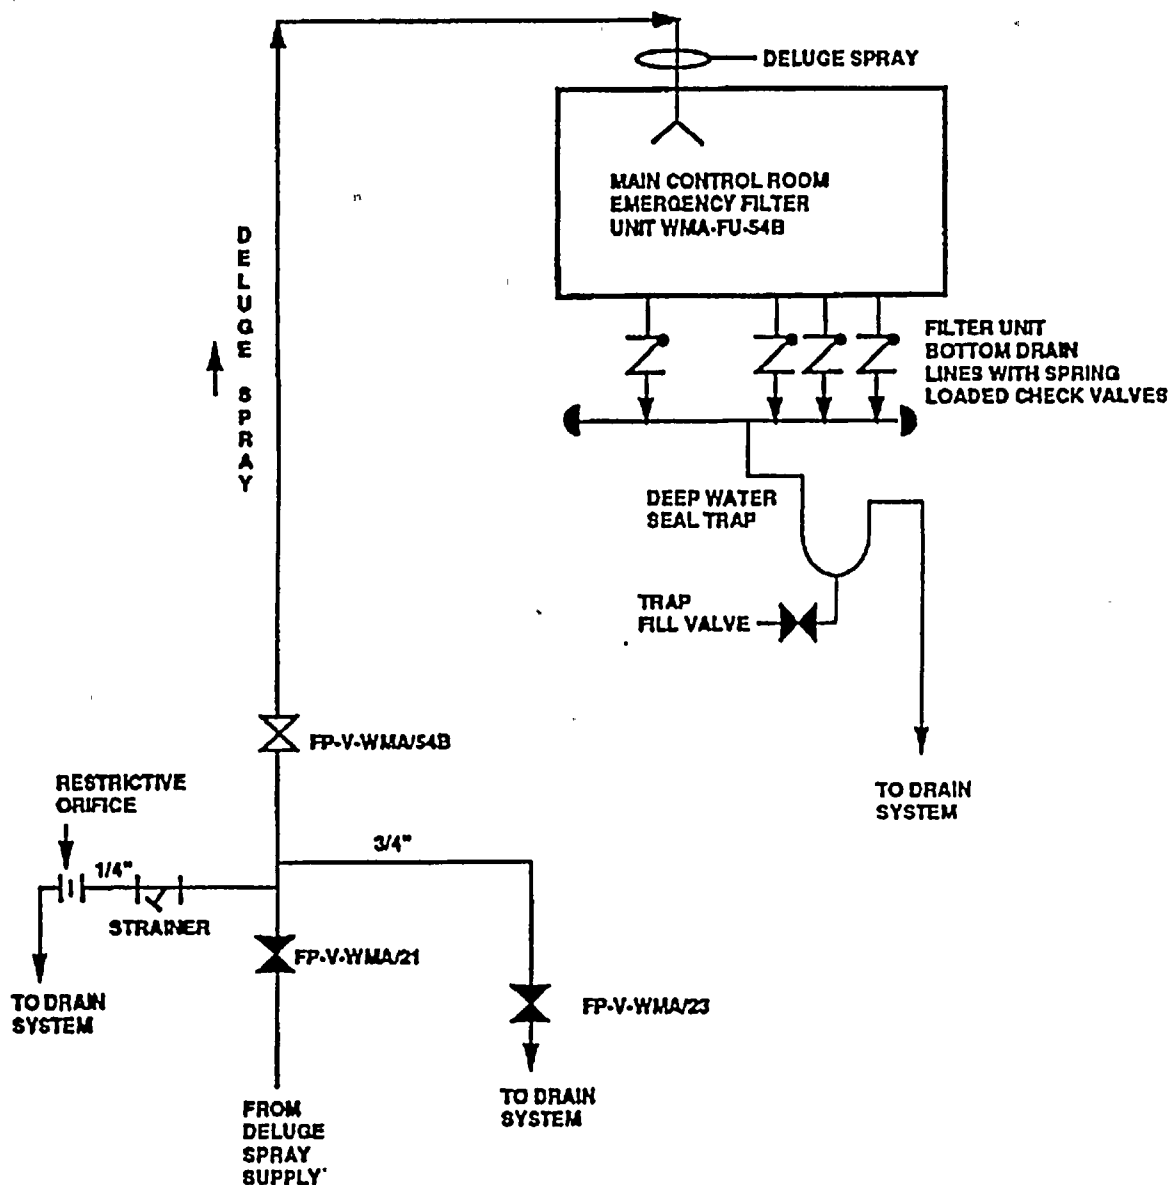
FIGURE 1: MAIN CONTROL ROOM EMERGENCY FILTER UNIT WMA-FU-54B DELUGE SYSTEM

At approximately 2310 hours on June 23, 1994, during maintenance with the reactor in cold shutdown, water was discovered in the bottom of control room emergency filter unit WMA-FU-54B. Water had leaked past normally closed charcoal filter deluge isolation valve FP-V-WMA/21 (see Figure 1) and collected at the bottom of the filter unit. Spring-loaded check valves installed in the unit's bottom drain lines trapped about five inches of water in the filter unit and rendered the unit's charcoal filter inoperable.

1. There were no other structures, systems, or components inoperable at the time that contributed to this event.
2. Control room emergency filter unit WMA-FU-54B includes a manually-operated deluge spray system (see Figure 1) designed to extinguish a charcoal bed fire. To initiate deluge spray, an operator would open normally-closed deluge spray isolation valve FP-V-WMA/21. During normal operation, the deluge station includes a quarter-inch overflow drain line (installed with a strainer and restricting orifice) just downstream of FP-V-WMA/21. This drain line is designed to pass water that might leak by FP-V-WMA/21 to a drain. Each of the filter unit's four bottom drain lines includes a spring-loaded check valve. These check valves, in conjunction with a deep water seal trap installed downstream of the unit's bottom drain collection manifold, ensure an airtight seal during normal operation and pass water from the unit to its plant drain connection during deluge system actuation.

5. The deluge system leakage had exceeded the capacity of the quarter-inch overflow drain line and collected at the bottom of the filter unit. Opening the three-quarter inch drain line precluded additional water from entering the unit, and the unit partially drained until decreasing differential pressure across the bottom drain line check valves allowed these valves to isolate and trap about five inches of water in the bottom of the unit.

The root cause of this event was a leaky deluge supply isolation valve. Leakage exceeded the capacity of the associated quarter-inch overflow drain line. This caused water to fill the deluge supply line, enter the filter unit, collect at its bottom, and render the charcoal filter inoperable.

1. Engineering inspected the filter unit and determined that the unit was not significantly corroded by the trapped water. Workers cleaned the unit and replaced the leaky valve.
2. The affected charcoal filter bed was replaced and tested satisfactorily. While other filters associated with the filter unit were not damaged, its HEPA filter was also replaced.

3. System engineering management will discuss the lessons learned from this event with the responsible system engineer by August 8, 1994.
4. By August 8, 1994, appropriate procedures will be revised to specify both upstream and downstream deluge supply isolation valves as normally closed, and the three-quarter inch deluge supply drain valve as normally open for both control room emergency filter units and other similar filter units. Given the revised lineups, these procedures will include appropriate guidance for manual deluge system actuation and restoration.
