SUBJECT: LER 92-037-03: on 920815, reactor manually acrammed due to indications of core instability. Caused by unanticipated interaction of operating conditions & components. Revised operating strategies & related procedures. W/940728 ltr.

Subject: NUCLEAR PLANT WNP-2, OPERATING LICENSE NPF-21  
LICENSEE EVENT REPORT NO. 92-037-03

**TITLE (4)**  
 MANUAL REACTOR SCRAM DUE TO CORE INSTABILITY

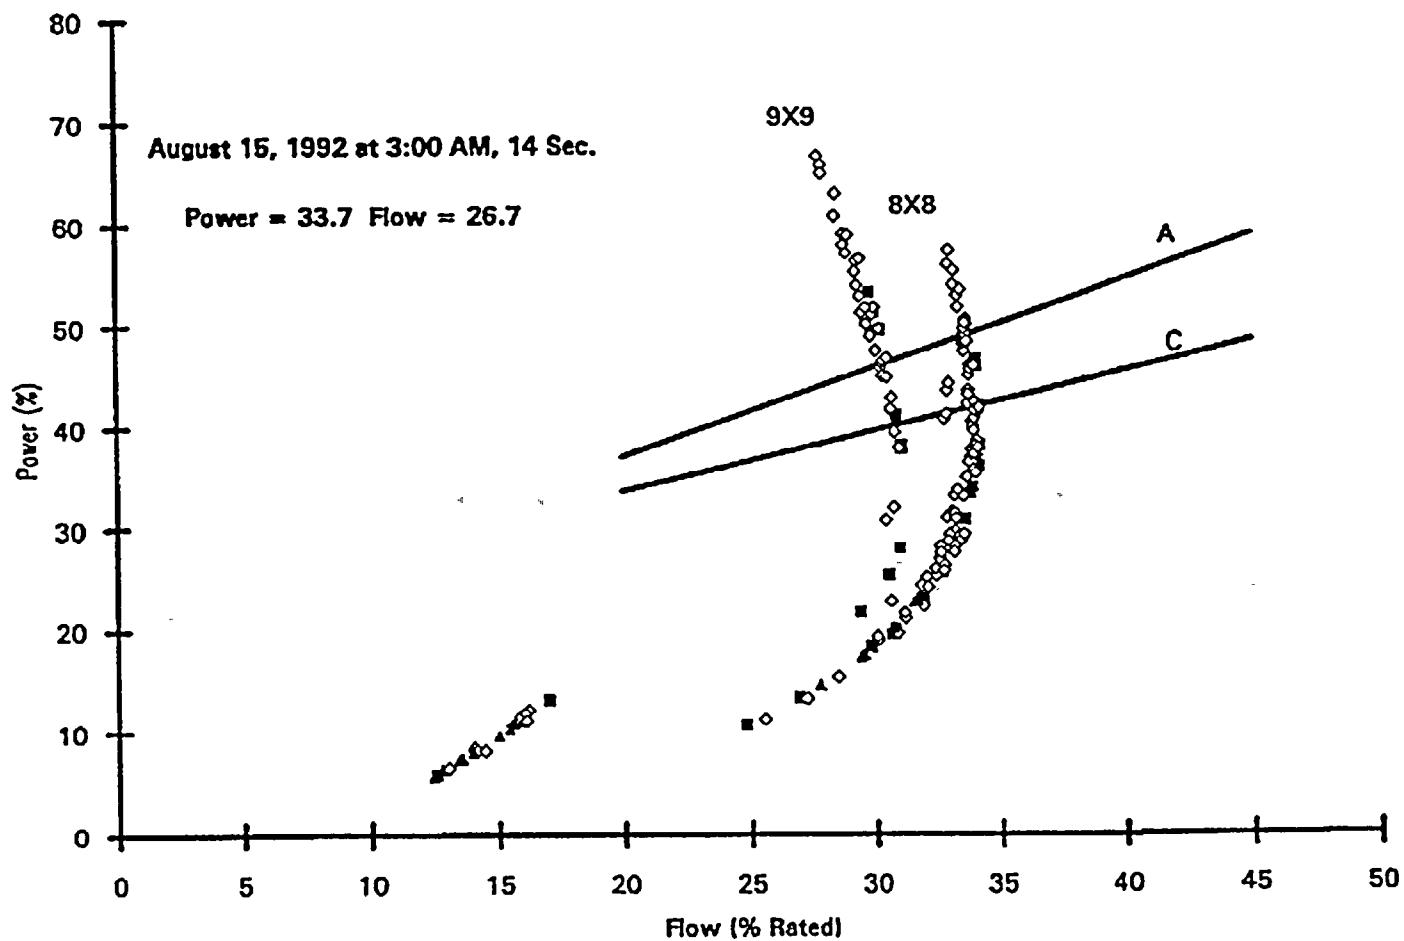
Figure 1

## Power Flow - Individual Assemblies
