SUBJECT: Forwards relief request 2ISI-16 for temporary non-code repair of standby svc water piping per GL 90-05.

Subject: **WNP-2, OPERATING LICENSE NPF-21
RELIEF REQUEST FOR TEMPORARY NON-CODE REPAIR PER
GENERIC LETTER 90-05 OF STANDBY SERVICE WATER PIPING**

RELIEF REQUEST NO. 2ISI-16

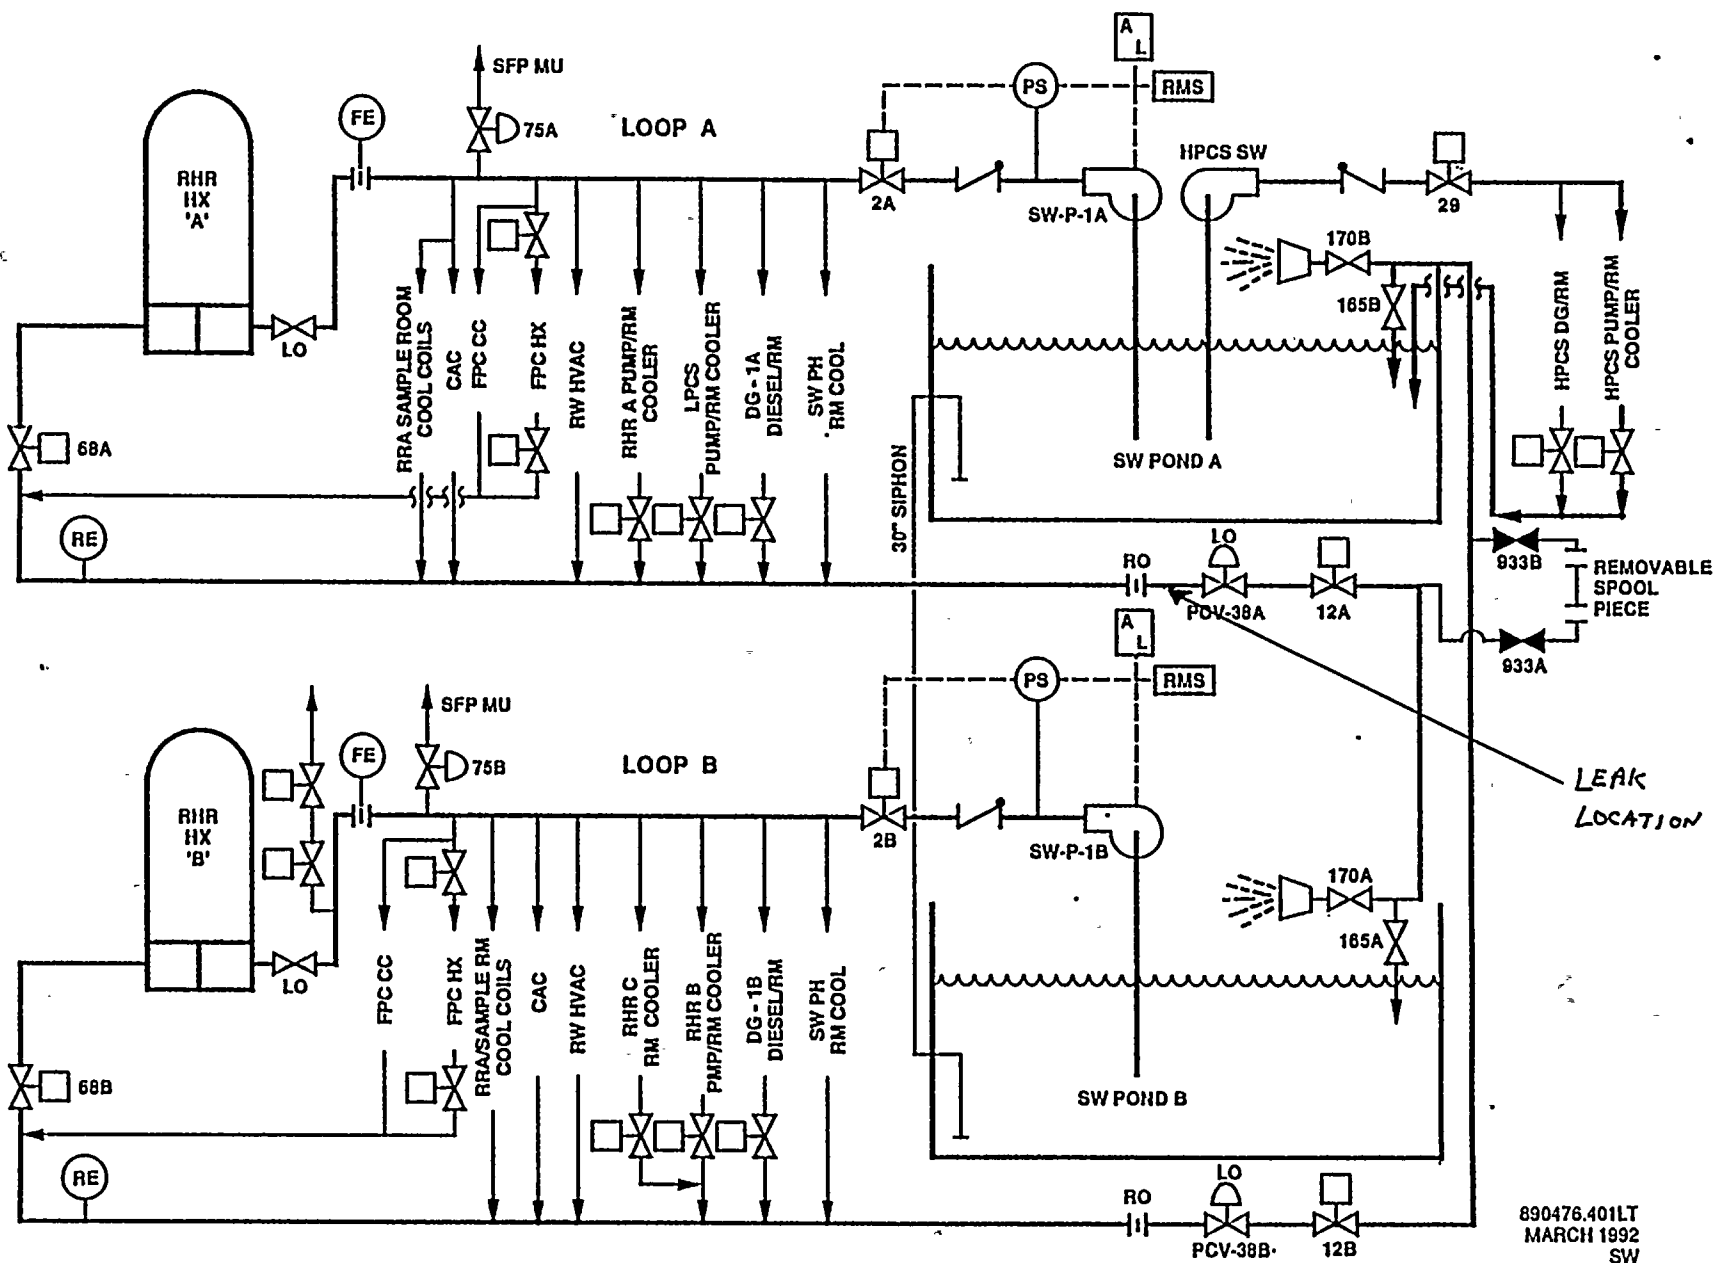
Repair of pinhole leak located in ASME Section III Code Class 3 Standby Service Water (SW) loop A piping, approximately 78 inches upstream of west flange connection at SW-PCV-38A. See Figures 1 and 2 for location of the leak.

A small through-wall flaw exists in the SW "A" division discharge piping to the spray pond header in the "B" pond. The flaw exists in line 18"SW(21)-2 (see Figures 1 and 2) within the SW Pumphouse-A valve pit. The leak rate is estimated at one quarter (0.25) gpm. Two additional areas of wall thinning near the through-wall flaw were found during the augmented inspection. These areas are approximately 5 and 6.5 inches from the through-wall flaw.

A temporary non-Code repair has been performed using the guidance of Generic Letter 90-05. This repair consists of a rubber gasket clamped over the flaw.
