SUBJECT: Responds to NRC 981112 ltr re violations noted in insp rept  
 50-397/98-20. Corrective actions: implemented interim actions  
 to assure that significant pressure surges do not occur in  
 plant fire protection sys.

Subject: **WNP-2, OPERATING LICENSE NPF-21,  
RESPONSE TO AN APPARENT VIOLATION IN NRC  
INSPECTION REPORT NO. 50-397/98-20**

# NRC INSPECTION REPORT 98-20, RESPONSE TO APPARENT VIOLATION

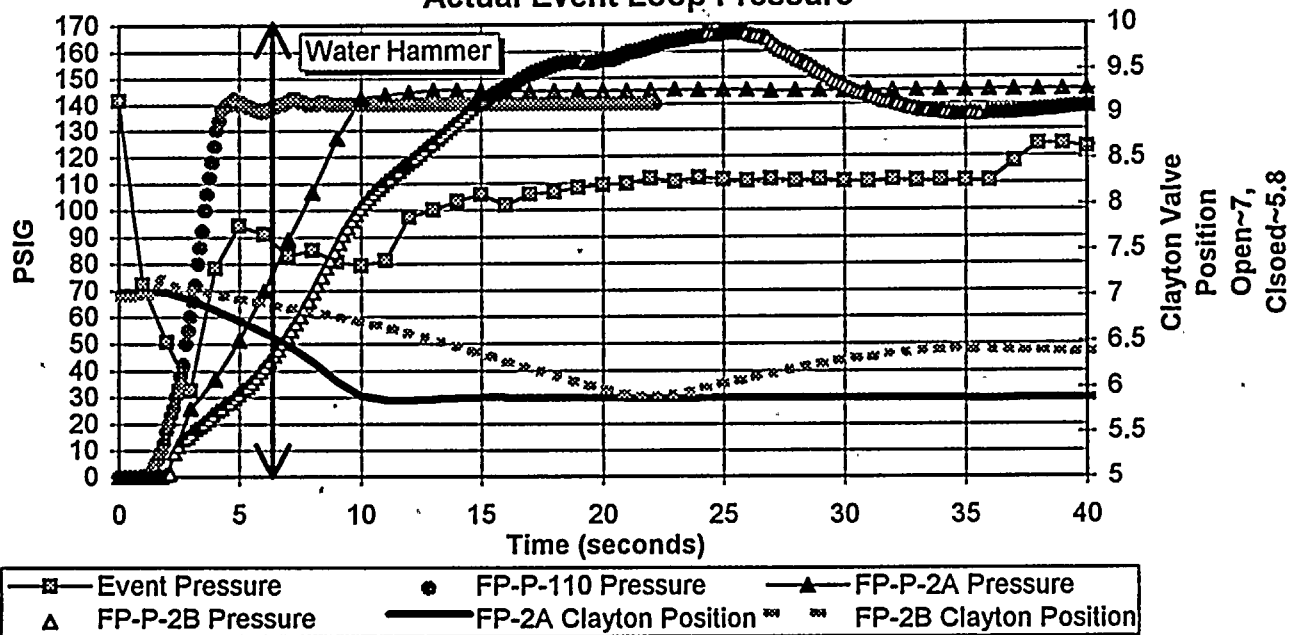
Figure C-1  
Fire Pumps 2A, 2B, & 110 & Clayton Valve Position  
(post event test data)  
vs  
Actual Event Loop Pressure

Post event testing of the motor driven pumps and the affect of the Clayton valves is shown superimposed on the actual event pressure curve in Figure C-1. The event pressure data was obtained from pressure transmitter FP-PT-10 located on the loop side of the motor driven discharge check valves. This data shows that FP-P-110 was the first pump to supply flow to the system (i.e., was much faster than the motor driven pumps in taking part in the transient). Both motor driven pumps' discharge is delayed, due to the lift time from the circulating water basin, by at least two seconds and the discharge was bypassed significantly during the initial water hammer transient. The combined effect was that loading of the motor driven pumps was effectively staggered by the Clayton valves.
