PALO VERDE NUCLEAR GENERATING STATION
PROJECT EVALUATION -
DEFICIENCY EVALUATION REPORT
JOB NO. 10407

REPORT NO. 82-53

FAILURE ANALYSIS

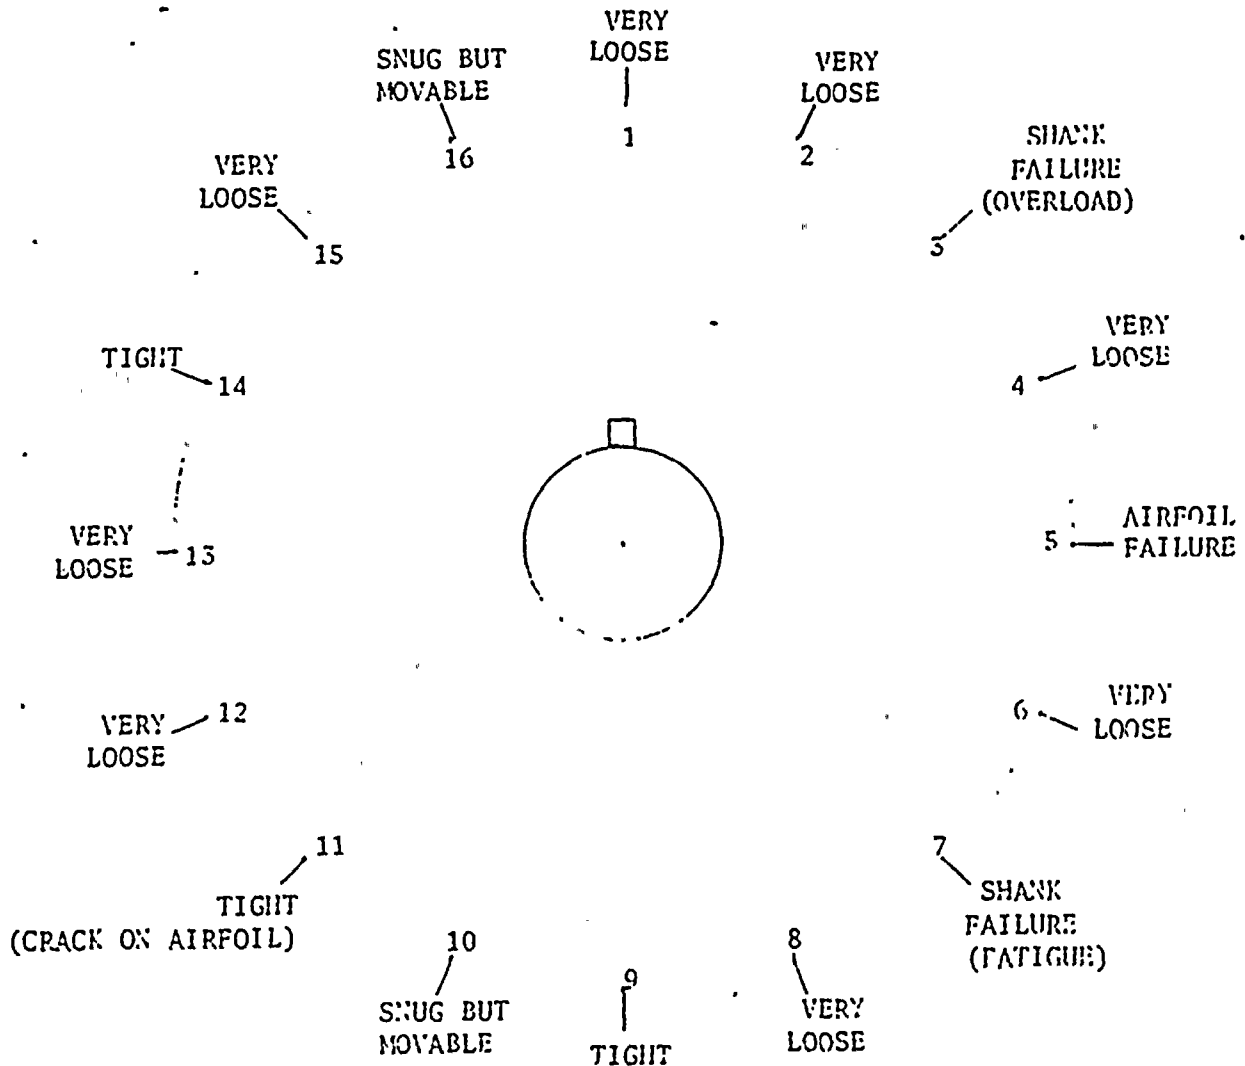
FIGURE 1

The blades were numbered consecutively starting at the keyways and proceeding clockwise as one looks at the leading edge of the rotor. See Figure 1. The airfoil with the crack became No. 11. The blades were then removed from the hub.

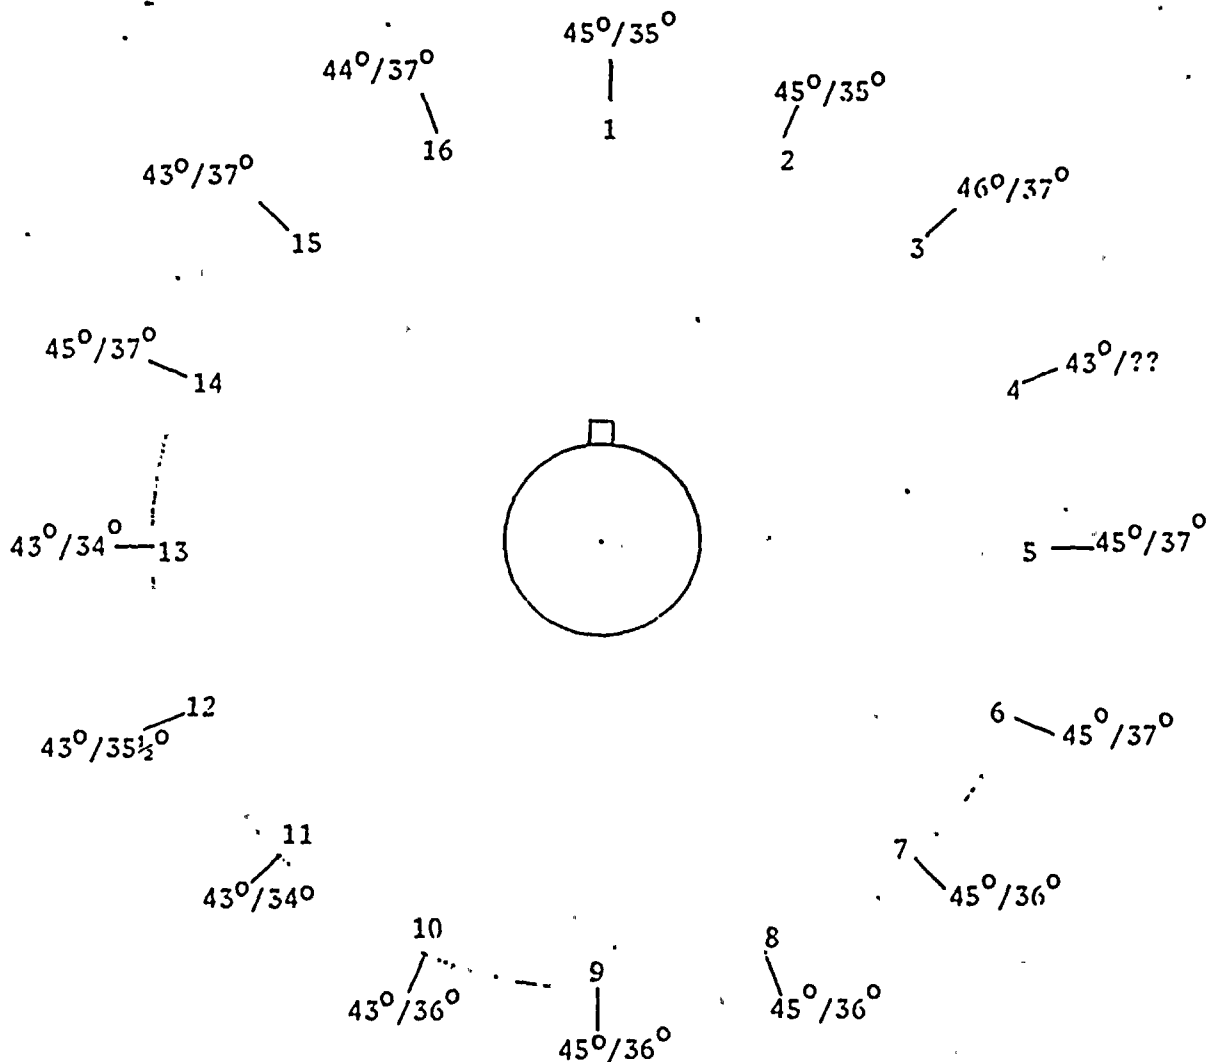
FIGURE 2

The only question left unanswered is why did the blades become loose in the hub. This is totally inconsistent with the operating history of this fan design. To our knowledge, this is the first instance of this occurring. The most plausible explanation is that the blades were not properly tightened. See photo 6. It is apparent from the dirt pattern on the hub that this unit was operated for some period at two (2) different settings. One (1) setting corresponds to the factory setting. The other is about 9° lower (see Figure 2). This angle is much too uniform to have occurred randomly as the blades loosened. In addition, Blades No. 9, 11 and 14 were still tight but at the same angle.

HUB ANGLES AS MEASURED FROM DIRT PATTERN ON HUB. ANGLES ESTABLISHED BY INSTALLING A BLADE, LINING UP WITH THE DIRT PATTERN, THEN MEASURING ANGLE. FIRST NUMBER CORRESPONDS TO ORIGINAL SETTING. SECOND PATTERN ON BLADE NO. 4 WAS NOT SUFFICIENTLY VISIBLE TO ESTABLISH ANGLE.

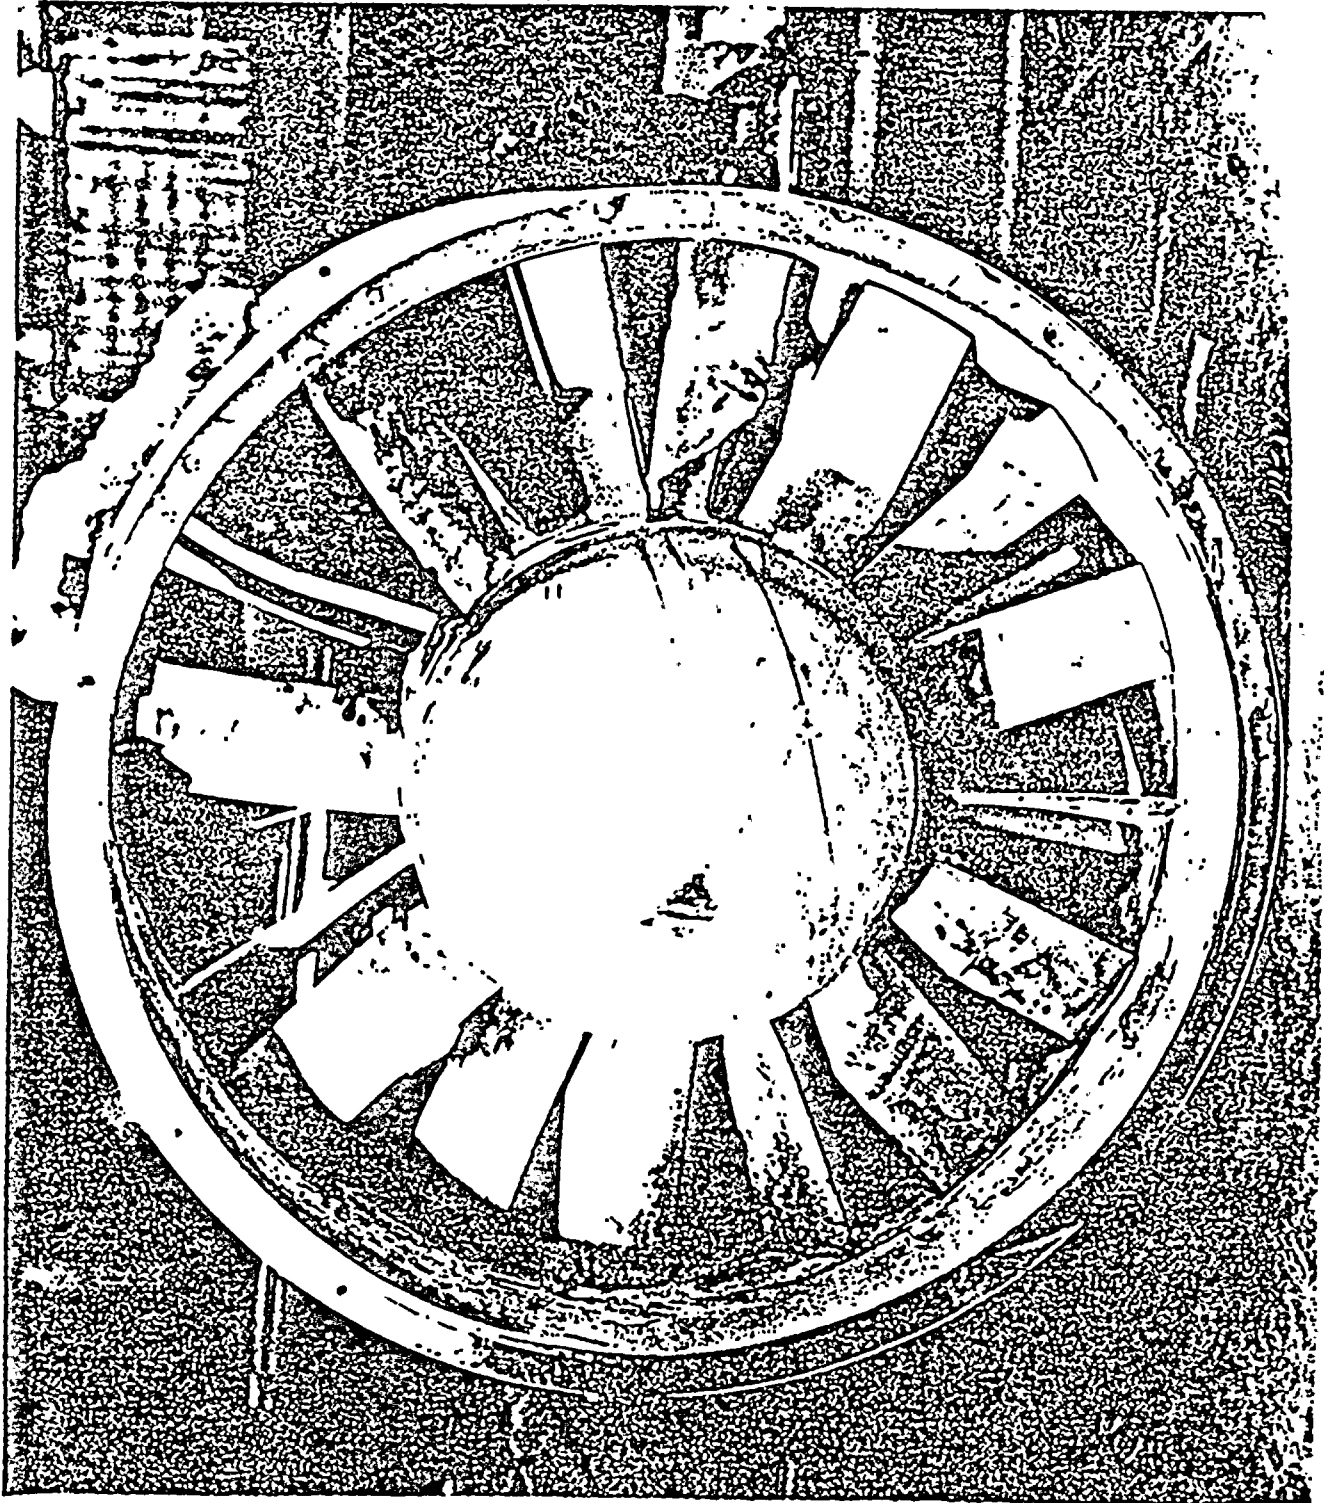
PHOTOGRAPH NO. 1

The unit was inspected on 9-28-82. Initial inspection showed that three (3) blades had broken; one (1) on the airfoil and two (2) in the threaded shank. There was some damage to the casing but nothing that cannot be repaired. (See photos 1 thru 5). One (1) of the vanes was bent but it can be straightened. The conduit pipe was missing and the motor lead wires completely covered with grease. Two (2) of the rear support rods were bent but not broken although the eyes on the ends had split. The rotor could still be rotated by hand but it was tight indicating that the bearings were in a failure mode. The nose was then removed. The safety wire was still in place although one (1) piece had been damaged. The two (2) blade shanks with nuts were still inside the nose. It was noticed that of the thirteen (13) remaining blades, ten (10) were loose in the hub. The three (3) blades that were still tight were at a somewhat lower angle than the unit had been operating as indicated by the dirt pattern on the hub (see photo 6). This same dirt pattern was visible on all sockets except one (1). Measurements were made for both settings. See Figure 2 for results.

OVERALL VIEW OF DAMAGE FROM INLET

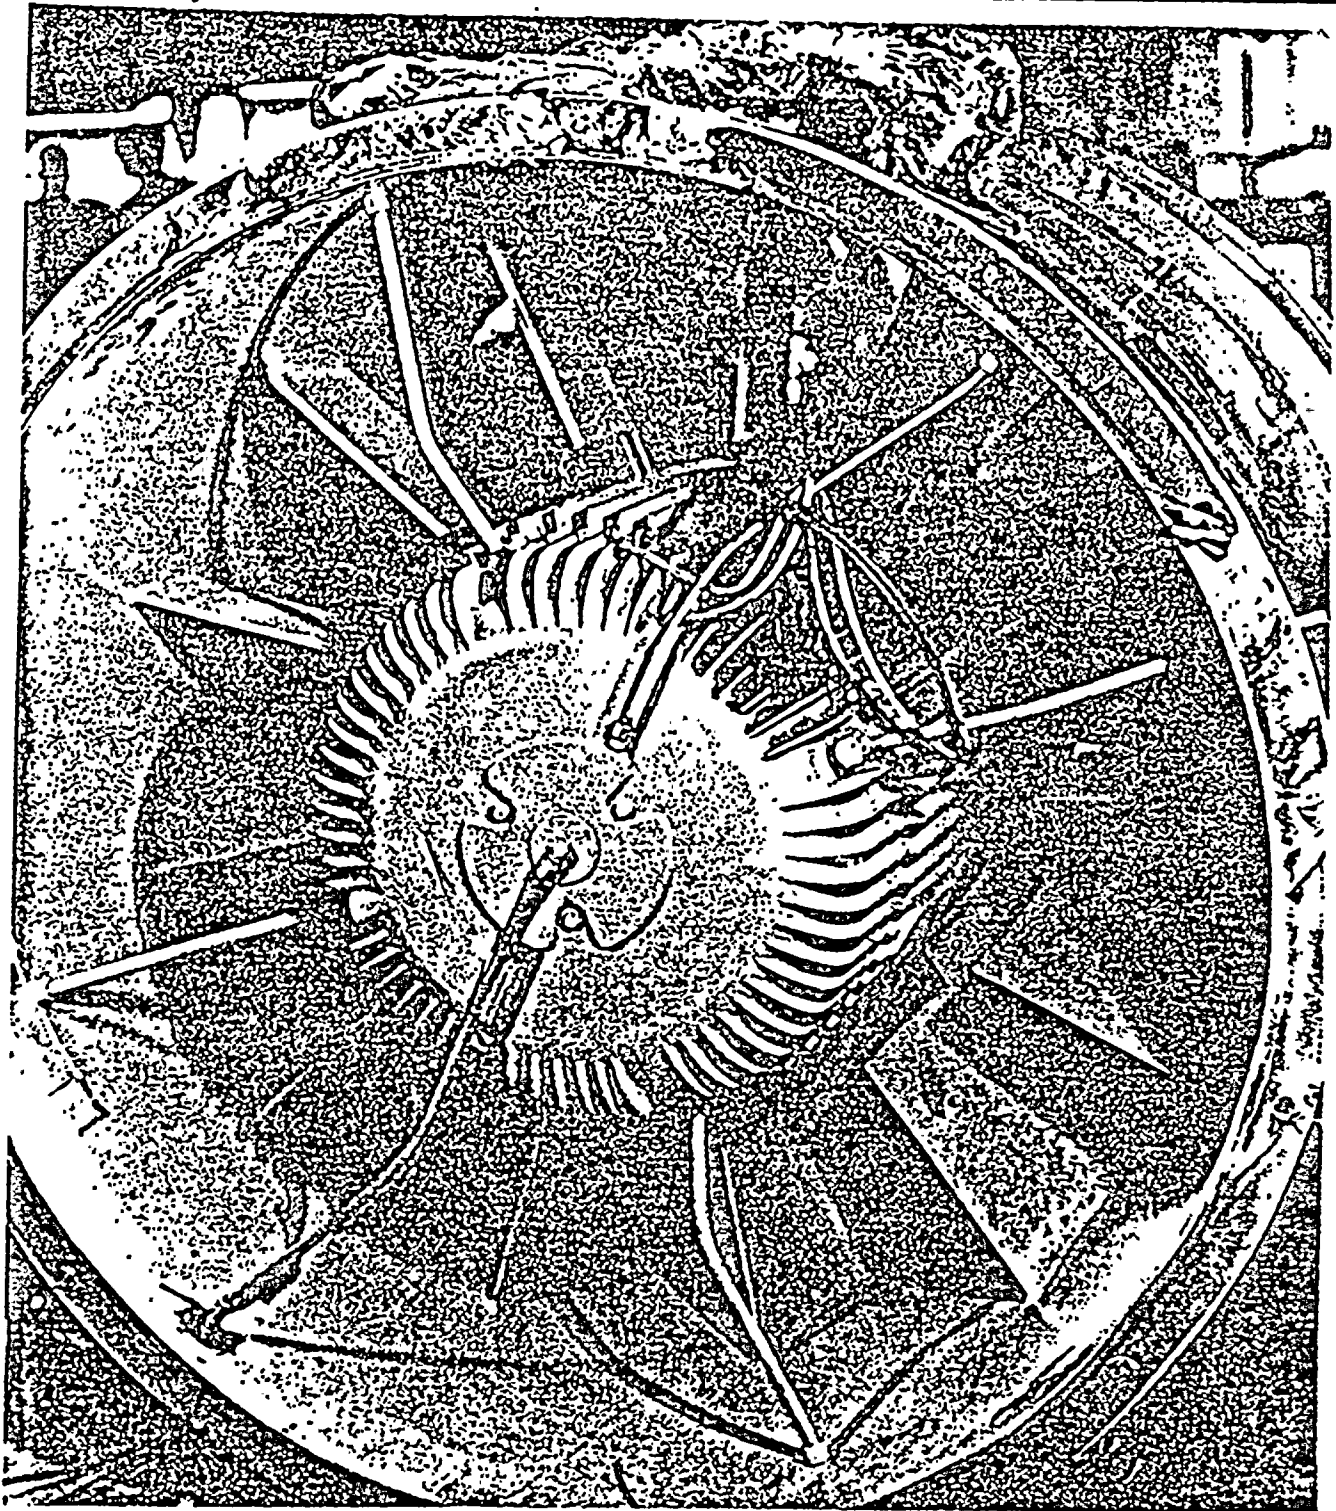
PHOTOGRAPH NO. 2

OVERALL VIEW OF DAMAGE FROM DISCHARGE

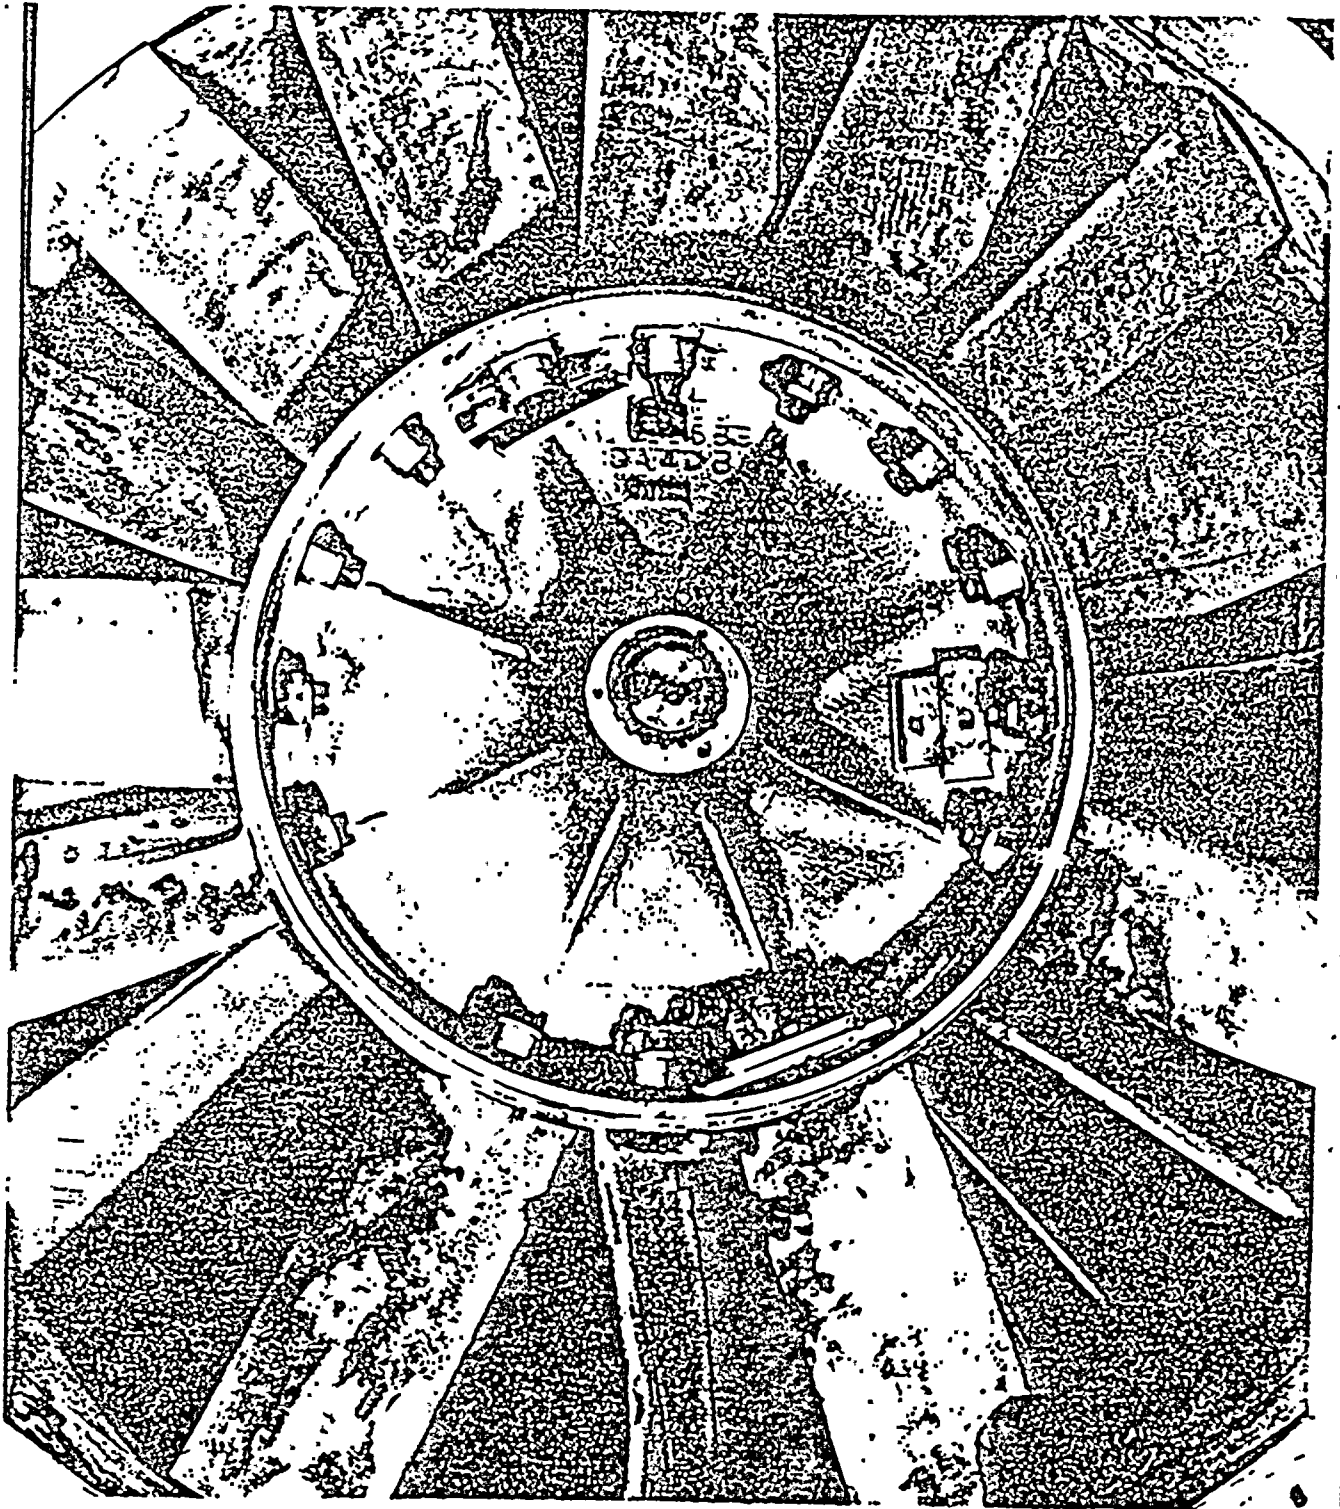
PHOTOGRAPH NO. 3

VIEW OF ROTOR WITH NOSE REMOVED

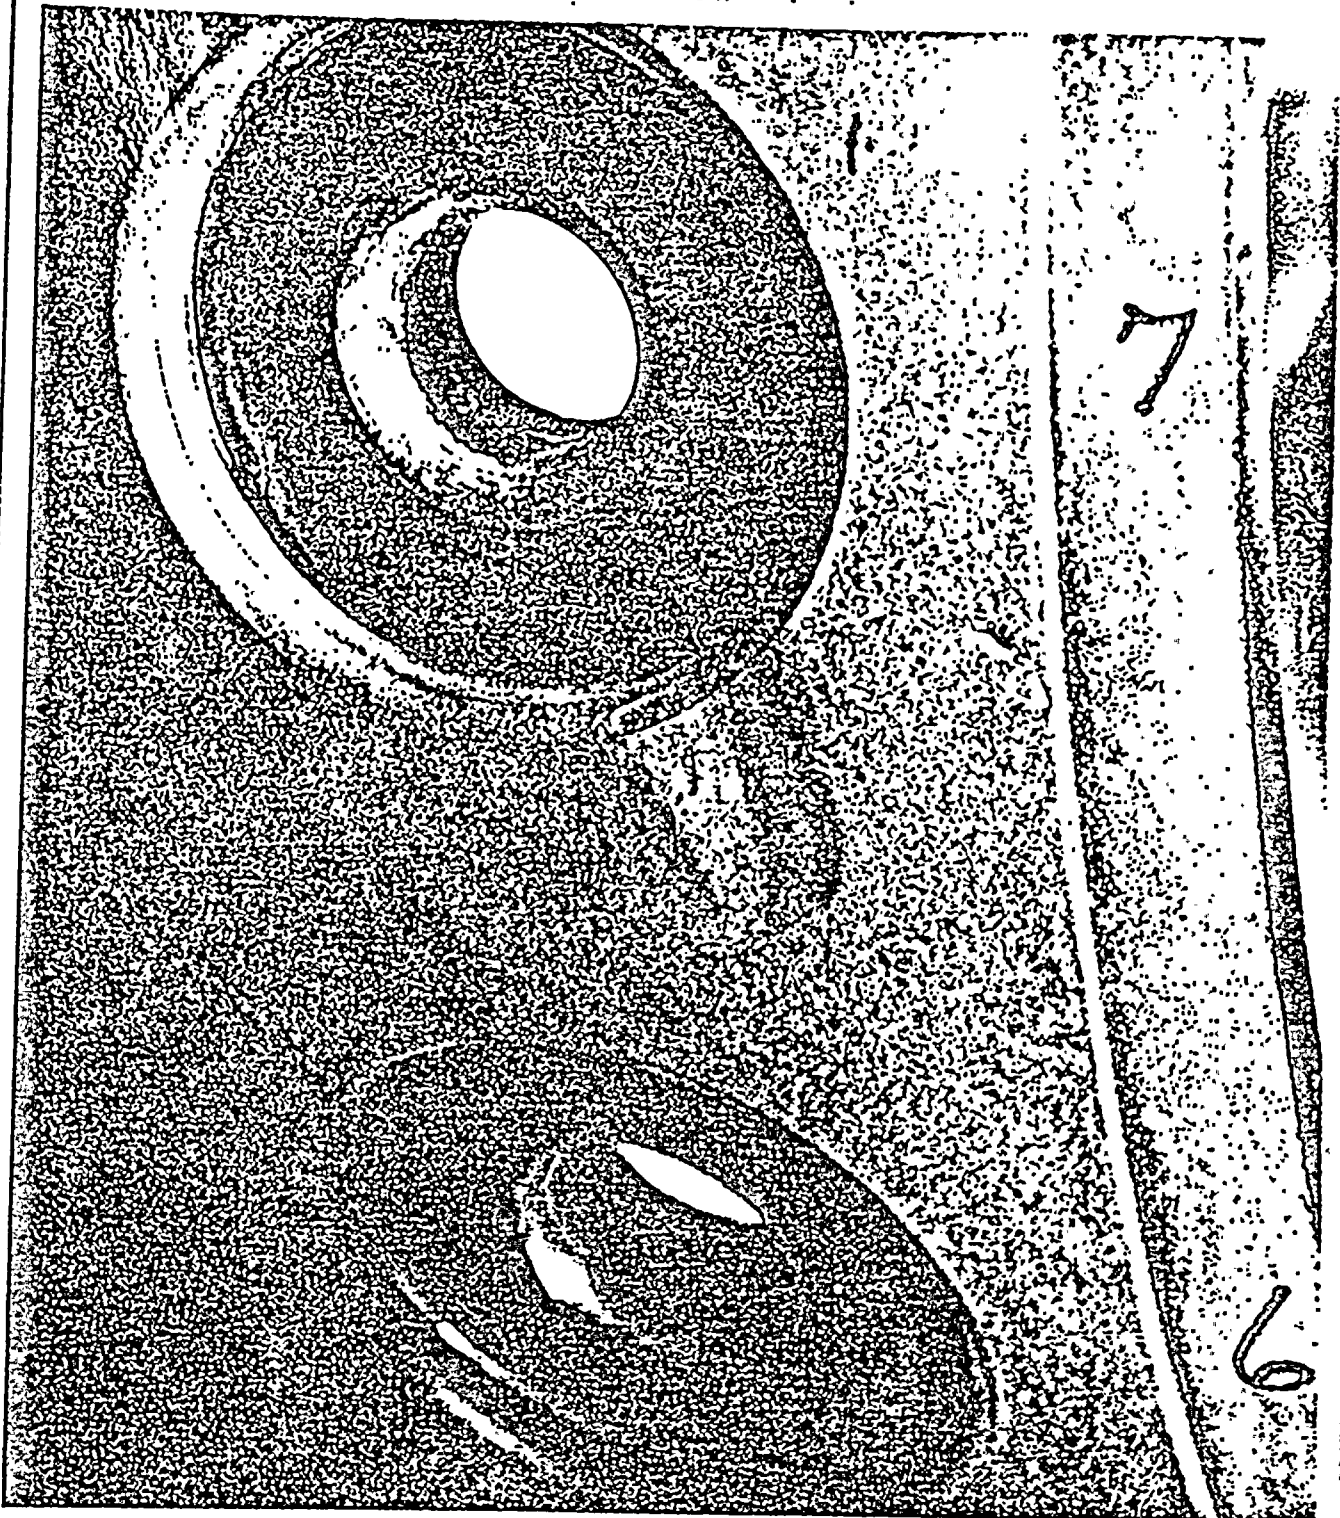
PHOTOGRAPH NO. 6
VIEW SHOWING DUAL DIRT PATTERN ON HUB

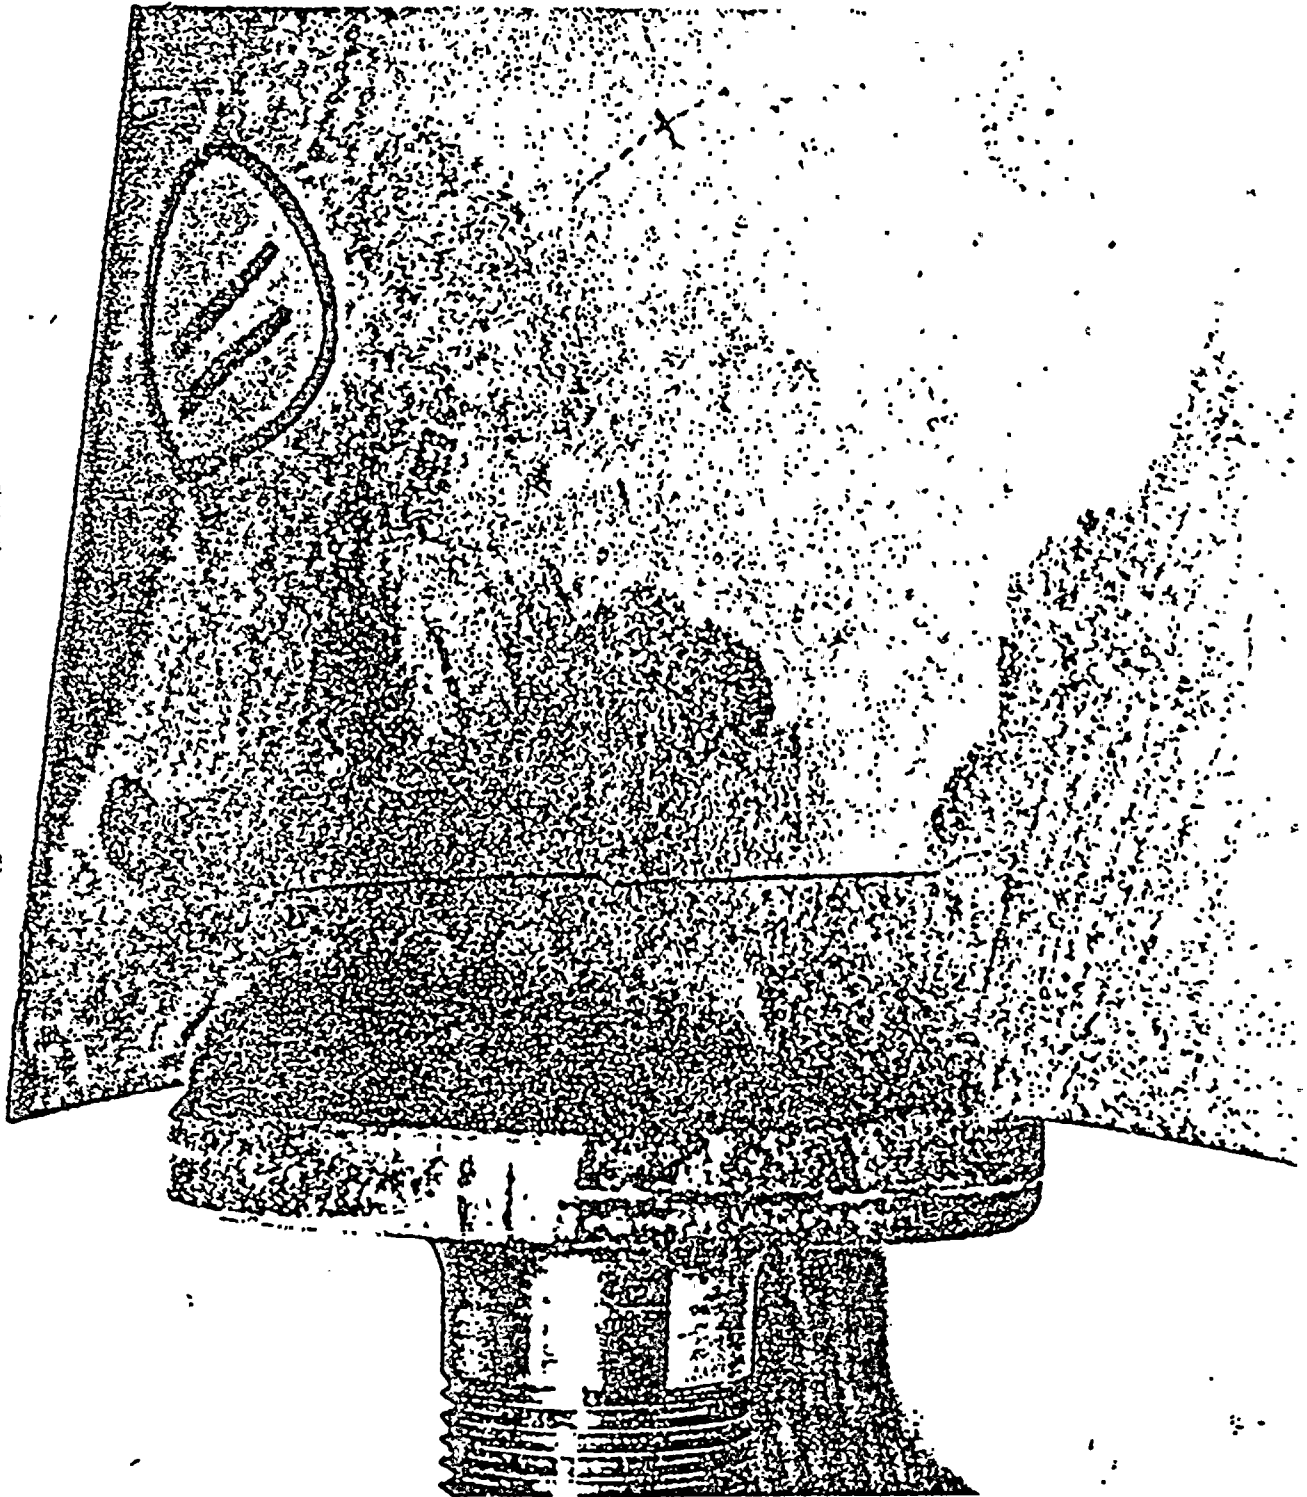
PHOTOGRAPH NO. 7

A crack was also noticed on the convex surface of one (1) of the airfoils. See photo 7.

For the stress at the base of the airfoil, refer to Figure 3. At the radial location of the crack found in Blade No. 11, the stresses are 15,300 PSI on the concave surface and negative 300 PSI on the convex surface. Note that the crack initiated on the convex side which has practically no normal operating stress. SEM fractography of the fatigue surface reveals the presence of striations with spacings as shown in Table 4. One cannot calculate the number of cycles exactly for this case either. However, tests indicate that for similar types of loading, the actual number of cycles is approximately 30 times the number of striations. Assuming an average striation spacing of .0003 inches yields a number of cycles of 47,000. At 1770 RPM, the total time for crack propagation is from 13 to 26 minutes depending on whether there was 1 or 2 cycles per revolution.

VIEW SHOWING CRACK ON CONVEX SURFACE OF BLADE NO. 11

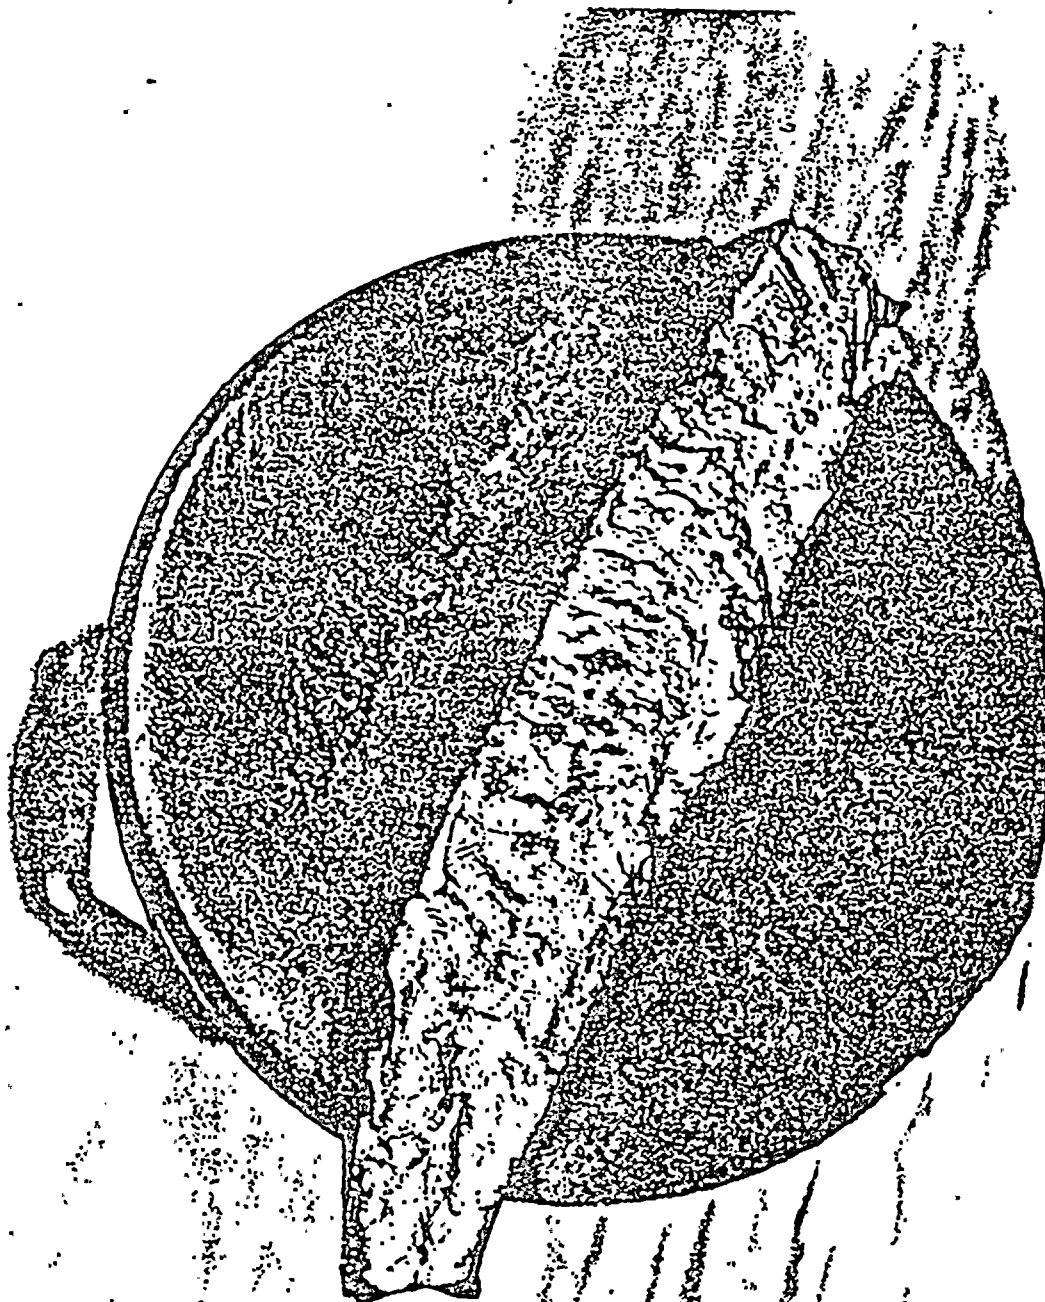
PHOTOGRAPH NO. 8

Inspection of the failed blades revealed that the airfoil failure (Blade No. 5), photos 8 and 9, and one (1) shank failure (Blade No. 3), photos 10 and 11, were overload failures resulting from impact. Blade No. 7, however, had the appearance of a classic fatigue failure. See photos 11 and 12. Blade No. 11 was sawed so that the crack could be broken out. See photo 13. This crack was also a fatigue crack which had initiated in a casting flaw on the convex surface of the airfoil.

VIEW OF HUB SIDE OF AIRFOIL FAILURE OF BLADE NO. 5

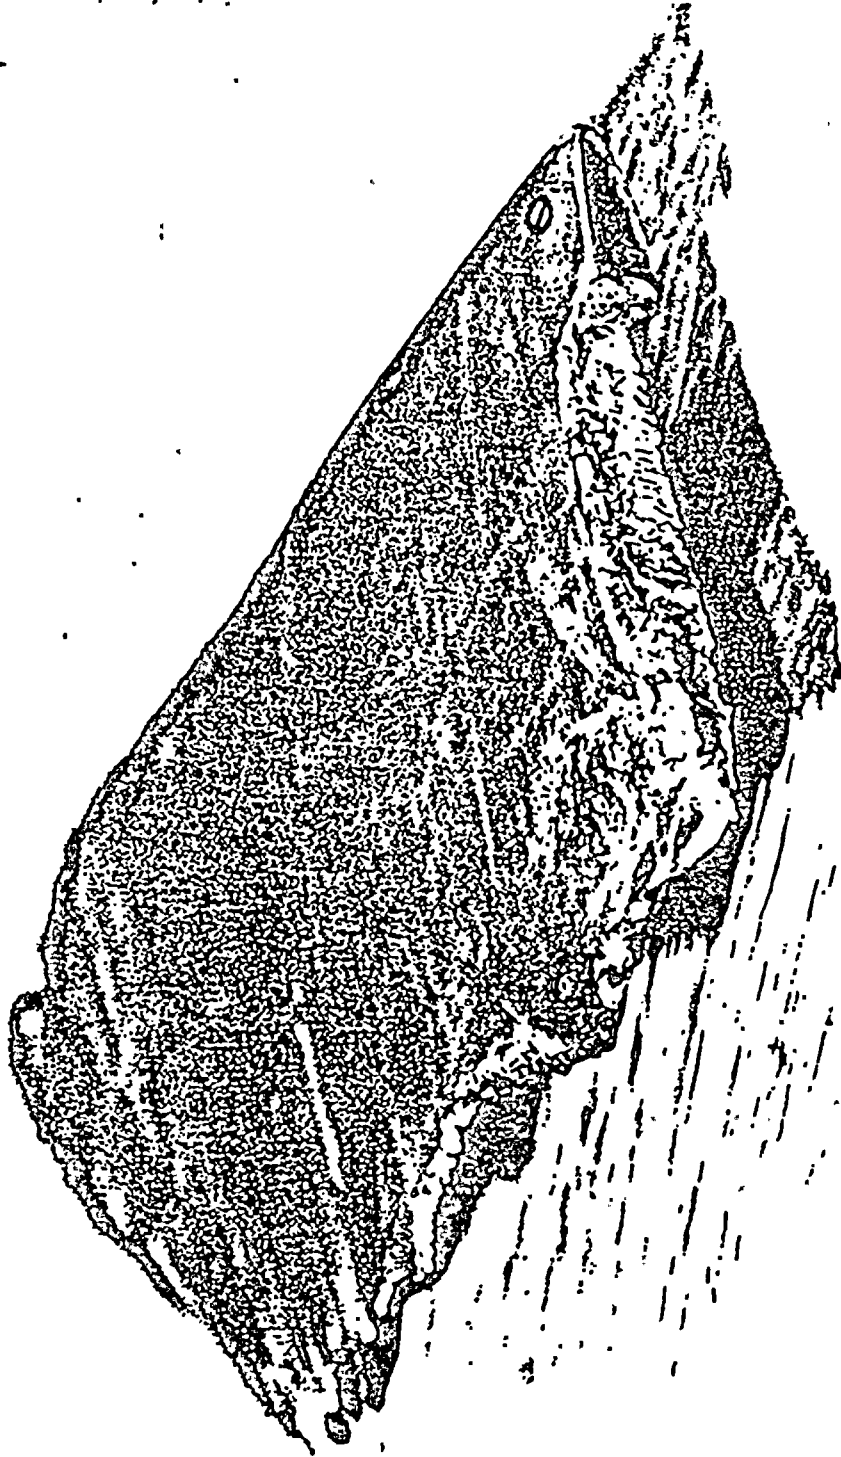
PHOTOGRAPH NO. 9

VIEW OF AIRFOIL SIDE OF AIRFOIL FAILURE ON BLADE NO. 5

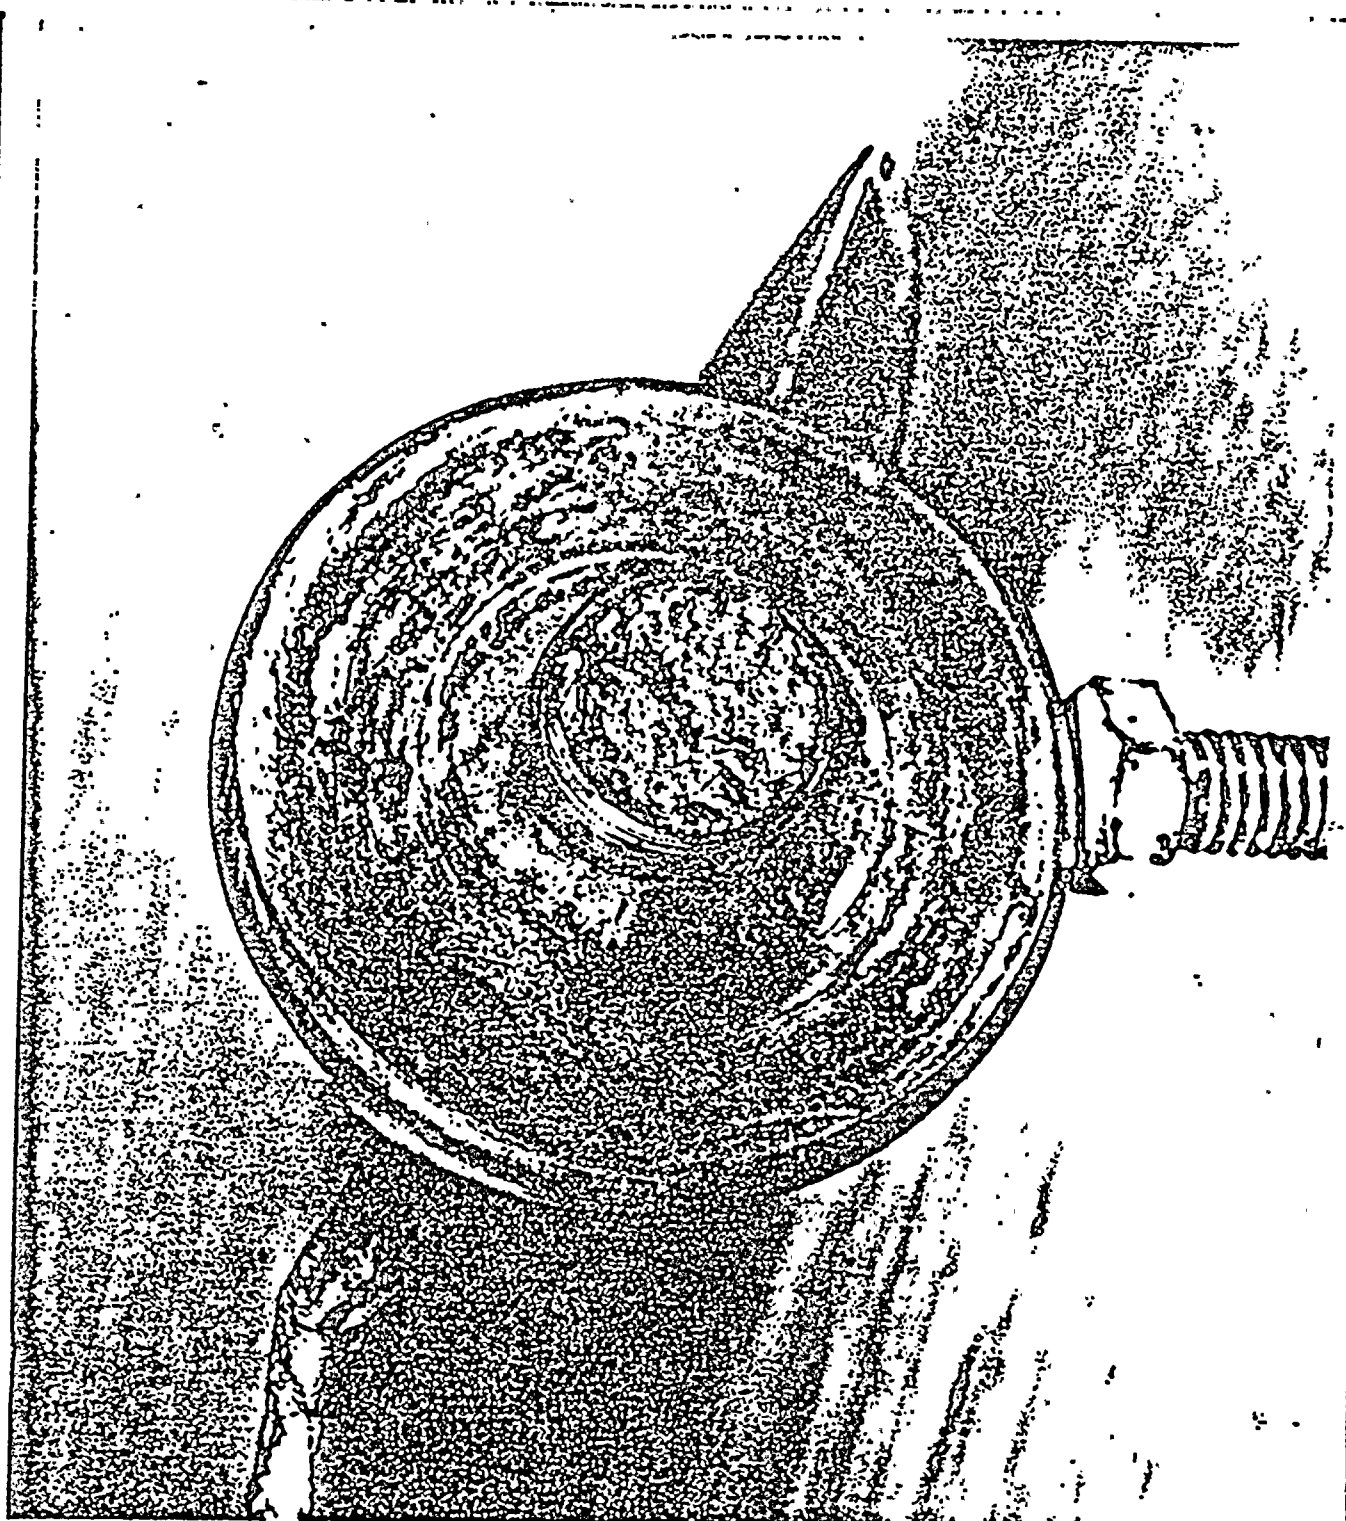
PHOTOGRAPH NO. 10

VIEW OF AIRFOIL SIDE OF BLADE NO. 3 (OVERLOAD)

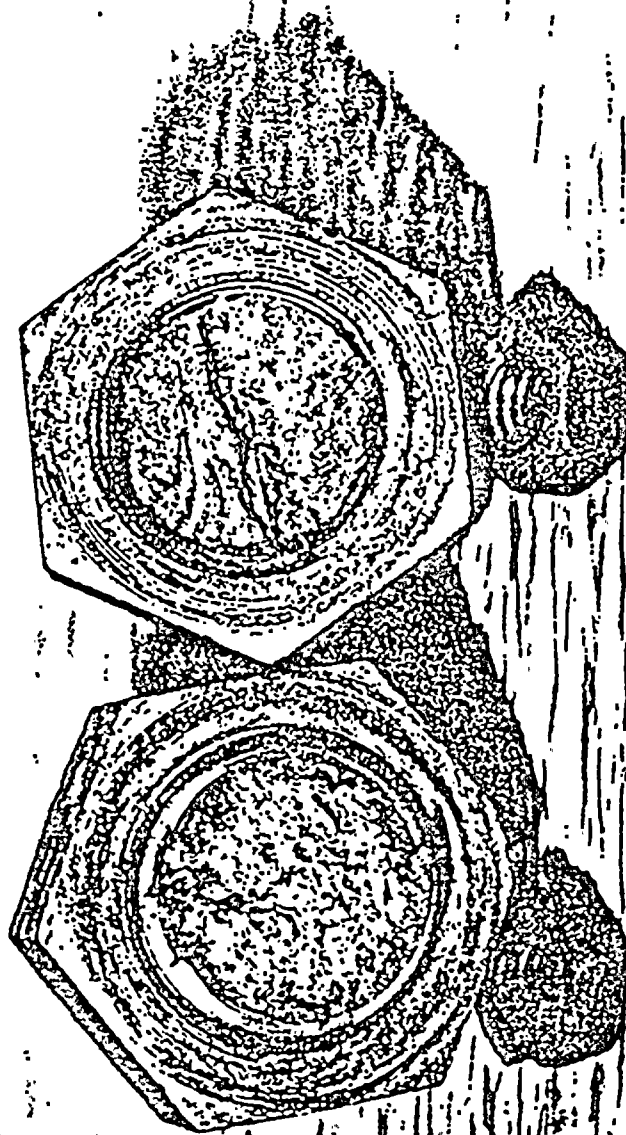
PHOTOGRAPH NO. 11

Normal operating stress in the blade shank is 20,490 PSI resulting from the centrifugal force of the blade. Normally, bending does not exist at this location because of the method of attachment. For Blade No. 7, the final overload section (center) was approximately .97 inches by .14 inches or .136 square inches. For a tensile stress of 160,000 PSI (tested value), this would support a load of 22,000 lbs. This compares reasonably with the known centrifugal load of 17,540 lbs. This is also strong evidence that the failure was relatively high cycle with low bending stress since a high bending load would have caused failure with a much larger center area remaining. SEM fractography of this surface did not reveal any defects at either crack origin that would be responsible for easy fatigue crack initiation. This same SEM fractography reveals a striation spacing that is shown in Table 3. This spacing is apparently in conflict with the rest of the evidence since it would imply a relatively low number of cycles. However, calculating the number of cycles from striation spacing is not very accurate especially with a relatively high mean stress.

VIEW OF HUB SIDE OF SHANK FAILURES
BLADE NO. 3 - BOTTOM
BLADE NO. 7 - TOP
