SUBJECT: Rev 1 to deficiency rept re weld failure on Unit 1 pipe
 support structure identified during 860313 surveillance
 insp. Caused by weld fracture due to overloading. Documents to
 implement repair issued for six supports.

Subject: Palo Verde Nuclear Generating Station
Unit 2
Docket No. STN 50-529 (License NPF-46)
Report on Pipe Support Failure
File: 86-073-419, P.3.04.1

WELD FAILURE ON PVNGS UNIT 1 PIPE SUPPORT STRUCTURE

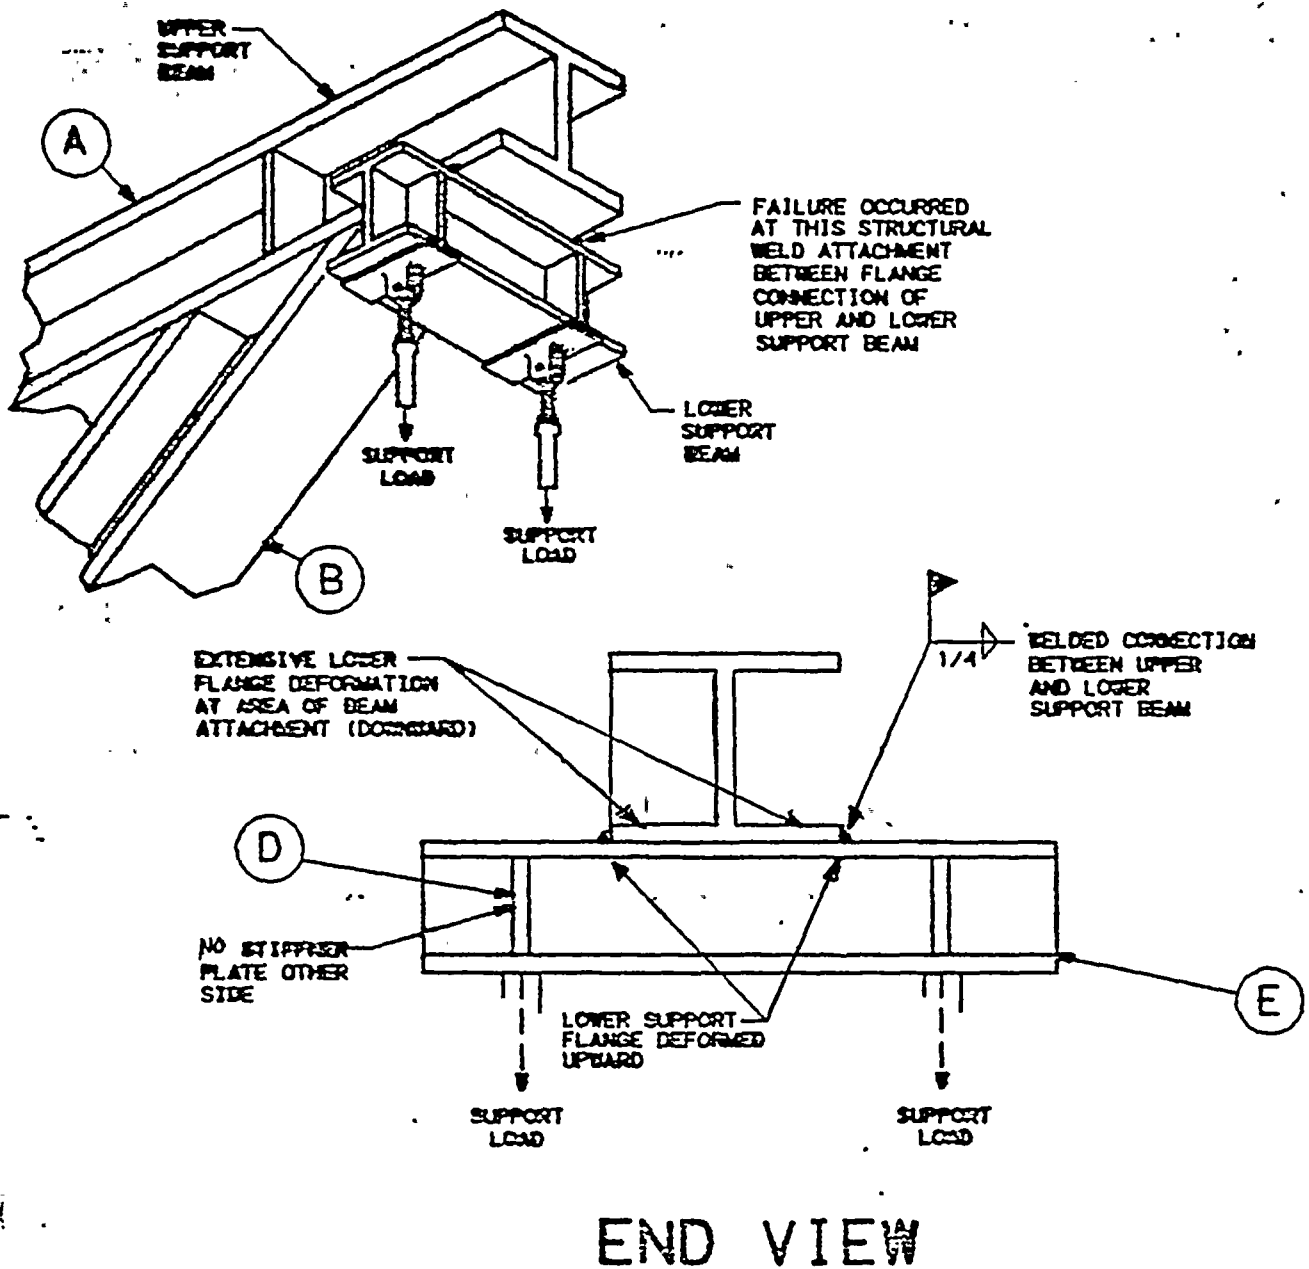
PIPE SUPPORT 1-SG-005-H008 FAILURE LOCATION

A surveillance inspection of Unit 1 on March 13, 1986, identified a broken pipe support (Support No. 1-SG-005-H008). The broken support was located inside the containment building and was a strut type support for the 24 inch main feedwater line to Steam Generator No. 2. The break occurred in the weld between the flange connection of the upper and lower support beams. The lower portion of the support separated completely from the upper support beam (see Attachment A). The axes of the two beams were oriented 90°, and it was discovered that the two 4 inch long, 1/4 inch leg fillet welds between member A (upper beam) and E (lower beam) fractured. Attachment A shows the location of the failure. A distortion of the beam flanges at the weld location occurred.

The broken support was visually inspected. The upper beam's bottom flange edge showed substantial bending. Similarly, the lower beam's upper flange showed some bending. Part of the fractured weld remained on the upper beam with the remainder on the lower beam.

The weld surfaces on the lower beam were also examined under a Stereo Microscope. Part of the fracture was in the base metal near the fusion zone and part was in weld metal. The weld quality was satisfactory. The fractured surface of the beam had a woody appearance, but the fractured surface in the weld metal appeared smooth.

Based on the above observations, it was concluded that the weld fractured due to overloading. Deformation of the flanges indicate that the weld transferred the loads until it could no longer accommodate strains imposed by deformation of the flange, causing the weld to fracture.

The root cause of the support weld failure on support 1-SG-005-H008 is improper consideration of localized flange bending loads during the original design of the support. The flange deformation without stiffeners caused additional bending stresses on the fillet welds and beam flange leading to weld failure.

A. For the six supports that require rework, the following work documents have been issued:

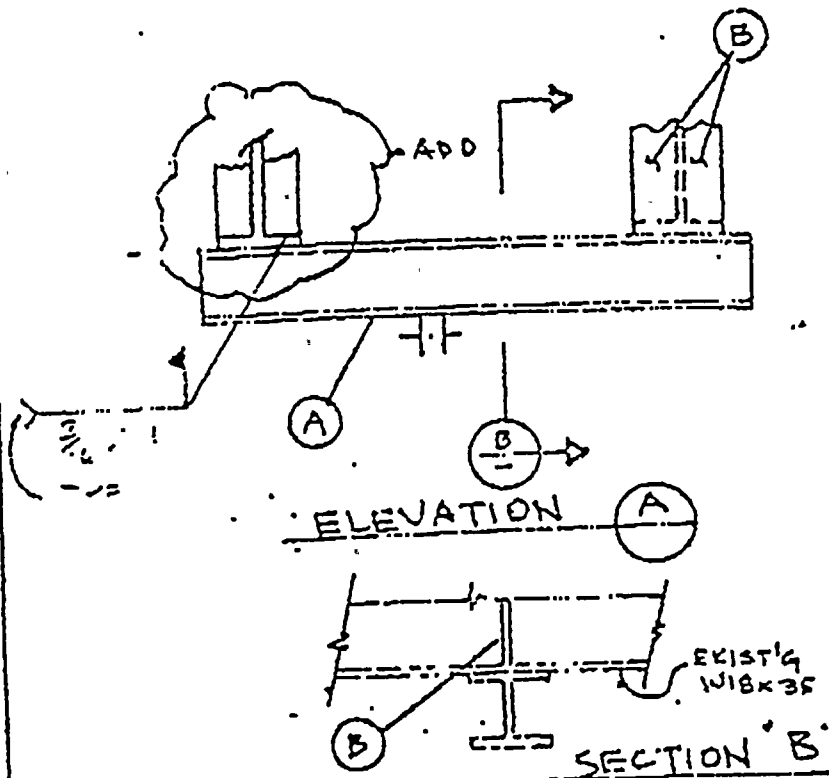
NO. 59,451-P

SUPPORT WAS REVISED PER FCC 15427 P
WHICH ALLOWED THE INSTALLATION OF TWO
ITEM B. FOUR ITEM B WERE
INSTALLED INSTEAD.

REVISE ITEM B ^{QTY} 4-
STEP, E 1/4 x 2 1/2 x 1-4 3/4
