SUBJECT: Forwards discussion on B61224 reactor trip & util plans for
 resolution of plant protection sys power supply problem.
 Bistable relay power supplies will be tested monthly to
 detect failed power supplies.

Subject: Palo Verde Nuclear Generating Station (PVNGS)
Unit 2
Docket No. STN 50-529 (License No. NPF-51)
Plant Protection System Power Supplies
File: 87-F-056-026

POWER SUPPLY SCHEMATIC

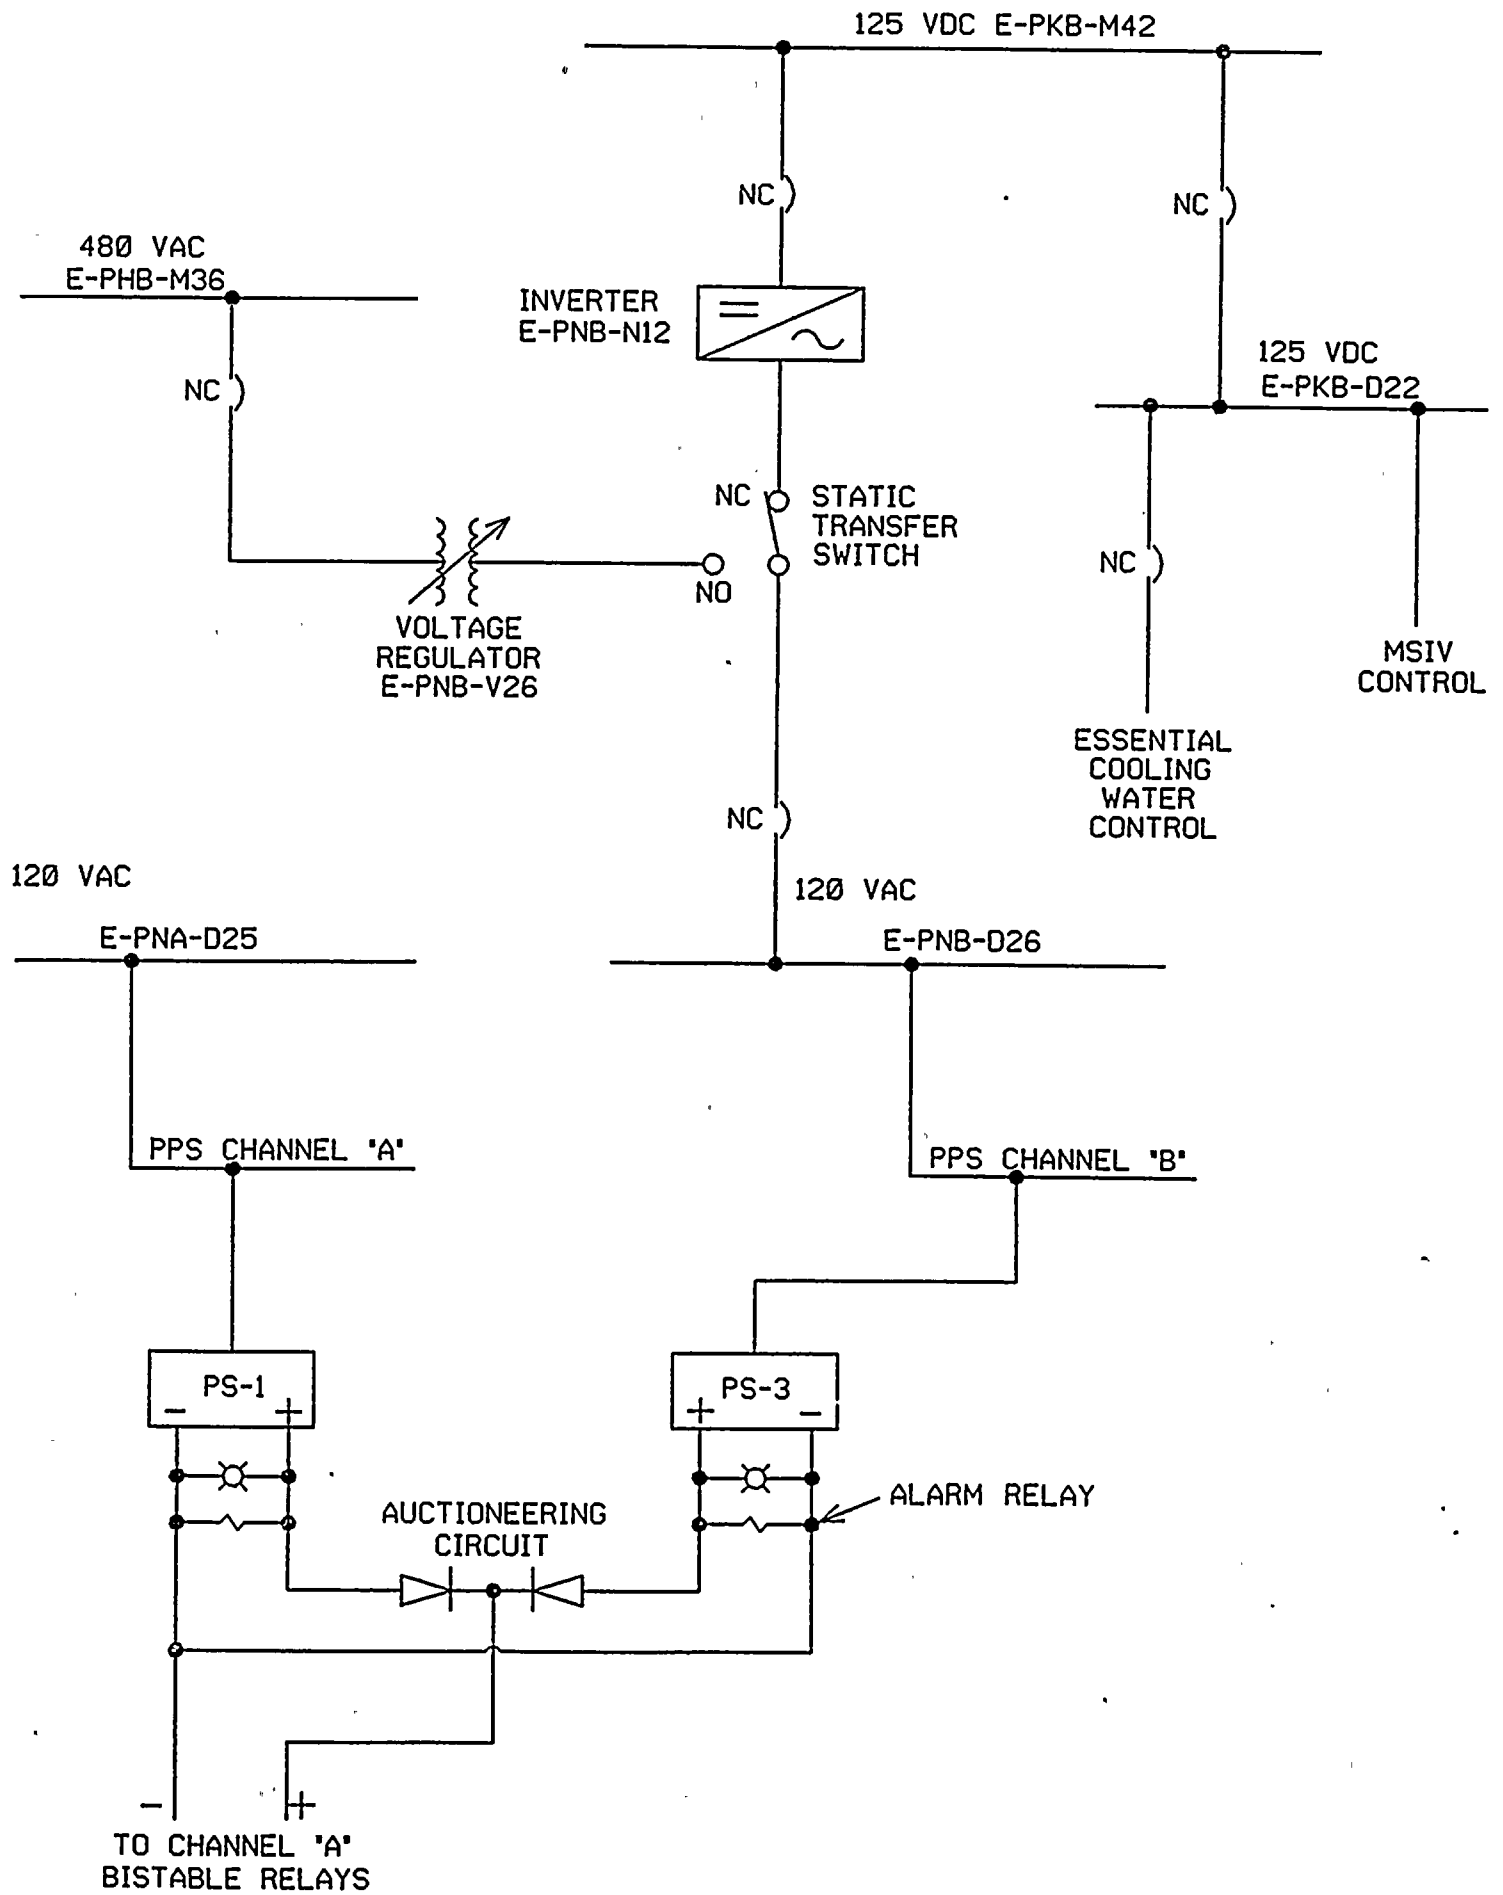
The events described above resulted in a loss of power to 120 volt AC bus D26 which resulted in a loss of power to the PPS Channel "B" instrumentation and a loss of power to Power Supply 3 (PS-3) which provides an alternate power supply to the PPS Channel "A" bistable relays. Additionally, the other power supply for the Channel "A" bistable relays (PS-1) was in a degraded voltage or "lockdown" condition at the time that D26 lost power. Thus, power was lost to the Channel "A" bistable relays due to the loss of PS-3 concurrent with PS-1 being in the "lockdown" condition. The loss of power to the Channel "A" bistable relays and the Channel "B" instruments satisfied the "AB" logic matrix and resulted in the PPS actuation.

During the review of the event, ANPP identified the fact that the degraded voltage condition of PS-1 had gone undetected because the "lockdown" condition for the power supply occurs at a higher voltage than the alarm relay actuation voltage. ANPP recognizes that it is clearly undesirable for a failed power supply in the PPS to go undetected. Therefore, ANPP is pursuing a modification to correct this undesirable condition. It should be noted that the objective of this modification is to ensure that any credible power supply failure is alarmed so that the power supply can be promptly repaired or replaced.

The resolution of this problem involves the implementation of a modification to the existing bistable relay power supplies to ensure that the power supplies are latched to a low output voltage for the over voltage lockdown condition. This will result in a positive alarmed condition. This power supply modification is being implemented at the vendor's facility. The modified power supplies will then be sent back to PVNGS for installation in the units. Additionally, ANPP is considering a modification to the power supply alarm relays. This modification would involve replacing or modifying the existing alarm relays to ensure that the alarm relays actuate at a higher voltage. The alarm relay modification would provide further assurance that power supply failures would be alarmed. Due to the uncertainties currently involved in the scheduling and completion of these modifications, a schedule for completion cannot be provided at this time. However, the monthly testing described below will be continued until such time as the modification is completed.

In the interim, until such time as the power supply modification can be completely implemented, the bistable relay power supplies in PVNGS Units 1, 2, and 3 will be tested monthly to detect failed power supplies. It should be noted that this monthly testing will not be conducted when the units are in shutdown modes where the PPS is not required to be operable. If plant conditions are such that the power supply test cannot be conducted without jeopardizing safe plant operations, then the test will be postponed until such time as it can be safely performed. ANPP believes that this monthly test is an acceptable interim measure until the modification is completed. This conclusion is supported by a reliability analysis which ANPP has performed. The analysis indicates that the probability of subsequent PPS actuations due to the specific scenario experienced on December 24, 1986, (loss of one instrument bus and a failure of a specific bistable power supply) is $9.4E-06$ per month per unit. This low probability of a subsequent similar event shows that the PVNGS units can be operated in a safe manner until the final solution can be implemented.
