REPORT ON THE STEAM GENERATOR

TUBE LEAK AT PVNGS UNIT 1

Revision 0  
February 1987

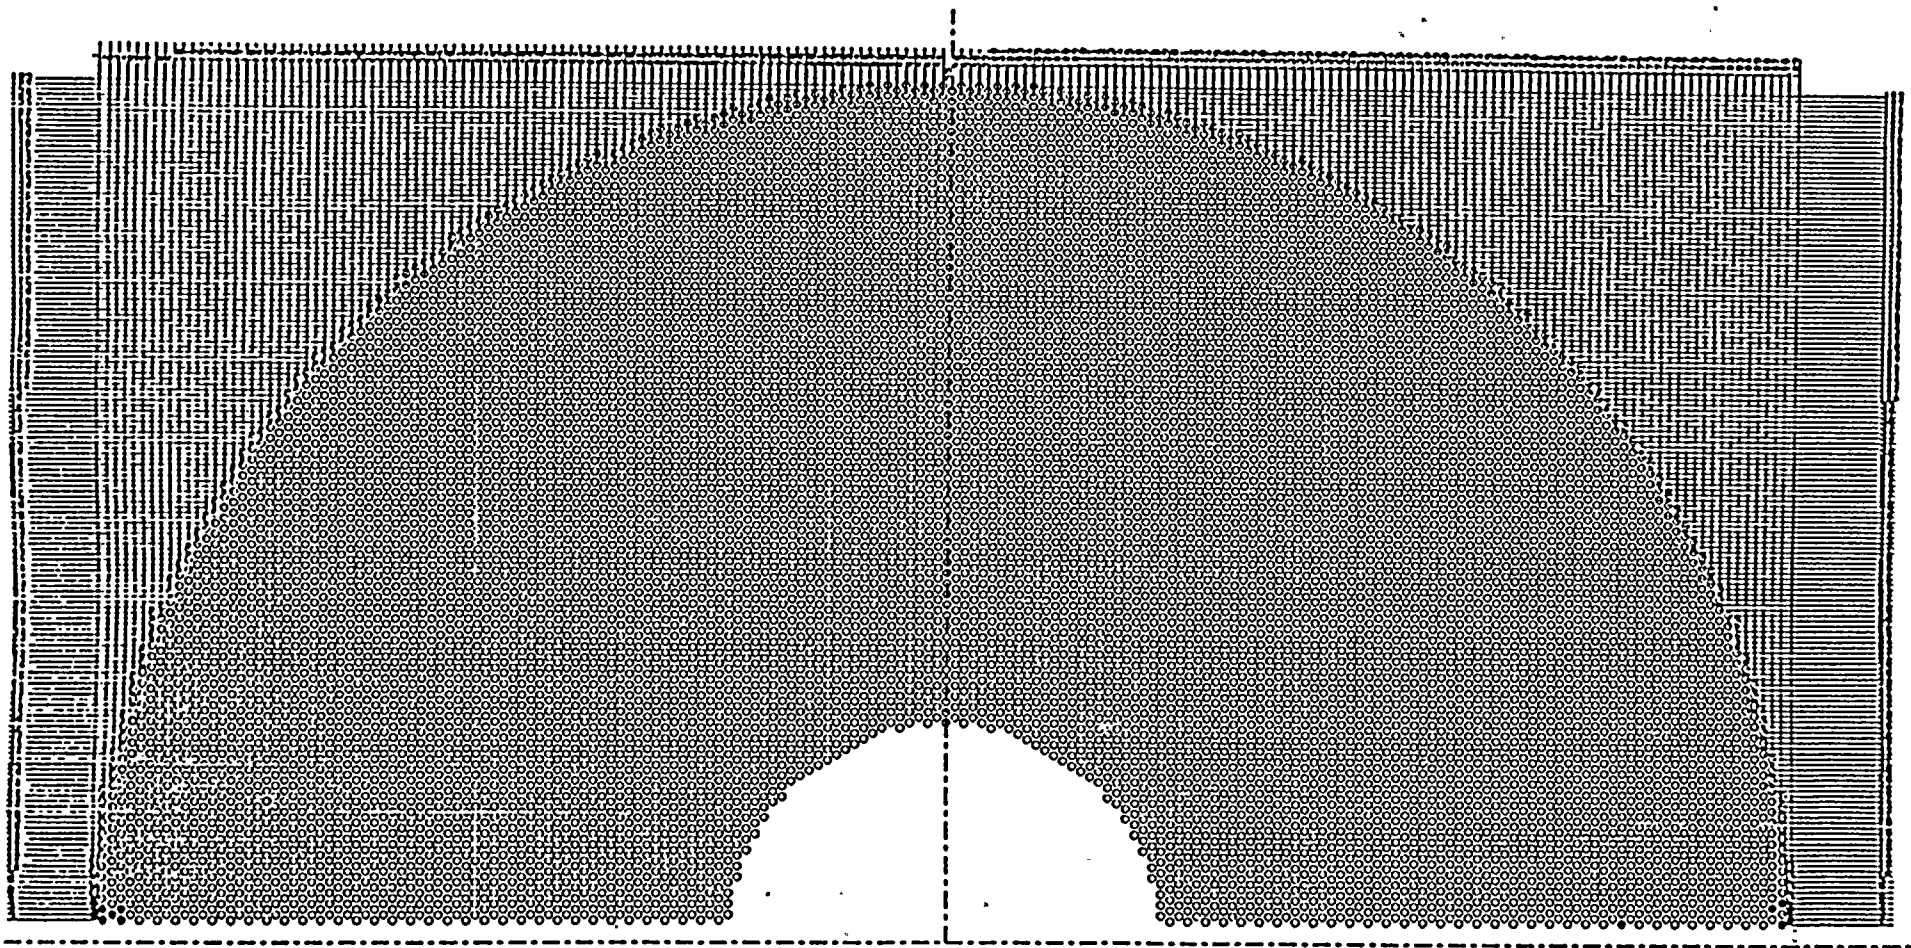
Figure 6

Indications of tube wall thinning were found on several tubes (Table 1) of steam generators 1 and 2 in both Units 1 and 2. These worn tubes are confined to a particular region of the steam generator (Figures 6 through 9). The region where tube wear has been observed is referred to as the cold leg corner region. The cold leg corner region is located on the outer periphery of the tube bundle adjacent to the economizer divider plate on the cold leg side of the steam generator. There are two cold leg corner regions in each steam generator. The indications of worn tubes are located at the second through sixth tube supports (first through fifth eggcrate supports) on the cold leg side of the steam generator.

Unit 1, Steam Generator #1 Tube Wear

An evaluation of the eddy current test data determined the indications to be typical of that caused by tube-to-support wear resulting from tube vibration. The cause of the tube vibration is postulated to be local high radial velocity flow streaming of entering recirculating fluid.

ANPP has plugged and staked all tubes with any indication of wear in the local high velocity region in Units 1 and 2. Those tubes with no wear to date are postulated to be sufficiently supported to preclude vibration and a mechanism by which this condition could change has not been identified. Therefore, these tubes will remain in service. All unplugged tubes in Units 1 and 2 in the region of interest will be reinspected during the next refueling outage to confirm that wear has not initiated in these tubes.

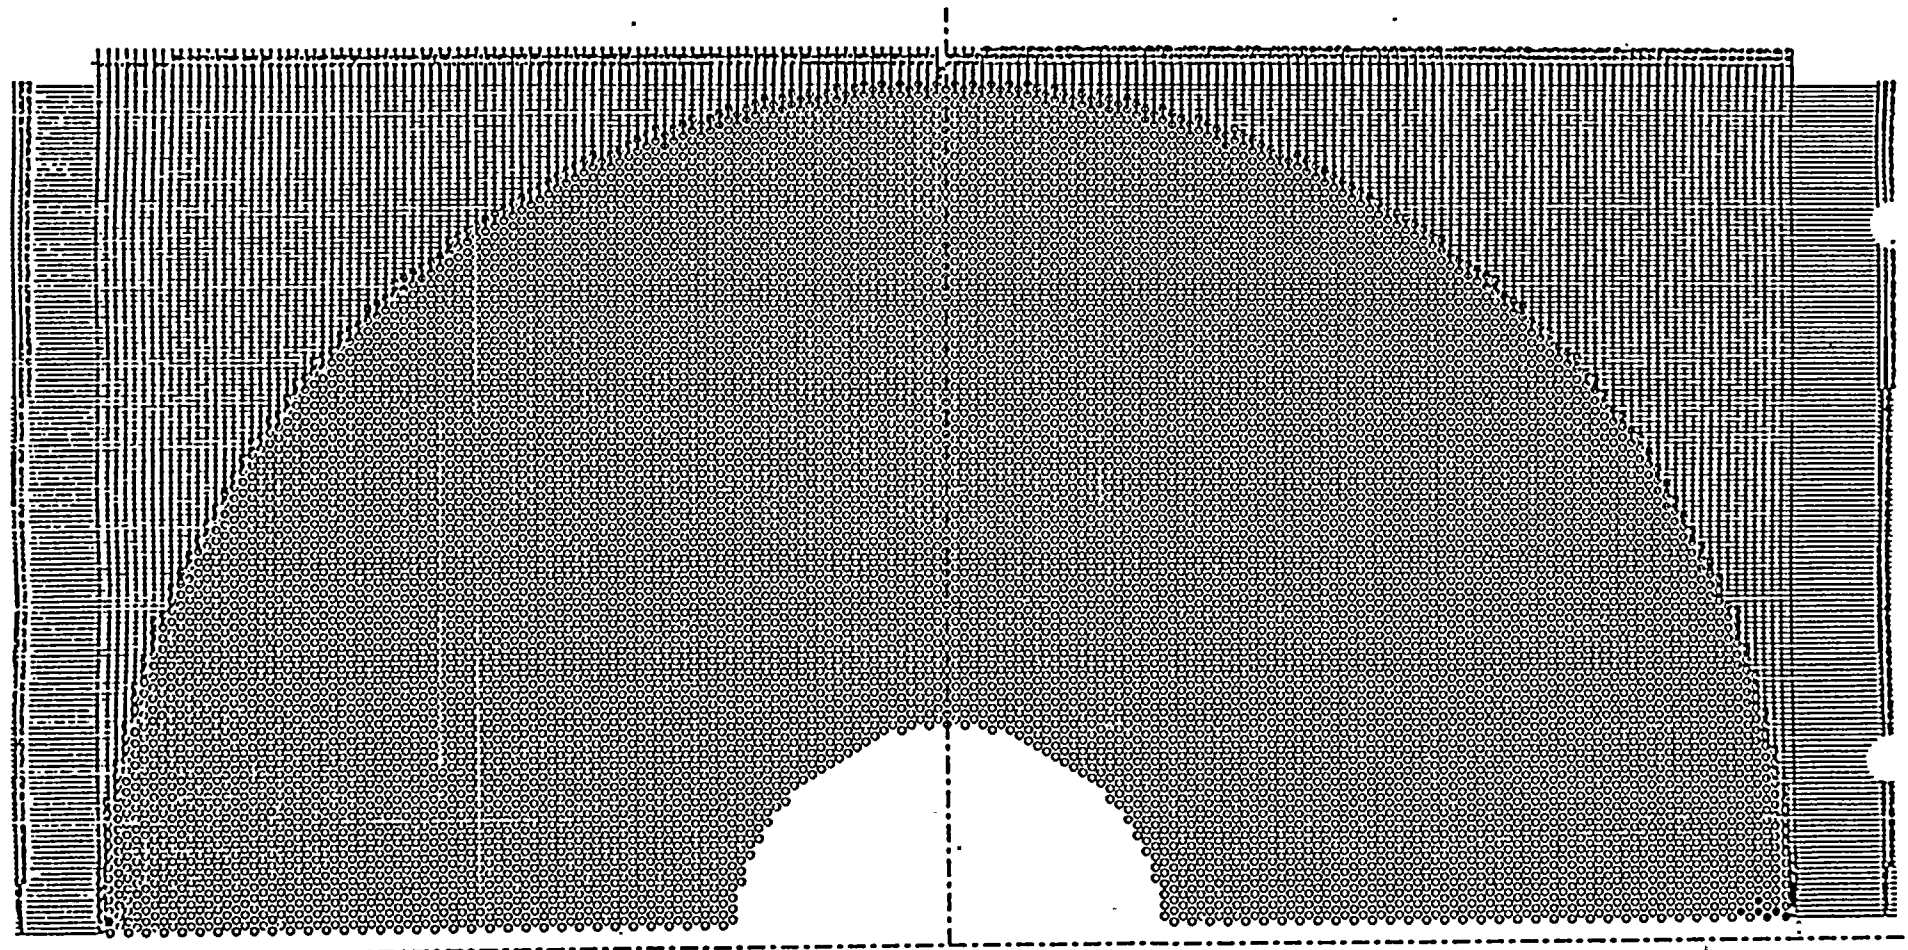
Figure 7

Unit 1, Steam Generator #2 Tube Wear

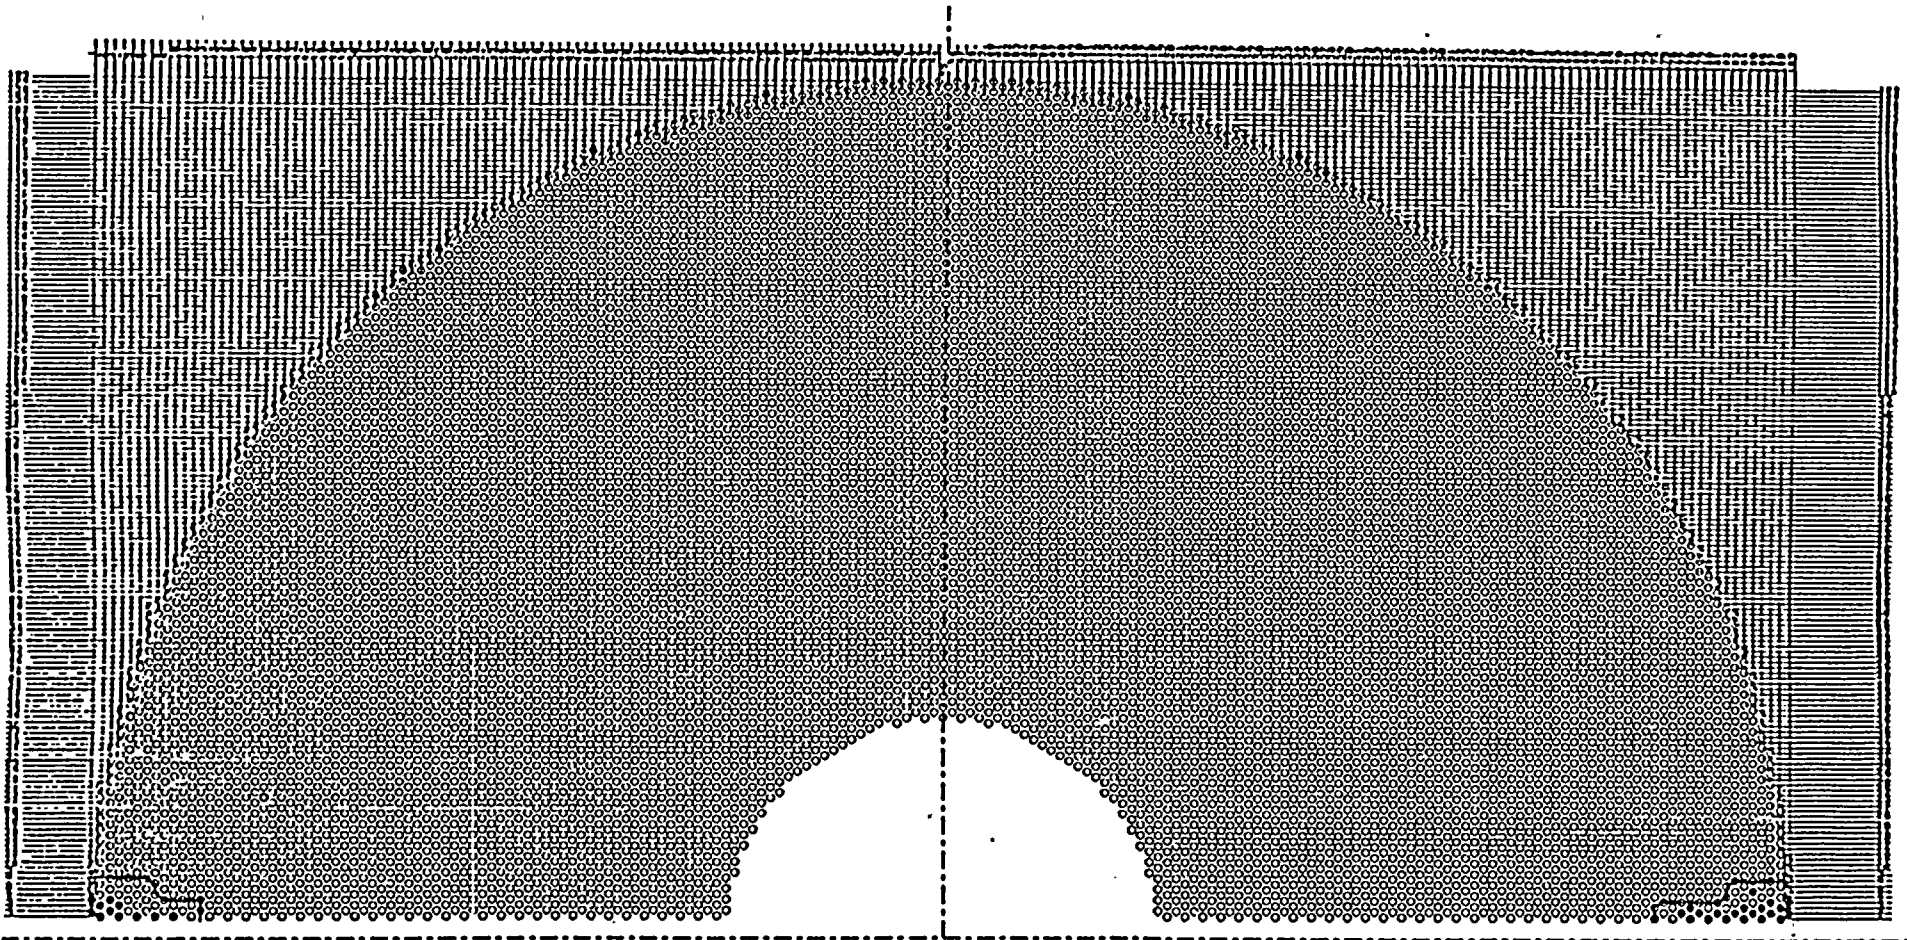
Figure 8

Unit 2, Steam Generator #1 Tube Wear  
and Inspection Plan

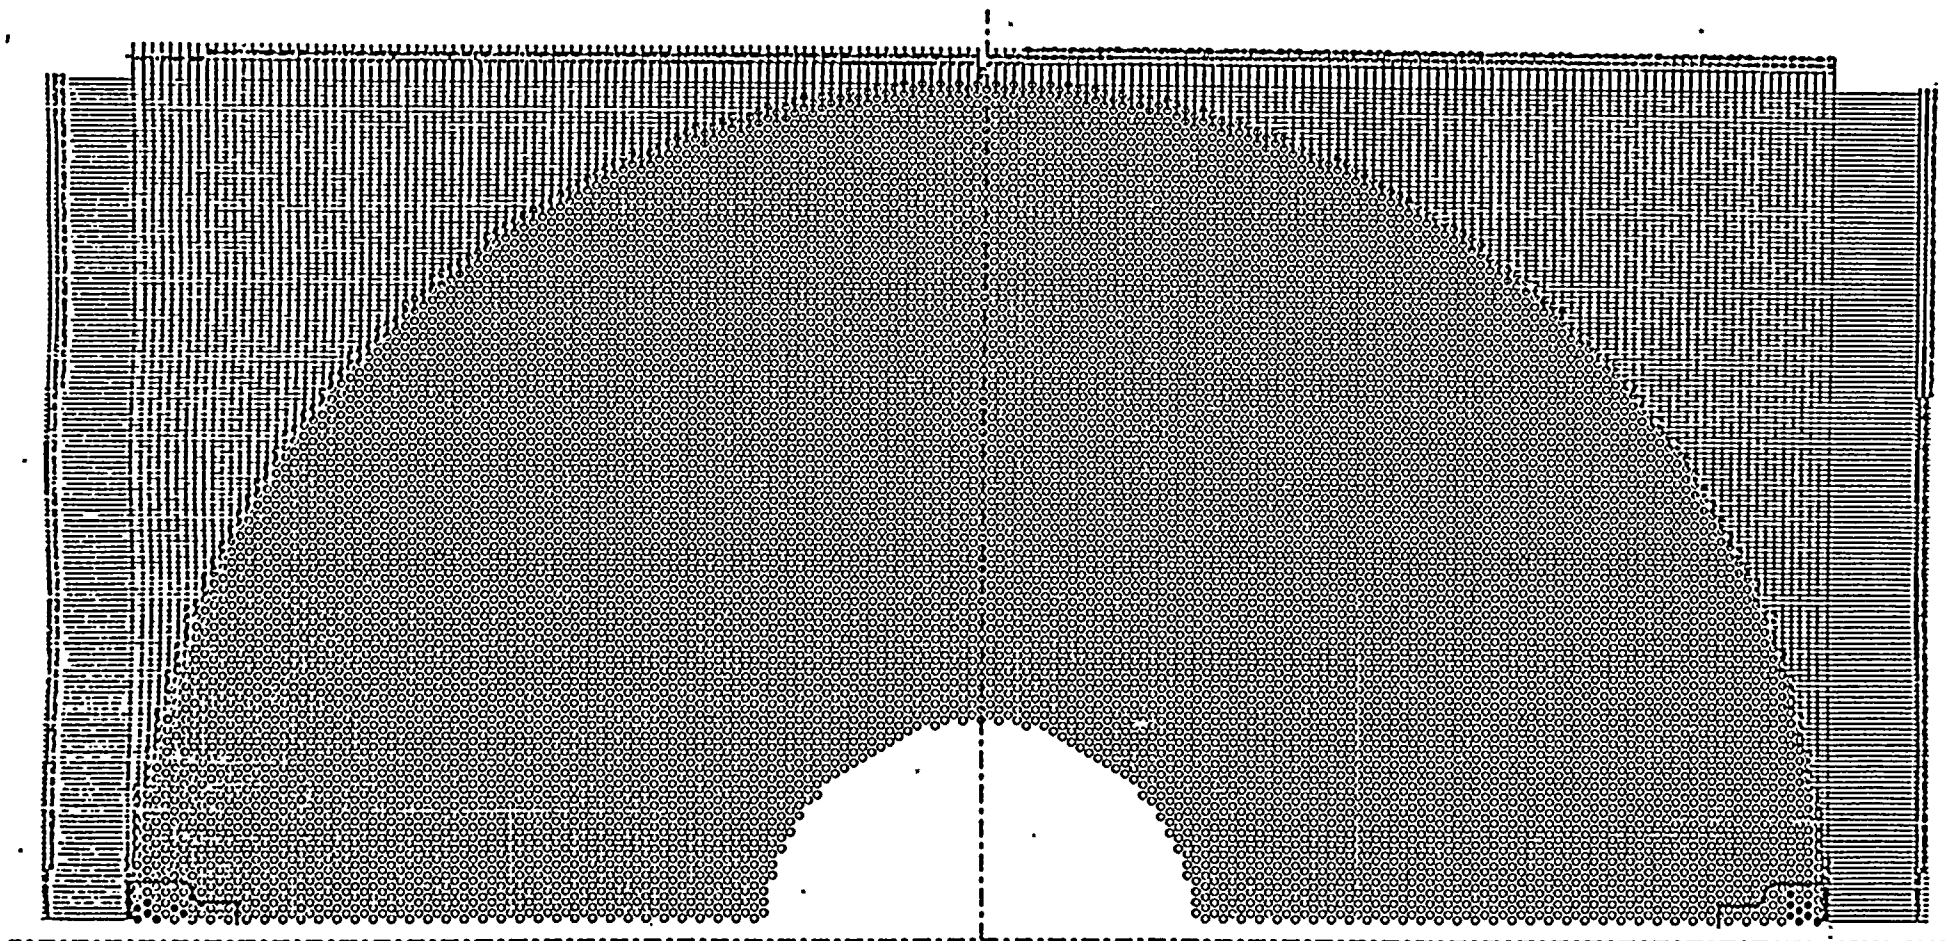
Figure 9

Unit 2, Steam Generator #2 Tube Wear  
and Inspection Plan

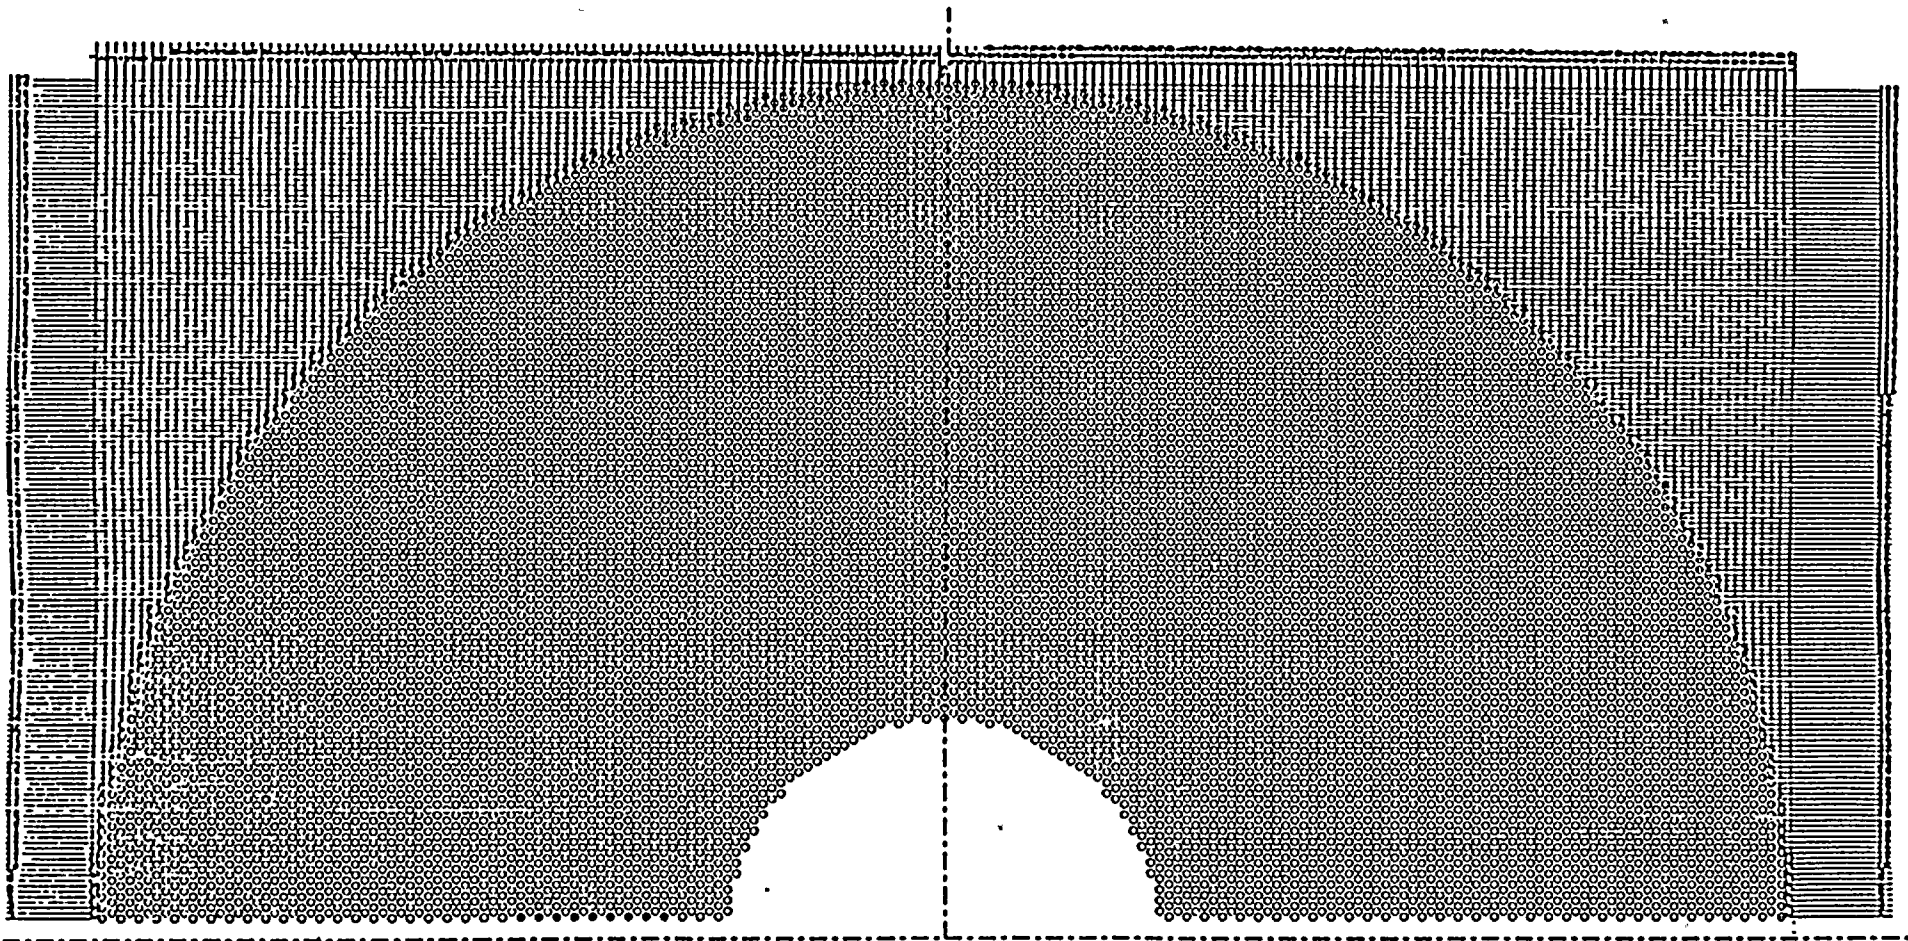
Figure 10

In steam generator #1 of PVNGS Unit 1, the tubes on the cold leg side in row 1 at columns 48 through 64 (a total of 9 tubes as shown on Figure 10), exhibited indications caused by

deformation of the tube at the top surface of the flow distribution plate (first tube support). Deformation of the tube at column 58 prevented passage of the 0.540 inch outside diameter eddy current probe. Therefore, no eddy current data was available for this tube. The other tubes that showed indications of denting were eddy current tested. There were no indications of wear or loss of tube wall for any of the inspected dented tubes.

Unit 1, Steam Generator #1 Dented Tubes

In light of the limited affected region and the detection of a metallic foreign object adjacent to the nine dented tubes, it is hypothesized that the deformation was caused by the wedging action of a metal "bar" between the economizer divider plate and the row 1 tubes during power operation. Since the flow distribution plate is made of 405 ferritic stainless steel, it has a lower coefficient of thermal expansion than the tube sheet. The relative temperature of the plate (secondary side, subcooled below saturation temperature) is also less than the tube sheet (RCS cold leg temperature). Therefore, the flow

Since the foreign object was trapped and presumably non-compressible, the tubes absorbed deformation of up to 1/8 inch. A dent of 1/8 inch would not allow passage of a 0.540 inch ECT probe. The tube could be dented at the elevation of the foreign object or at the top of the flow distribution plate by the reaction force, or by the combination of both. A fiberoptics inspection of a dented tube tended to confirm the above hypothesis. A slight straight edged indentation was found above and opposite to a smaller partial circumferential indication. This would indicate a primary dent induced by a "bar-like" object causing a reactive dent on the opposite side of a tube caused by the reaction force at the top edge of the drilled holes in the flow distribution plate.

procedures, such as tube pulling, do not seem warranted in light of ALARA considerations and no further anticipated tube damage. It is ANPP's and CE's opinion that tube plugging, regardless of method, is not necessary. Monitoring selective dented tubes during a future planned eddy current inspection would confirm the non-progression of the tube dents with time.

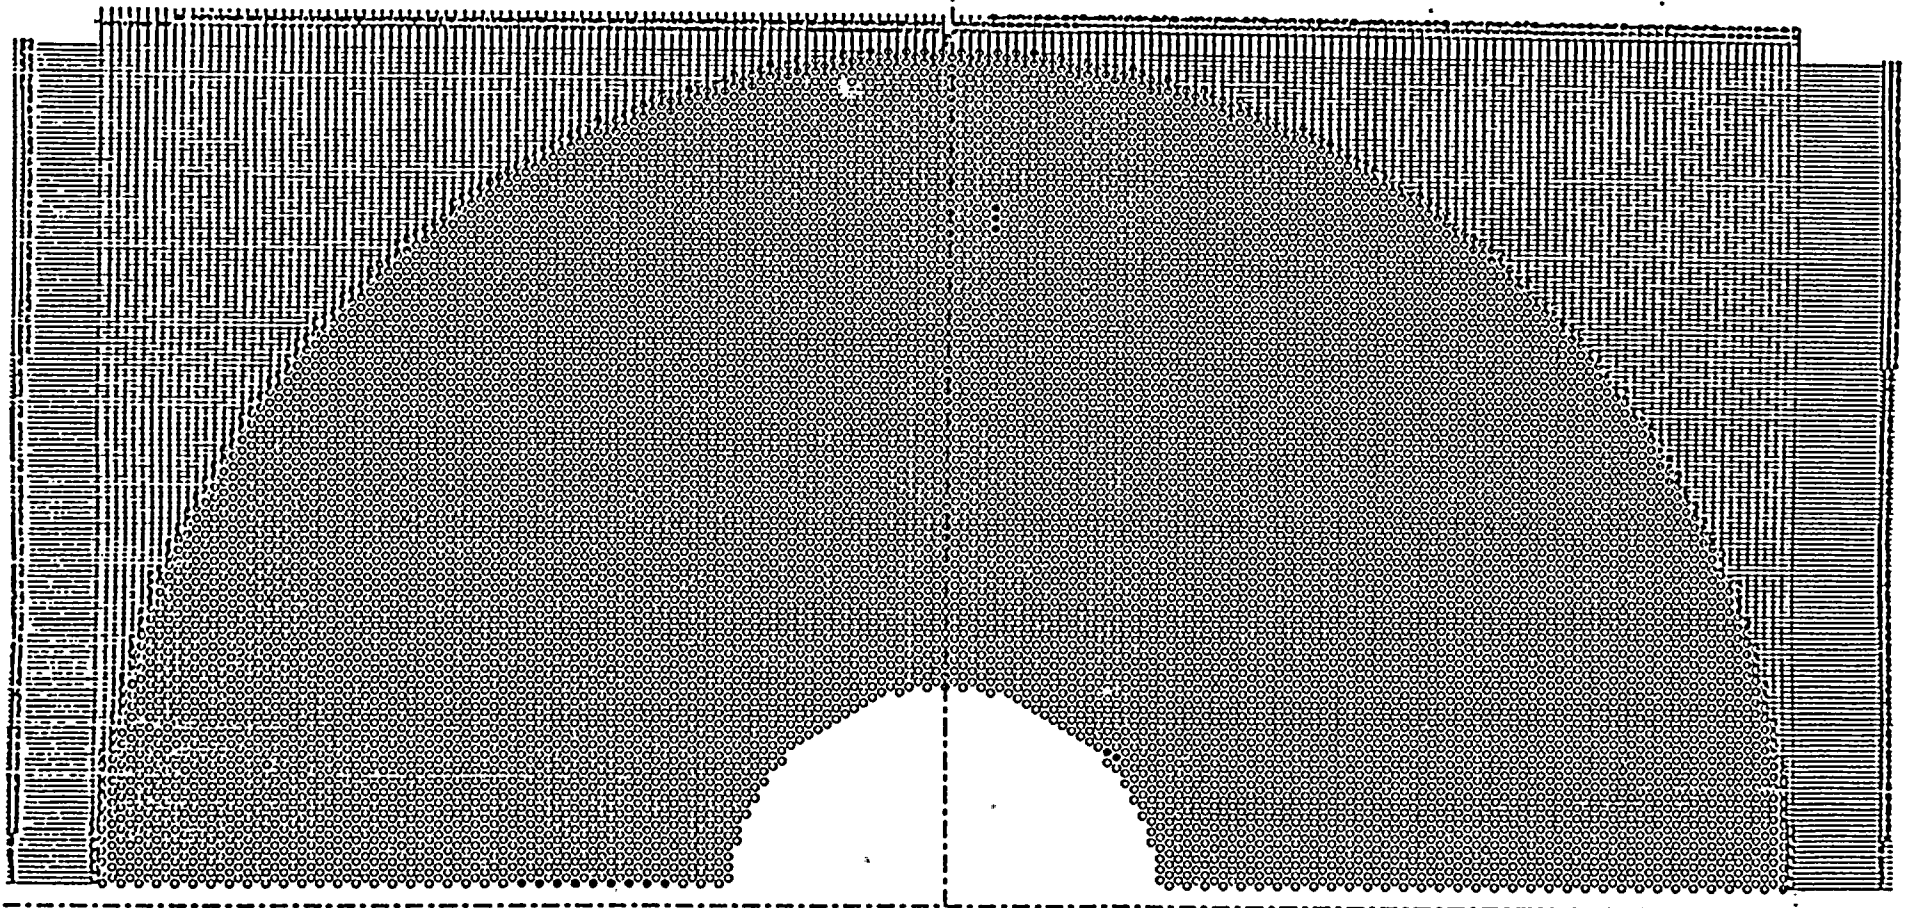
Figure 11

The use of a multi-frequency eddy current probe allows for the detection of potential loose parts or other anomalies when using the lower frequency range of the eddy current probe. As reported by our eddy current inspection team, potential loose part indications were found at the locations described in Table 2 and shown in Figures 11 and 12.

Unit 1, Steam Generator #1 Potential  
Loose Parts Indications

The indication in Unit 1 steam generator #1 at rows 125 through 129 - column 100 and in steam generator #2 at row 39 - column 4 have been determined to be variations in the tubes themselves, such as the result of a permeability change in the tube. A multi-frequency mix of the eddy current signals indicates no tube wall degradation and no actual presence of foreign material. Therefore, these indications do not represent a significant safety concern.

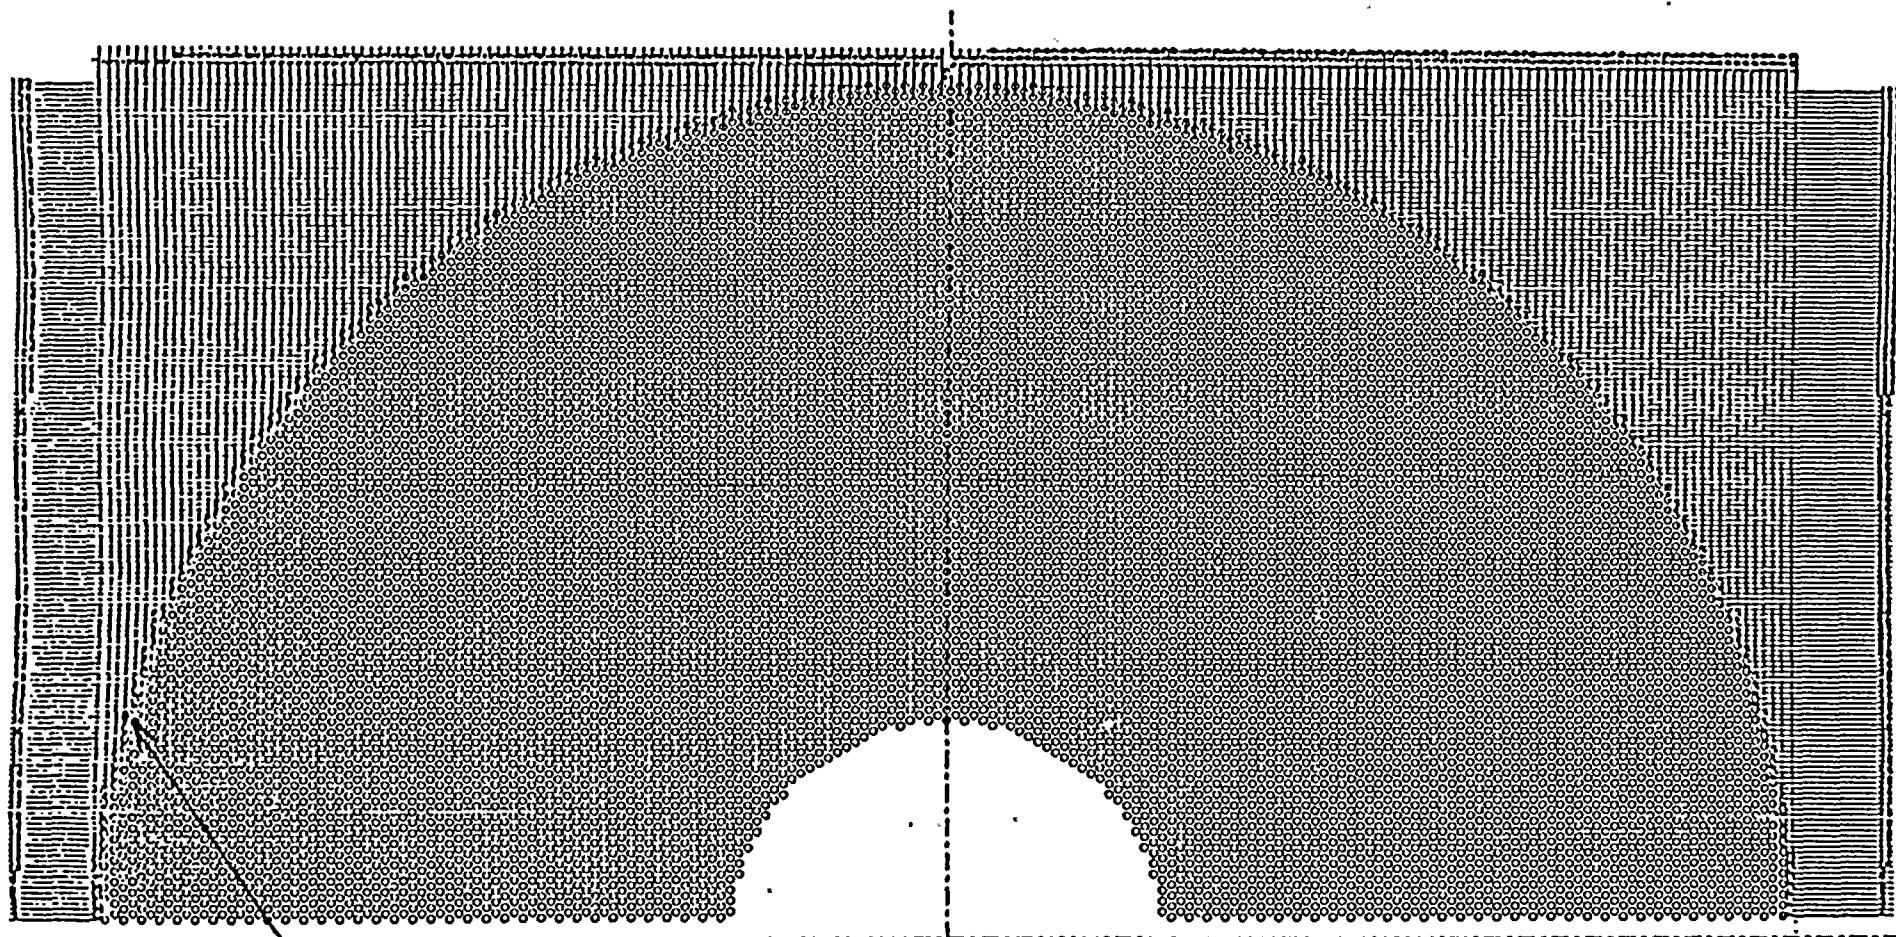
Figure 12

Unit 1, Steam Generator #2 Potential  
Loose Parts Indications

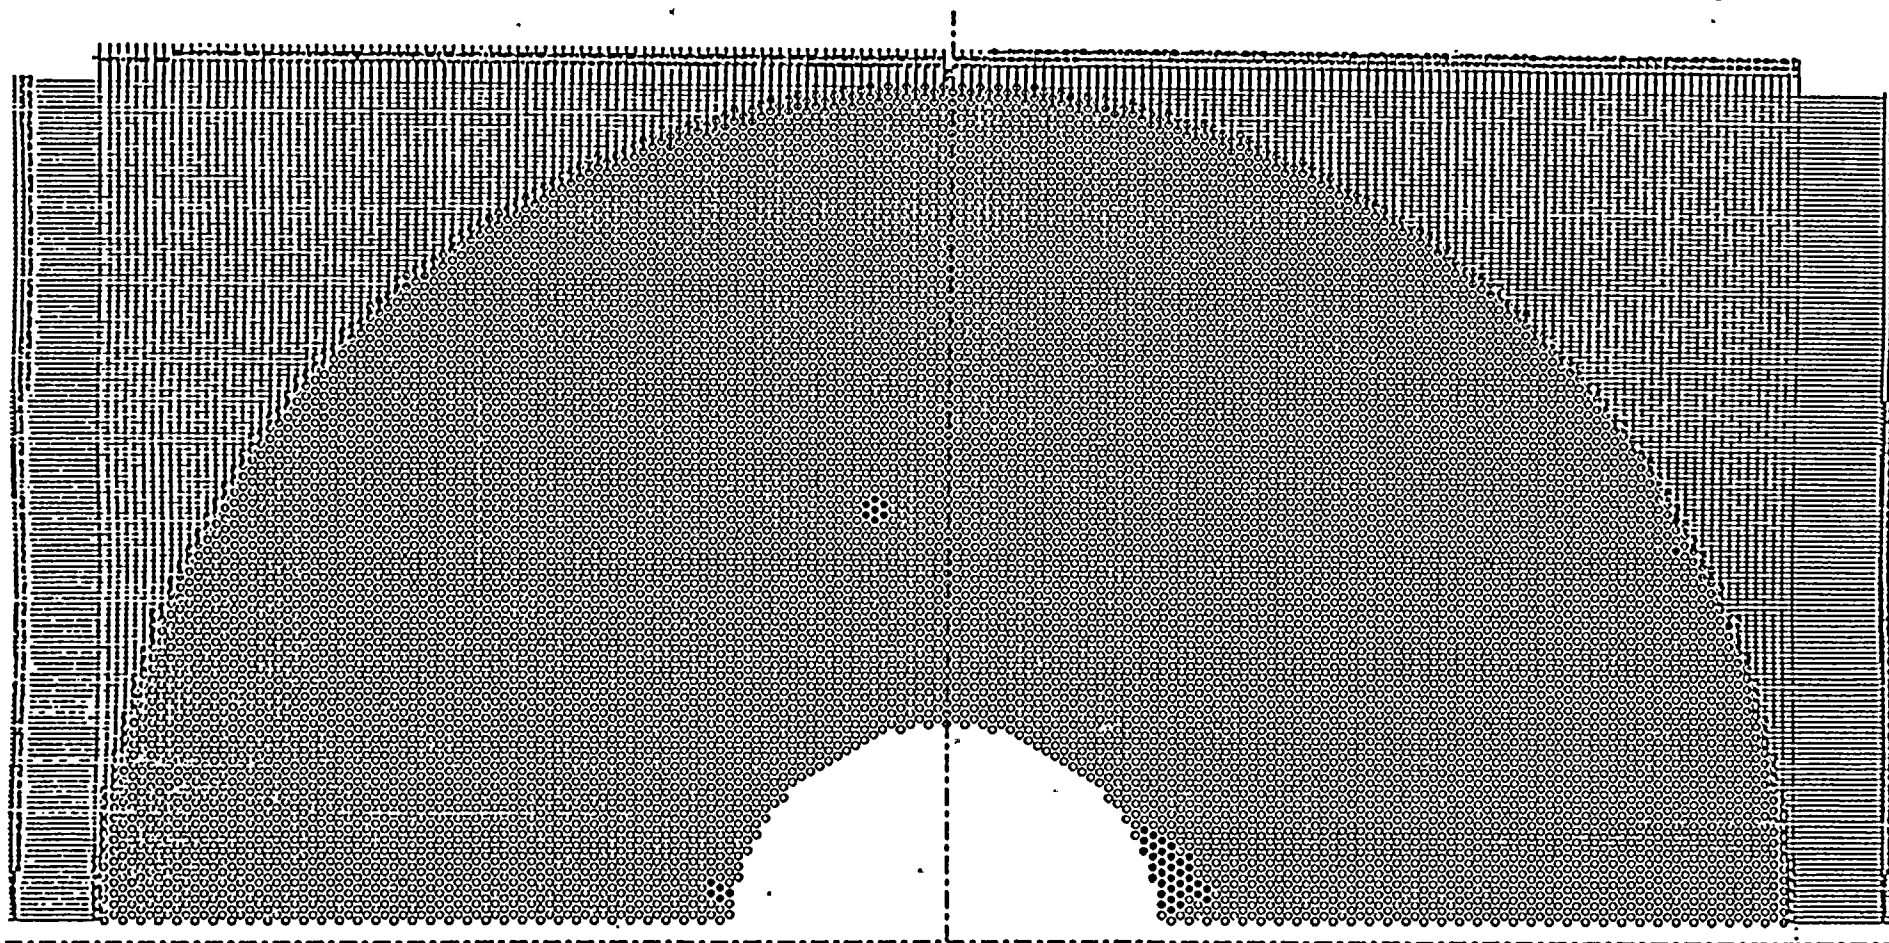
Figure 13

Unit 1, Steam Generator #1 Cold Leg  
Side Sludge

The very small amount of sludge found in the Unit 1 steam generators indicates that secondary chemistry control has been good. The locations of the largest deposits of sludge indicate that the sludge is being swept across the tube sheet to the area of the blowdown ring. This indicates that the blowdown system is operating as designed to prevent sludge accumulations from forming in the center regions of the tube bundle which have been a concern in previous steam generator designs.

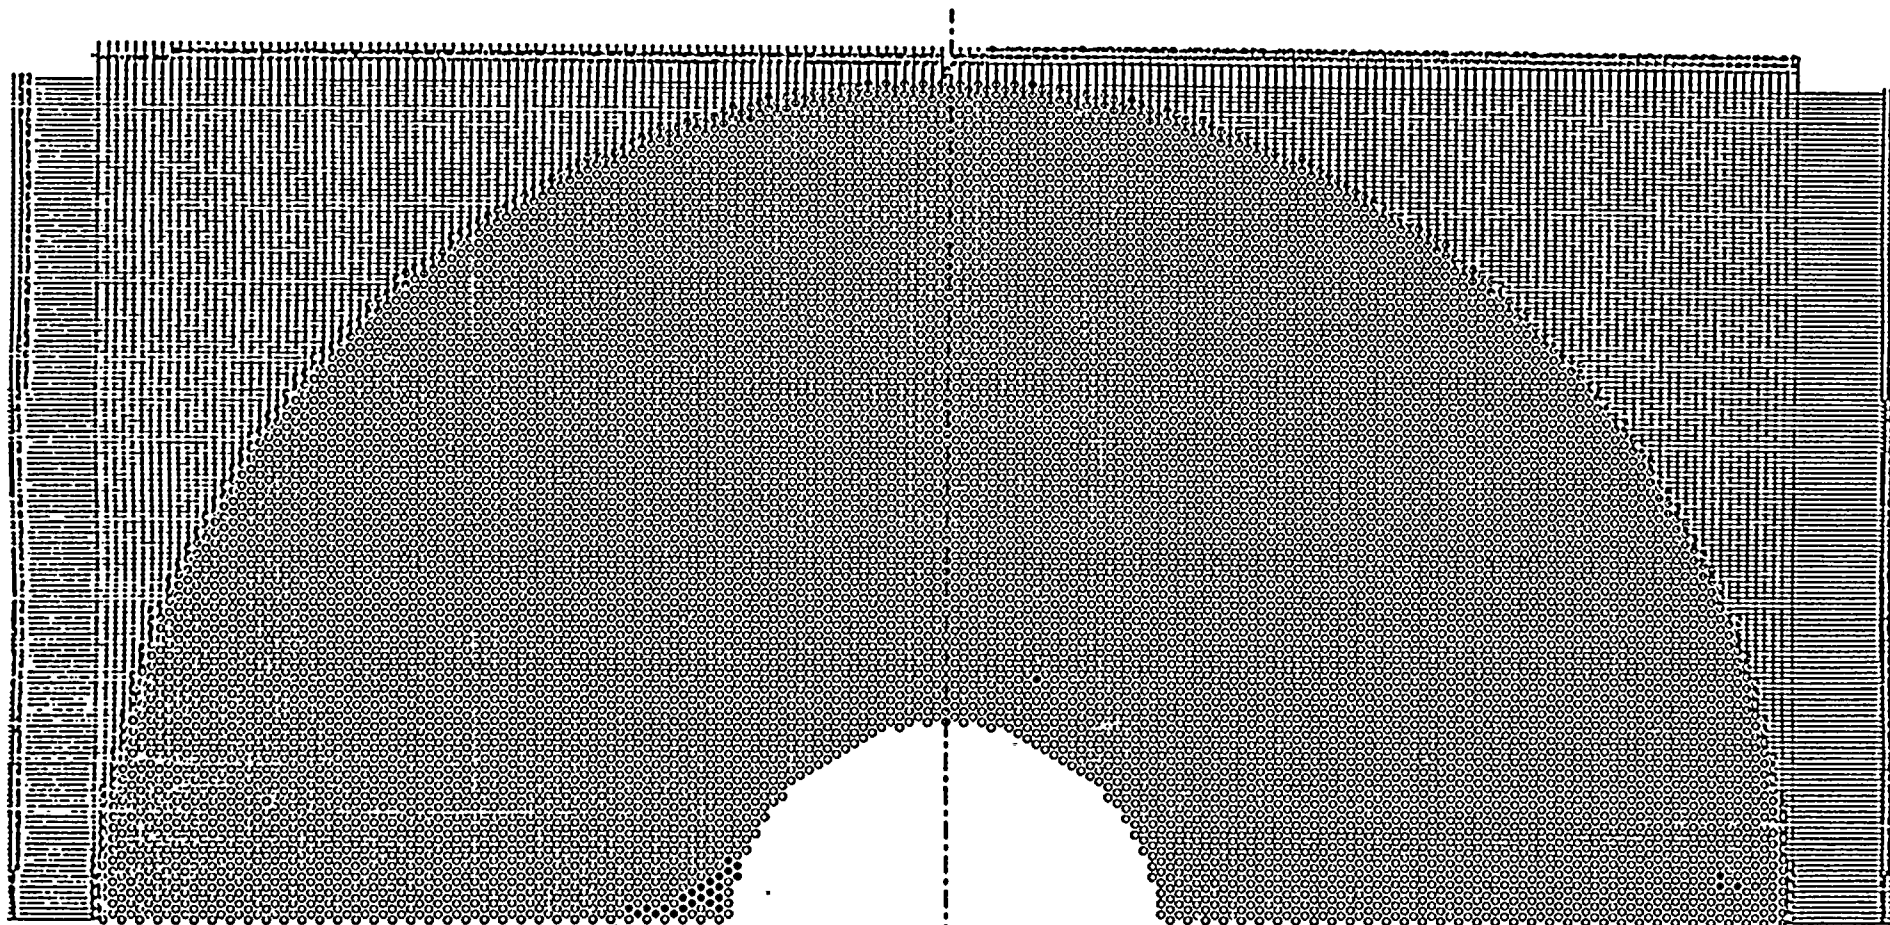
Figure 14

Unit 1, Steam Generator #2 Cold Leg  
Side Sludge

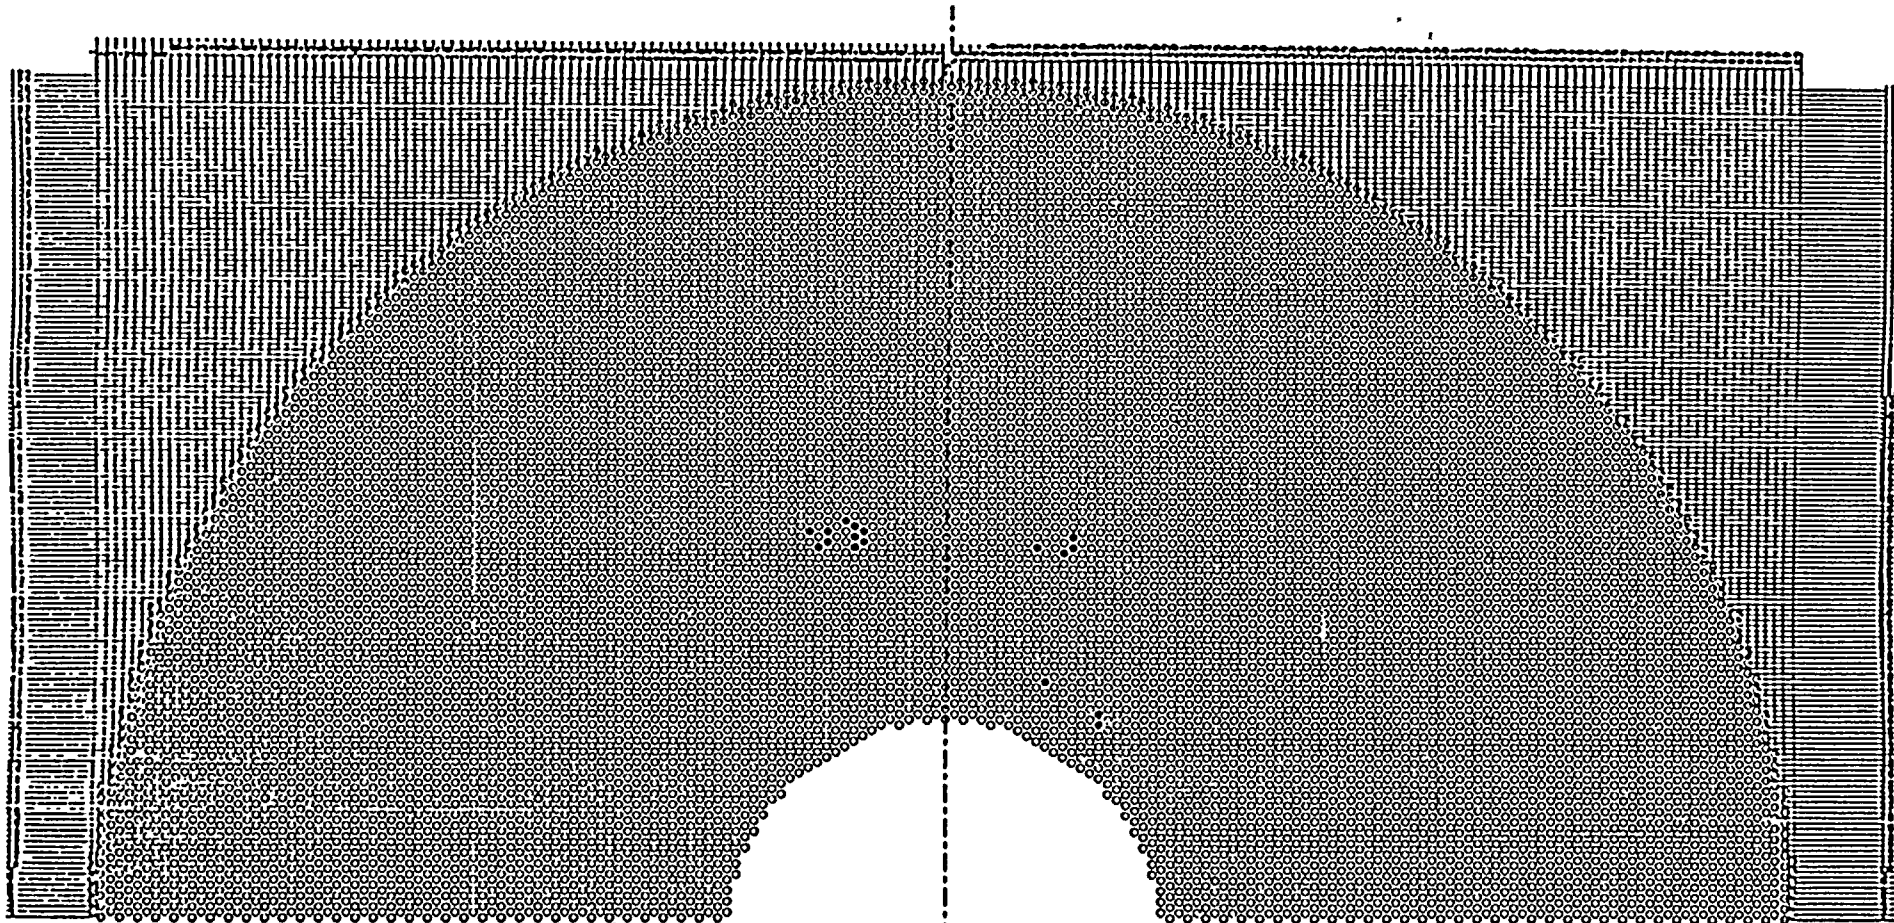
Figure 15

Unit 1, Steam Generator #2 Hot Leg  
Side Sludge

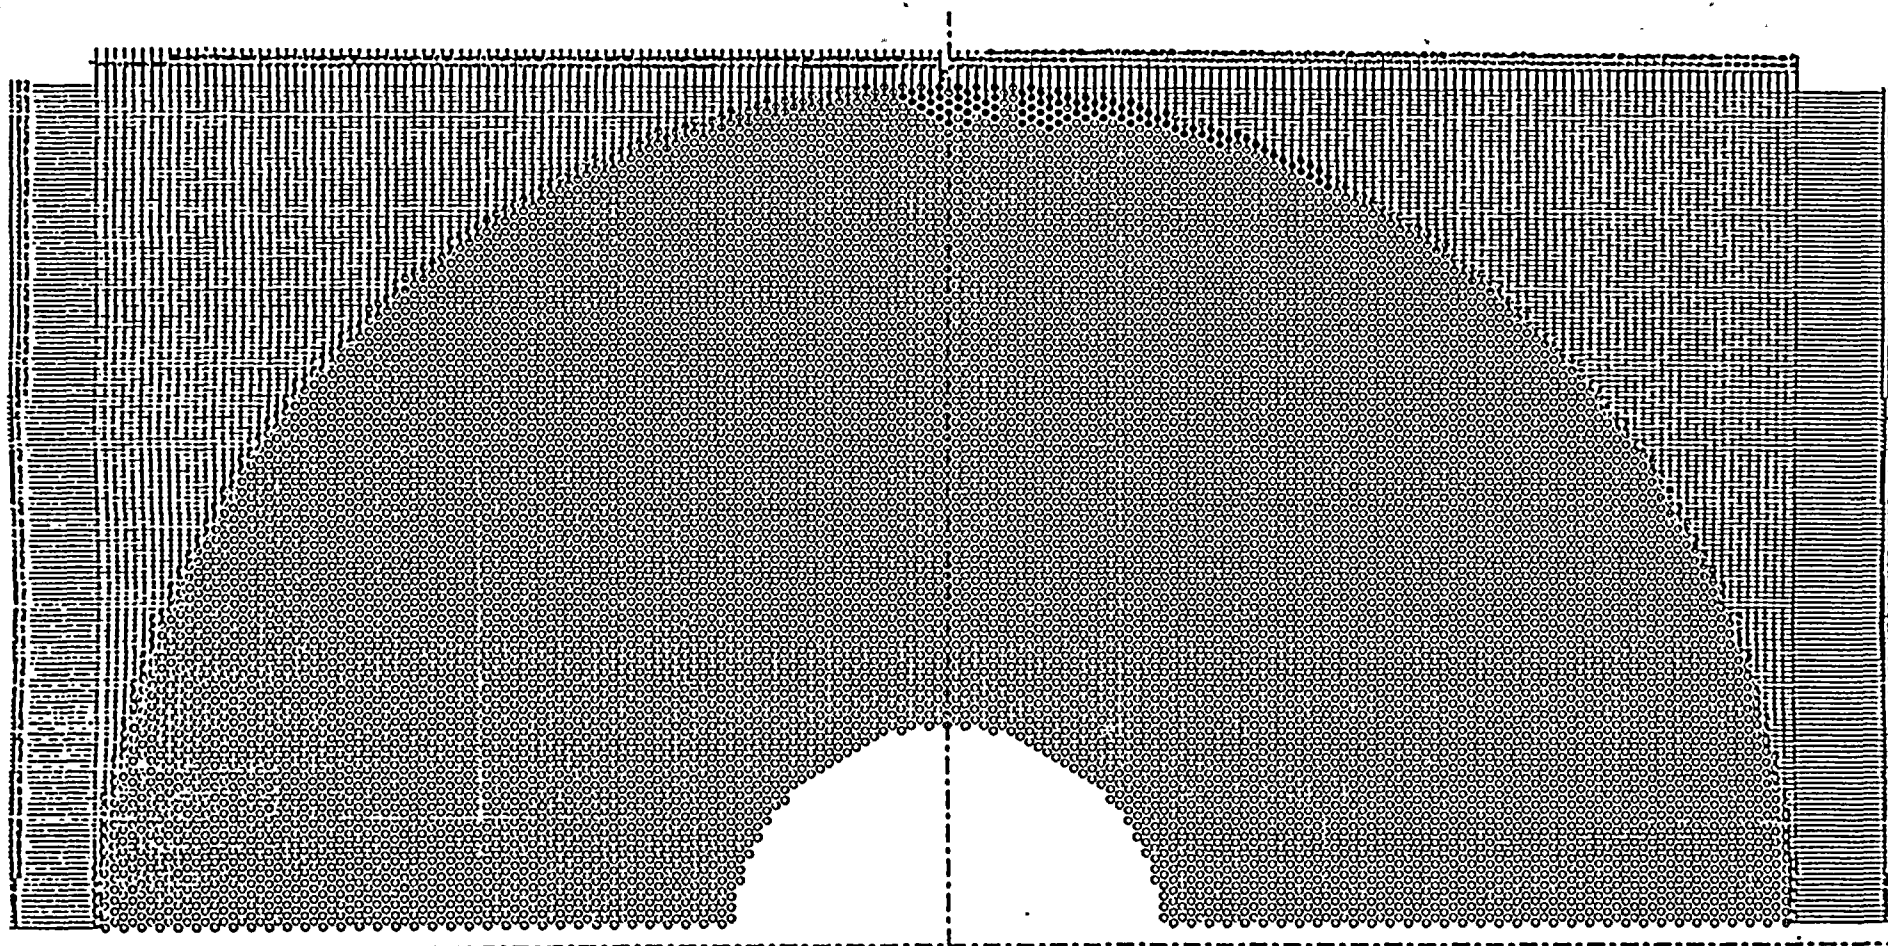
Figure 16

Unit 1, Steam Generator #1 Foreign  
Material Locations

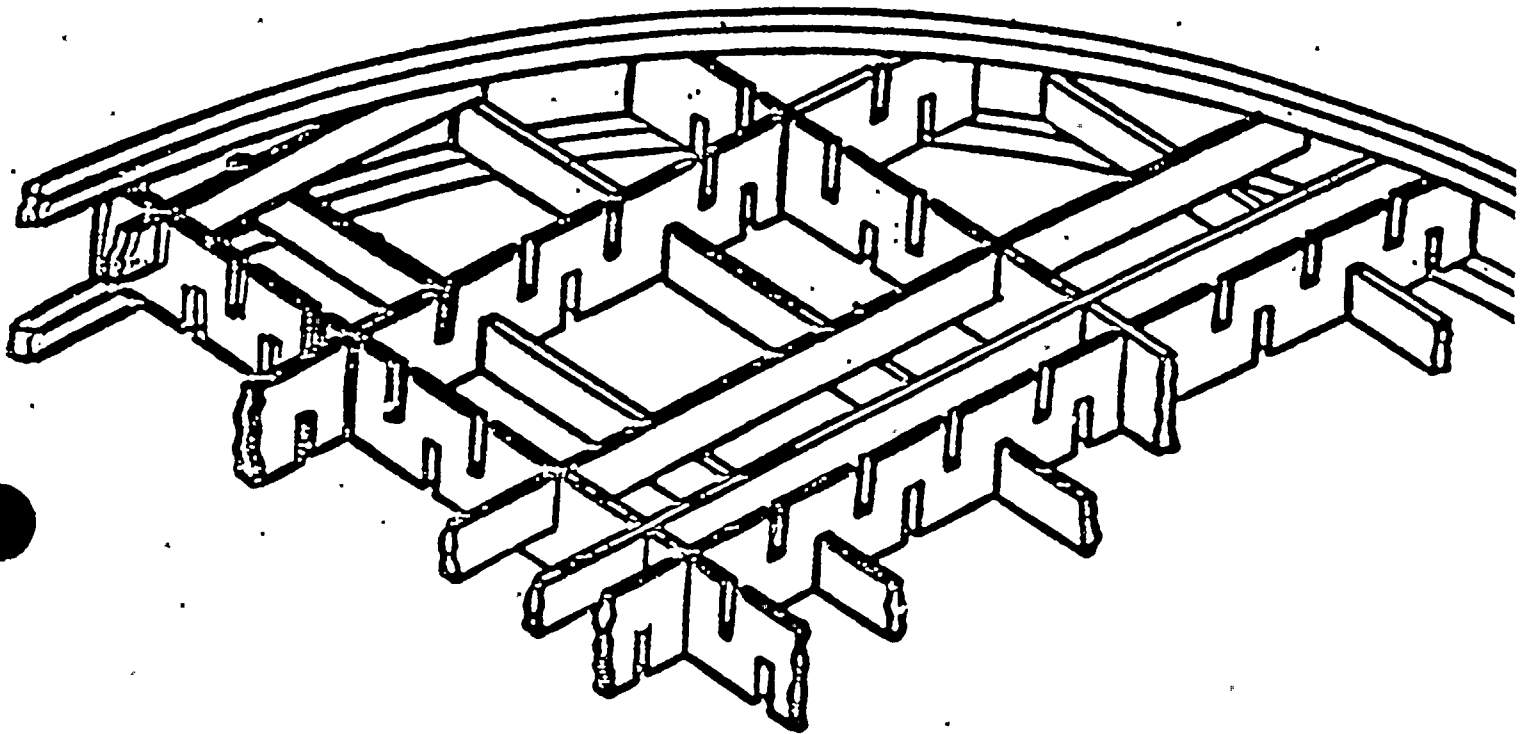
Figure 18

This condition can be further aggravated near the outer periphery where the eggcrates are welded to the shroud support bars (Figure 18), potentially resulting in slight distortion of individual eggcrate members. The tighter held tubes are sufficiently stiff to resist vibration and, thus, exhibit no wear. Therefore, both conditions, loosely held tubes and high radial cross flow velocity must exist to cause this tube wear phenomenon.
