SUBJECT: Forwards response to comments of 870225 telcon re plant protection sys & contribution of power supply problems to actuations resulting in reactor trip on 861224.

Subject: Palo Verde Nuclear Generating Station (PVNGS)
Unit 2
Docket No. STN 50-529 (License No. NPF-51)
Plant Protection System Power Supplies
File: 87-F-056-026

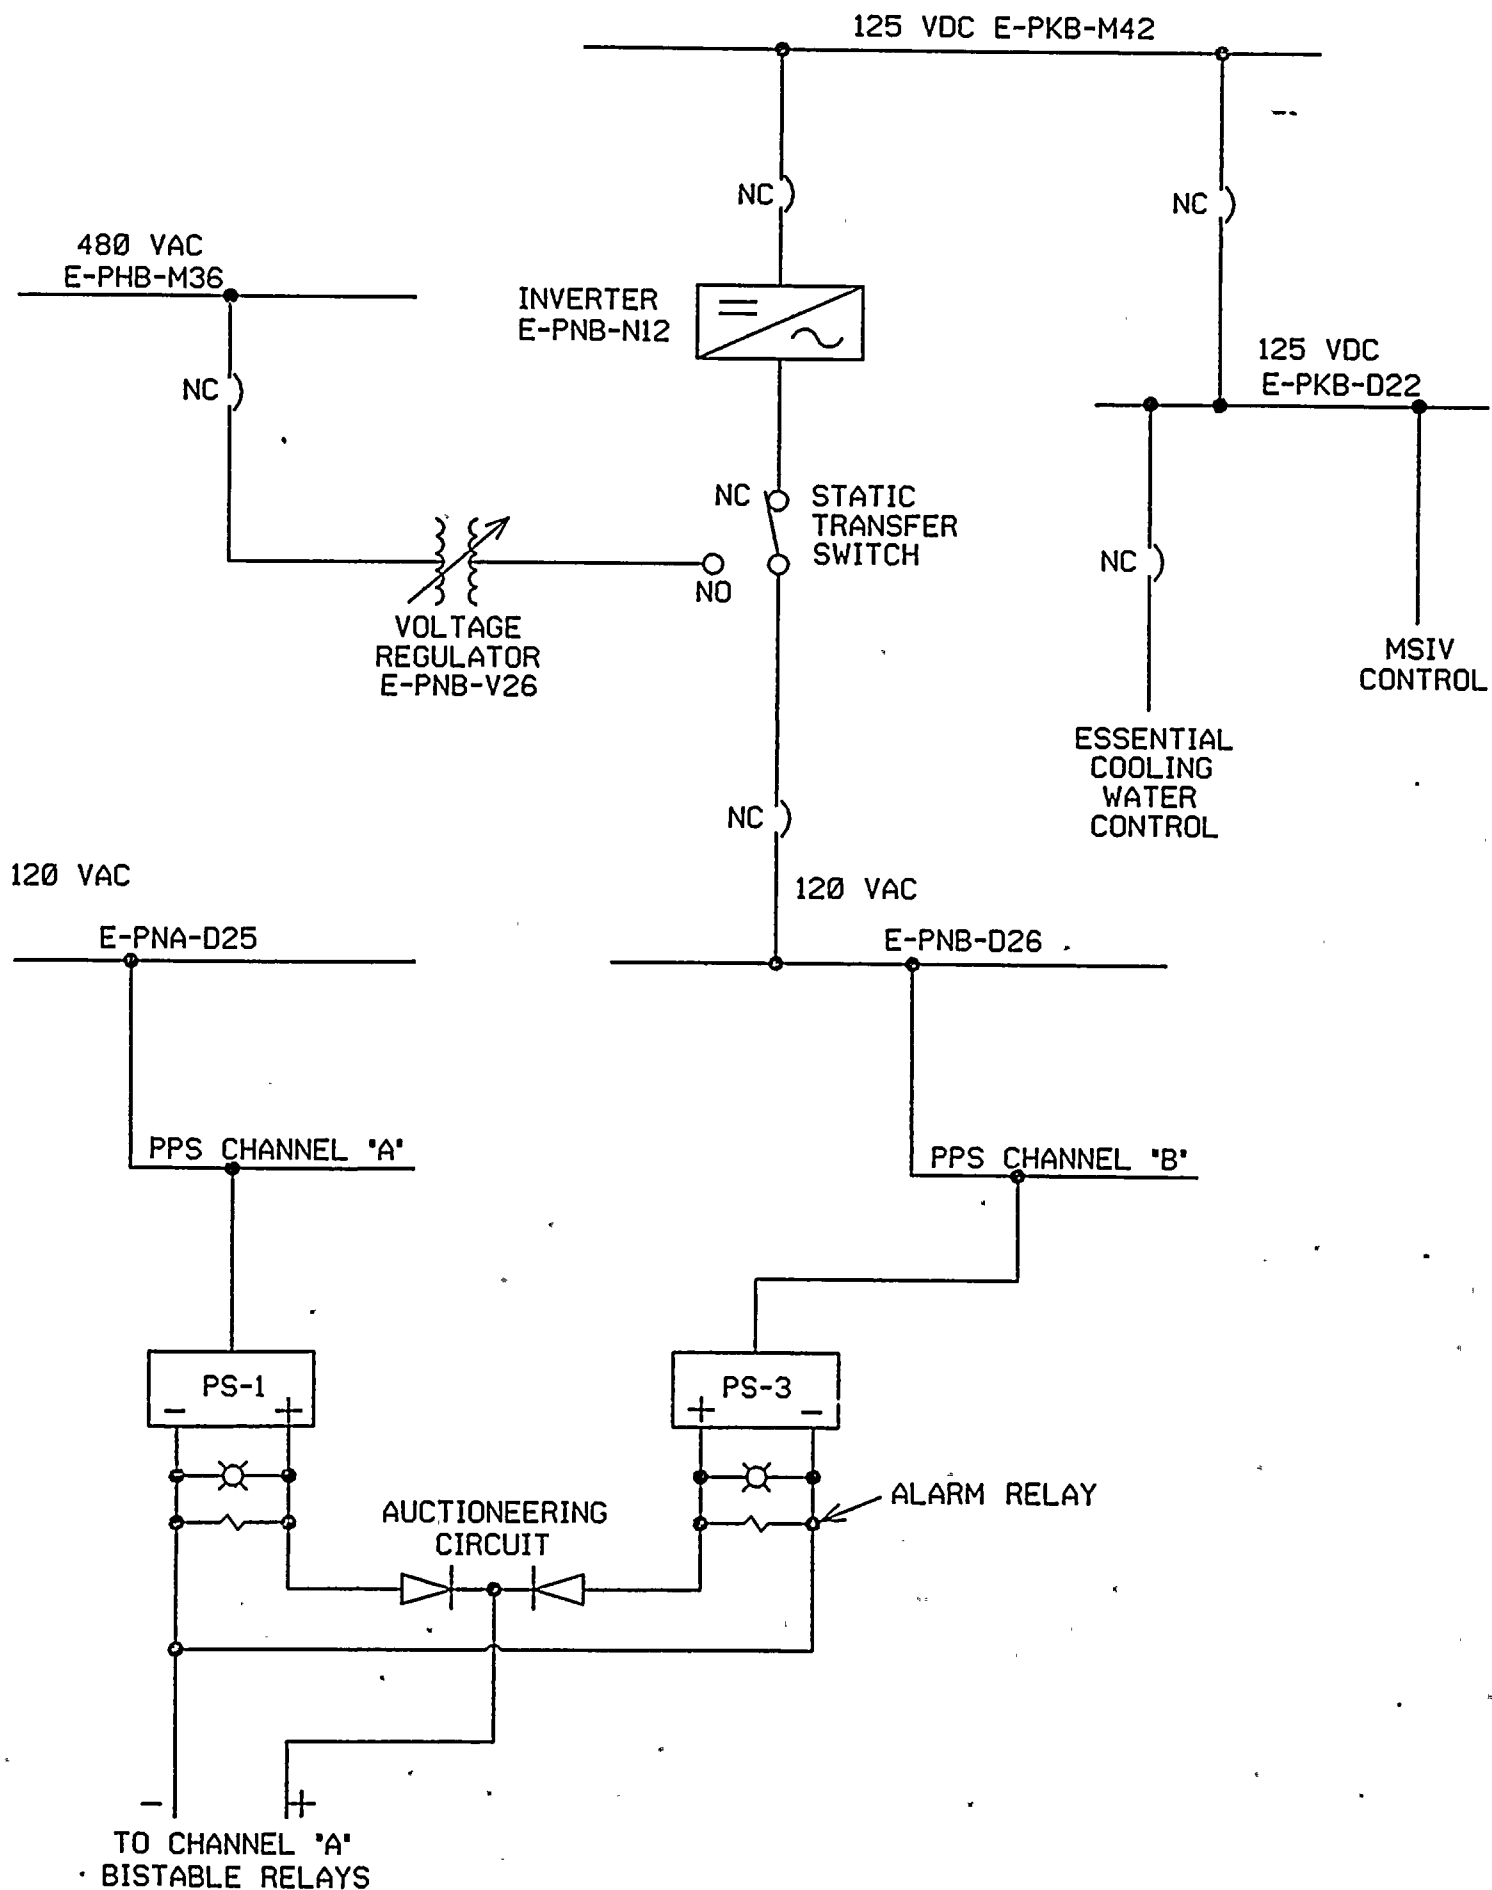
POWER SUPPLY SCHEMATIC

The events described above resulted in a loss of power to 120 volt AC bus D26 which resulted in a loss of power to the PPS Channel "B" instrumentation and a loss of power to Power Supply 3 (PS-3) which provides an alternate power supply to the PPS Channel "A" bistable relays. Additionally, the other power supply for the Channel "A" bistable relays (PS-1) was in a degraded voltage or "lockdown" condition at the time that D26 lost power. Thus, power was lost to the Channel "A" bistable relays due to the loss of PS-3 concurrent with PS-1 being in the "lockdown" condition. The loss of power to the Channel "A" bistable relays and the Channel "B" instruments satisfied the "AB" logic matrix and resulted in the PPS actuation.

During the review of the event, ANPP identified the fact that the degraded voltage condition of PS-1 had gone undetected because the "lockdown" condition for the power supply occurs at a higher voltage than the alarm relay actuation voltage. ANPP recognizes that it is clearly undesirable for a failed power supply in the PPS to go undetected. Therefore, ANPP is pursuing a modification to correct this undesirable condition. It should be noted that the objective of this modification is to ensure that any credible power supply failure is alarmed so that the power supply can be promptly repaired or replaced.

The resolution of this problem involves the implementation of a modification to the existing bistable relay power supplies to ensure that the power supplies are latched to a low output voltage for the over voltage lockdown condition. This will result in a positive alarmed condition. This power supply modification is being implemented at the vendor's facility. The modified power supplies will then be sent back to PVNGS for installation in the units. Additionally, ANPP is considering a modification to the power supply alarm relays. This modification would involve replacing or modifying the existing alarm relays to ensure that the alarm relays actuate at a higher voltage. The alarm relay modification would provide further assurance that power supply failures would be alarmed. Due to the uncertainties currently involved in the scheduling and completion of these modifications, a schedule for completion cannot be provided at this time. However, the monthly testing described below will be continued until such time as the modification is completed.

In the interim, until such time as the power supply modification can be completely implemented, the bistable relay power supplies in PVNGS Units 1, 2, and 3 will be tested monthly to detect failed power supplies. It should be noted that this monthly testing will not be conducted when the units are in shutdown modes where the PPS is not required to be operable. If plant conditions are such that the power supply test cannot be conducted without jeopardizing safe plant operations, then the test will be postponed until such time as it can be safely performed. However, the monthly power supply test will not be deferred for a period greater than one month (i.e., maximum two month interval between successive tests). If plant conditions at the end of the maximum deferral period are still such that the power supply test cannot be safely conducted, then ANPP will discuss the circumstances with the NRC Staff prior to exceeding the maximum deferral period. ANPP believes that this monthly test is an acceptable interim measure until the modification is completed. This conclusion is supported by a reliability analysis which ANPP has performed. The analysis indicates that the probability of subsequent PPS actuations due to the specific scenario experienced on December 24, 1986, (loss of one instrument bus and a failure of a specific bistable power supply) is $9.4E-06$ per month per unit. This low probability of a subsequent similar event shows that the PVNGS units can be operated in a safe manner until the final solution can be implemented.
