SUBJECT: Discusses insp of reactor coolant shafts for potential fatigue cracking. Submits preliminary results of insp, comparison w/European insp results, action plan for each unit & justification for continued operation of Unit 2.

Arizona Nuclear Power Project

Subject: Palo Verde Nuclear Generating Station (PVNGS)
Units 1, 2 and 3
Reactor Coolant Pump Shafts
File: 87-A-056-026

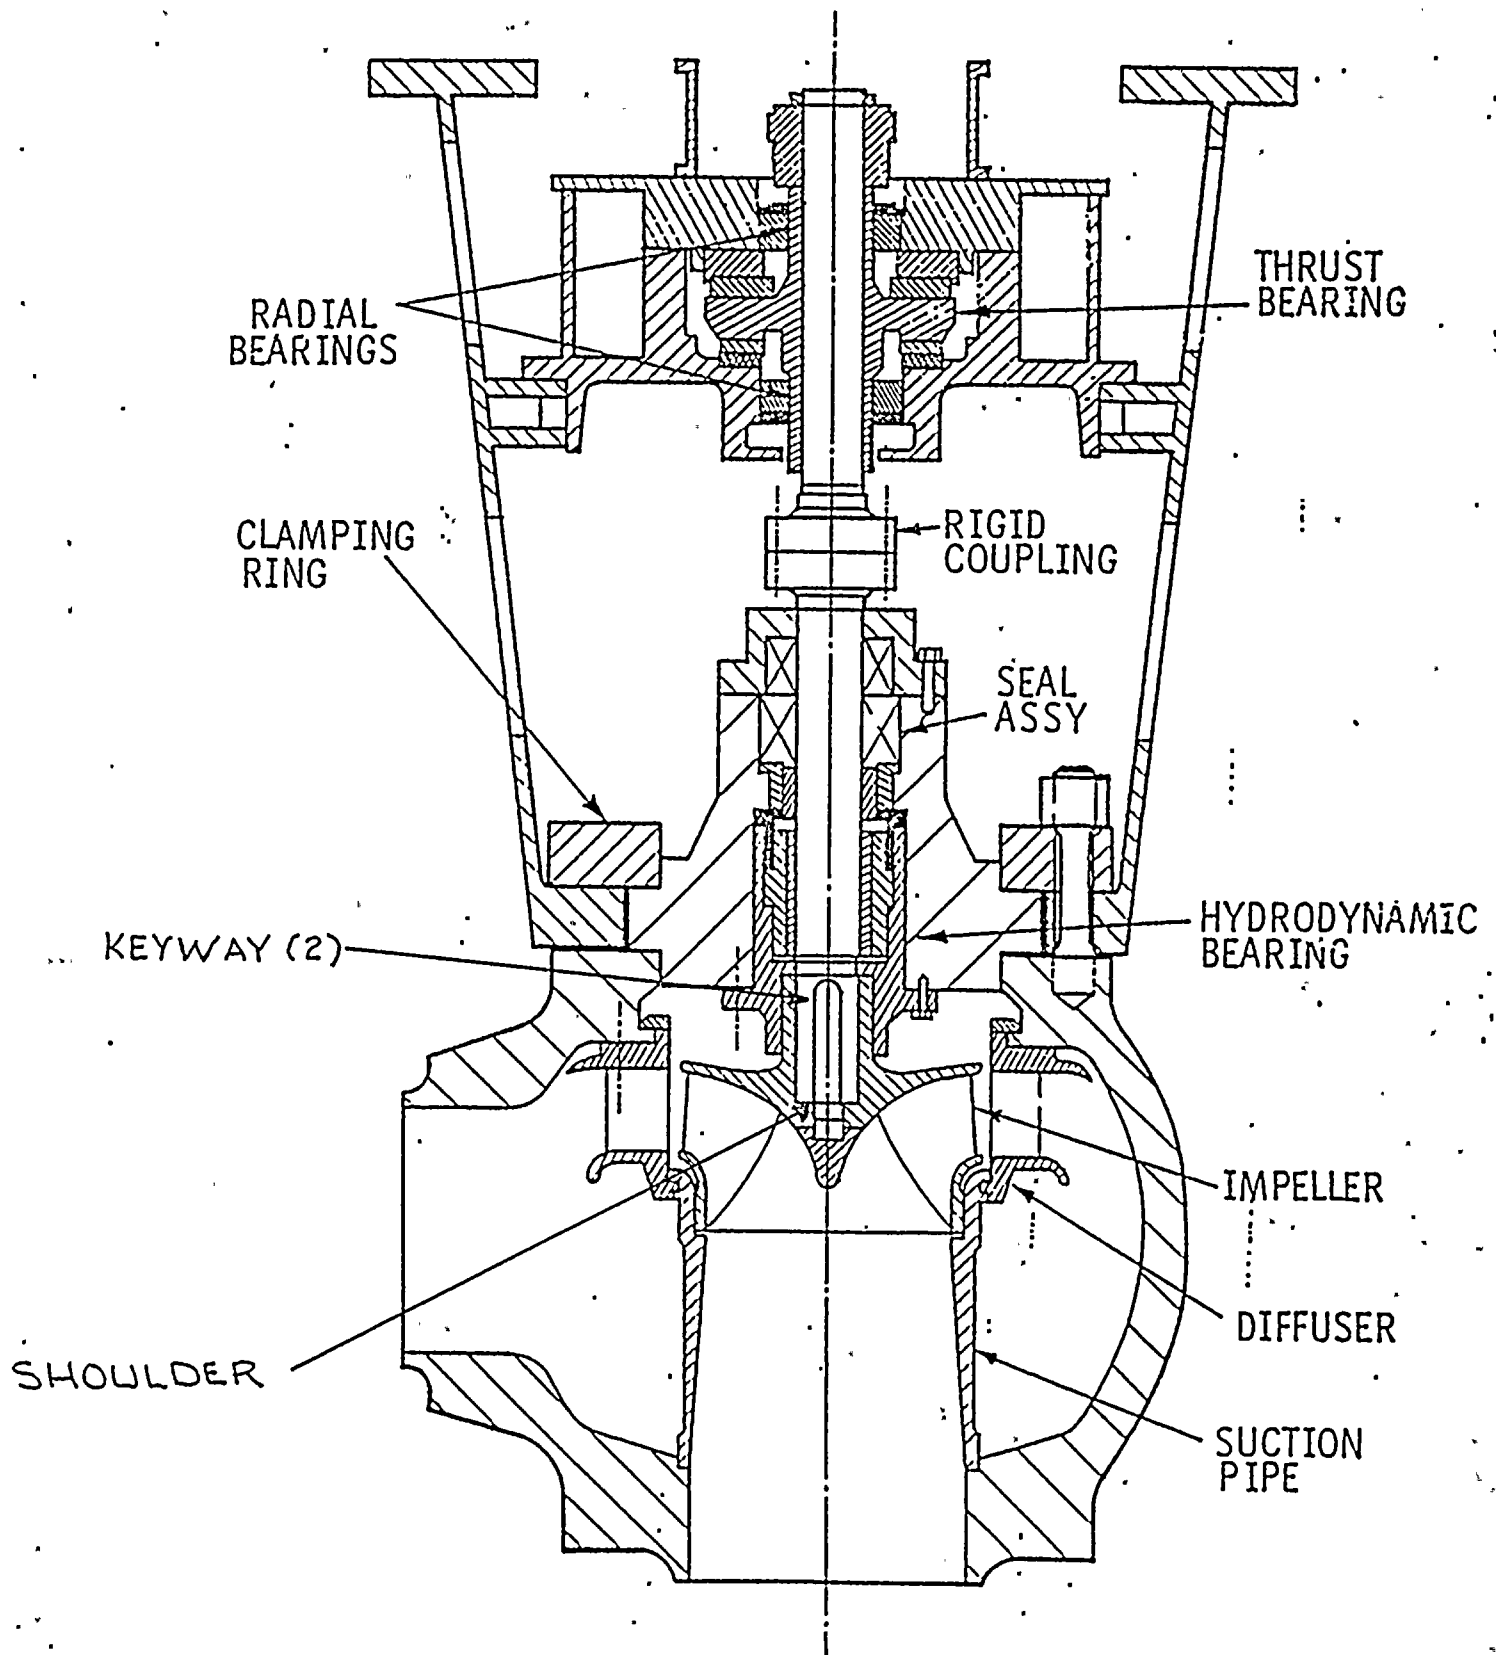
FIGURE 1

Crack indications were found in the impeller keyway region (Figure 1) in three of the four Unit 1 pumps. The most extensive crack indication was found on pump 1B which exhibited 3 indications of at least 17 mm deep and ranging up to 56 mm in length. Figure 2 provides a representation of a typical crack indication location and Table 1 provides a summary of the crack indications for each pump.

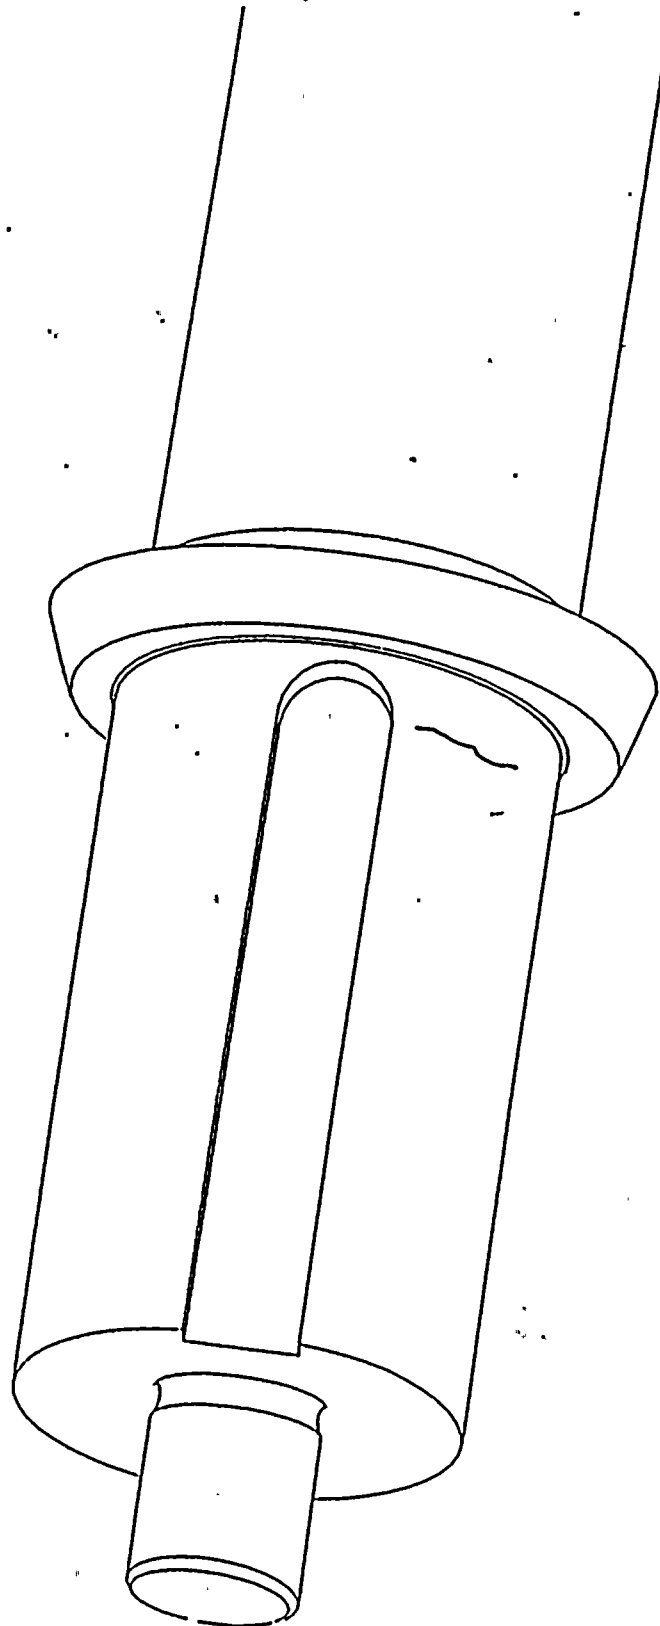
FIGURE 2
TYPICAL CRACK INDICATION

The crack indications in Unit 1 are similar in size and location to the cracks found in the European plants. The crack indications are located in the upper keyway region extending circumferentially away from the keyway as were the majority of the cracks in the European plants. The size of the crack indications found in pump 1B keyway area were larger than those previously reported by KSB.
