Arizona Nuclear Power Project

# NDE Summary Report

UNIT 1 STEAM GENERATOR EDDY CURRENT EXAMINATION

1ST REFUELING OUTAGE

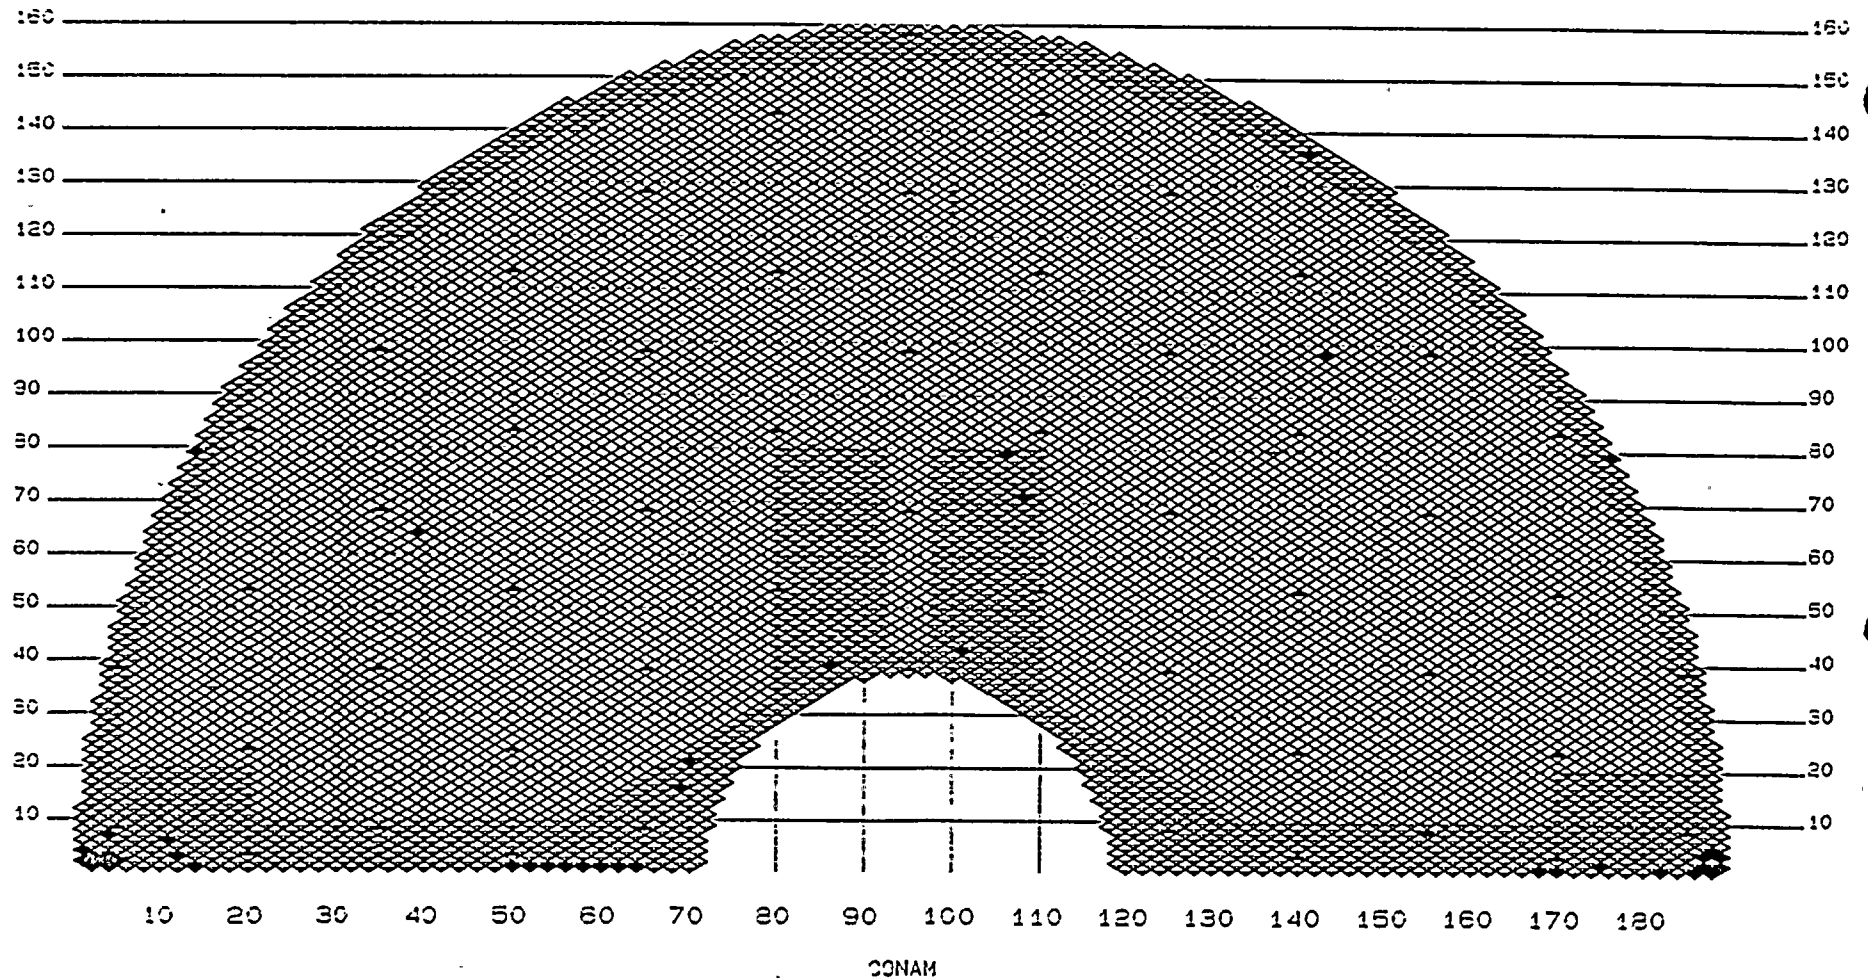
STEAM GENERATOR: 1  
DATE: 12/30/87  
LOCATION: ALL  
CRITERIA: PLG

SG11: R1C186, R2C187, R7C4, R2C5, R3C12, R1C14, R1C168, R71C108, R1C62, R1C64, and R6C11.

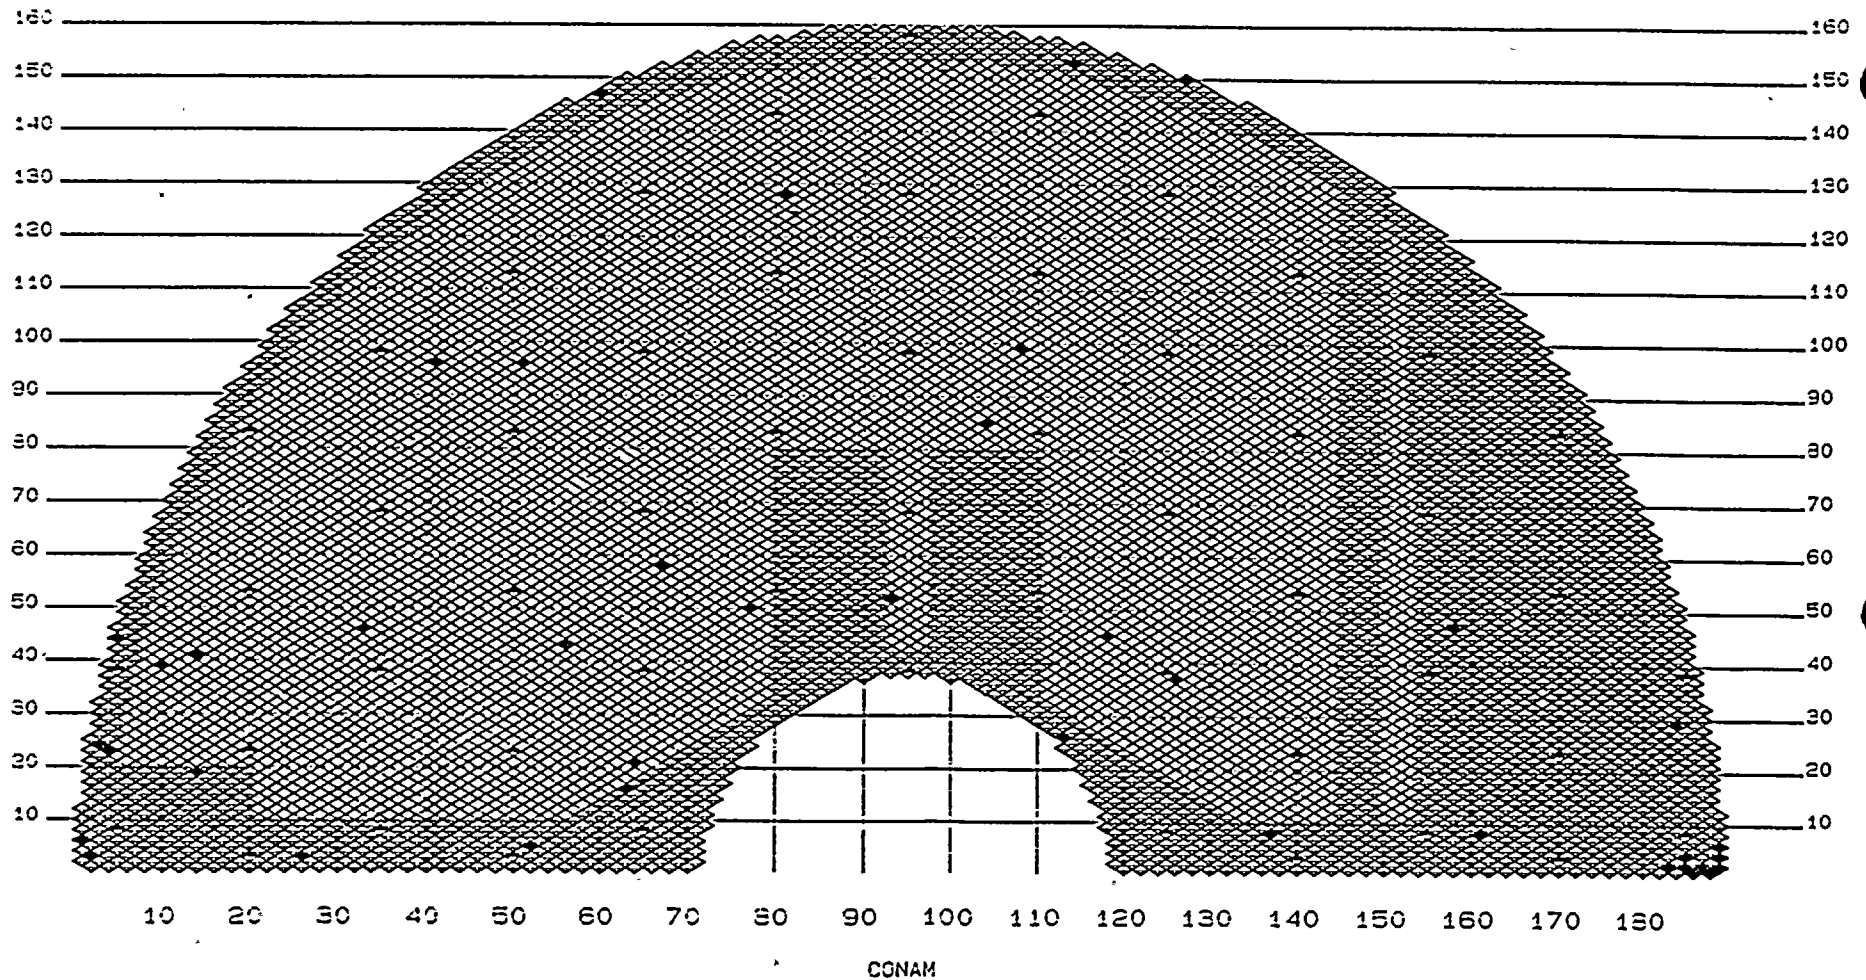
STEAM GENERATOR: 2  
 DATE: 12/30/87  
 LOCATION: ALL  
 CRITERIA: PLG

SG12: R29C184
