SUBJECT: Submits addl info on maint history of multi stud tensioner
 & justification for continued operation. Floor layout encl.

Subject: Palo Verde Nuclear Generating Station
Unit 1
Request for Additional Information - Justification
for Continued Operation: Re: Inability of CEA 56
to Drop
File: 88-A-056-026

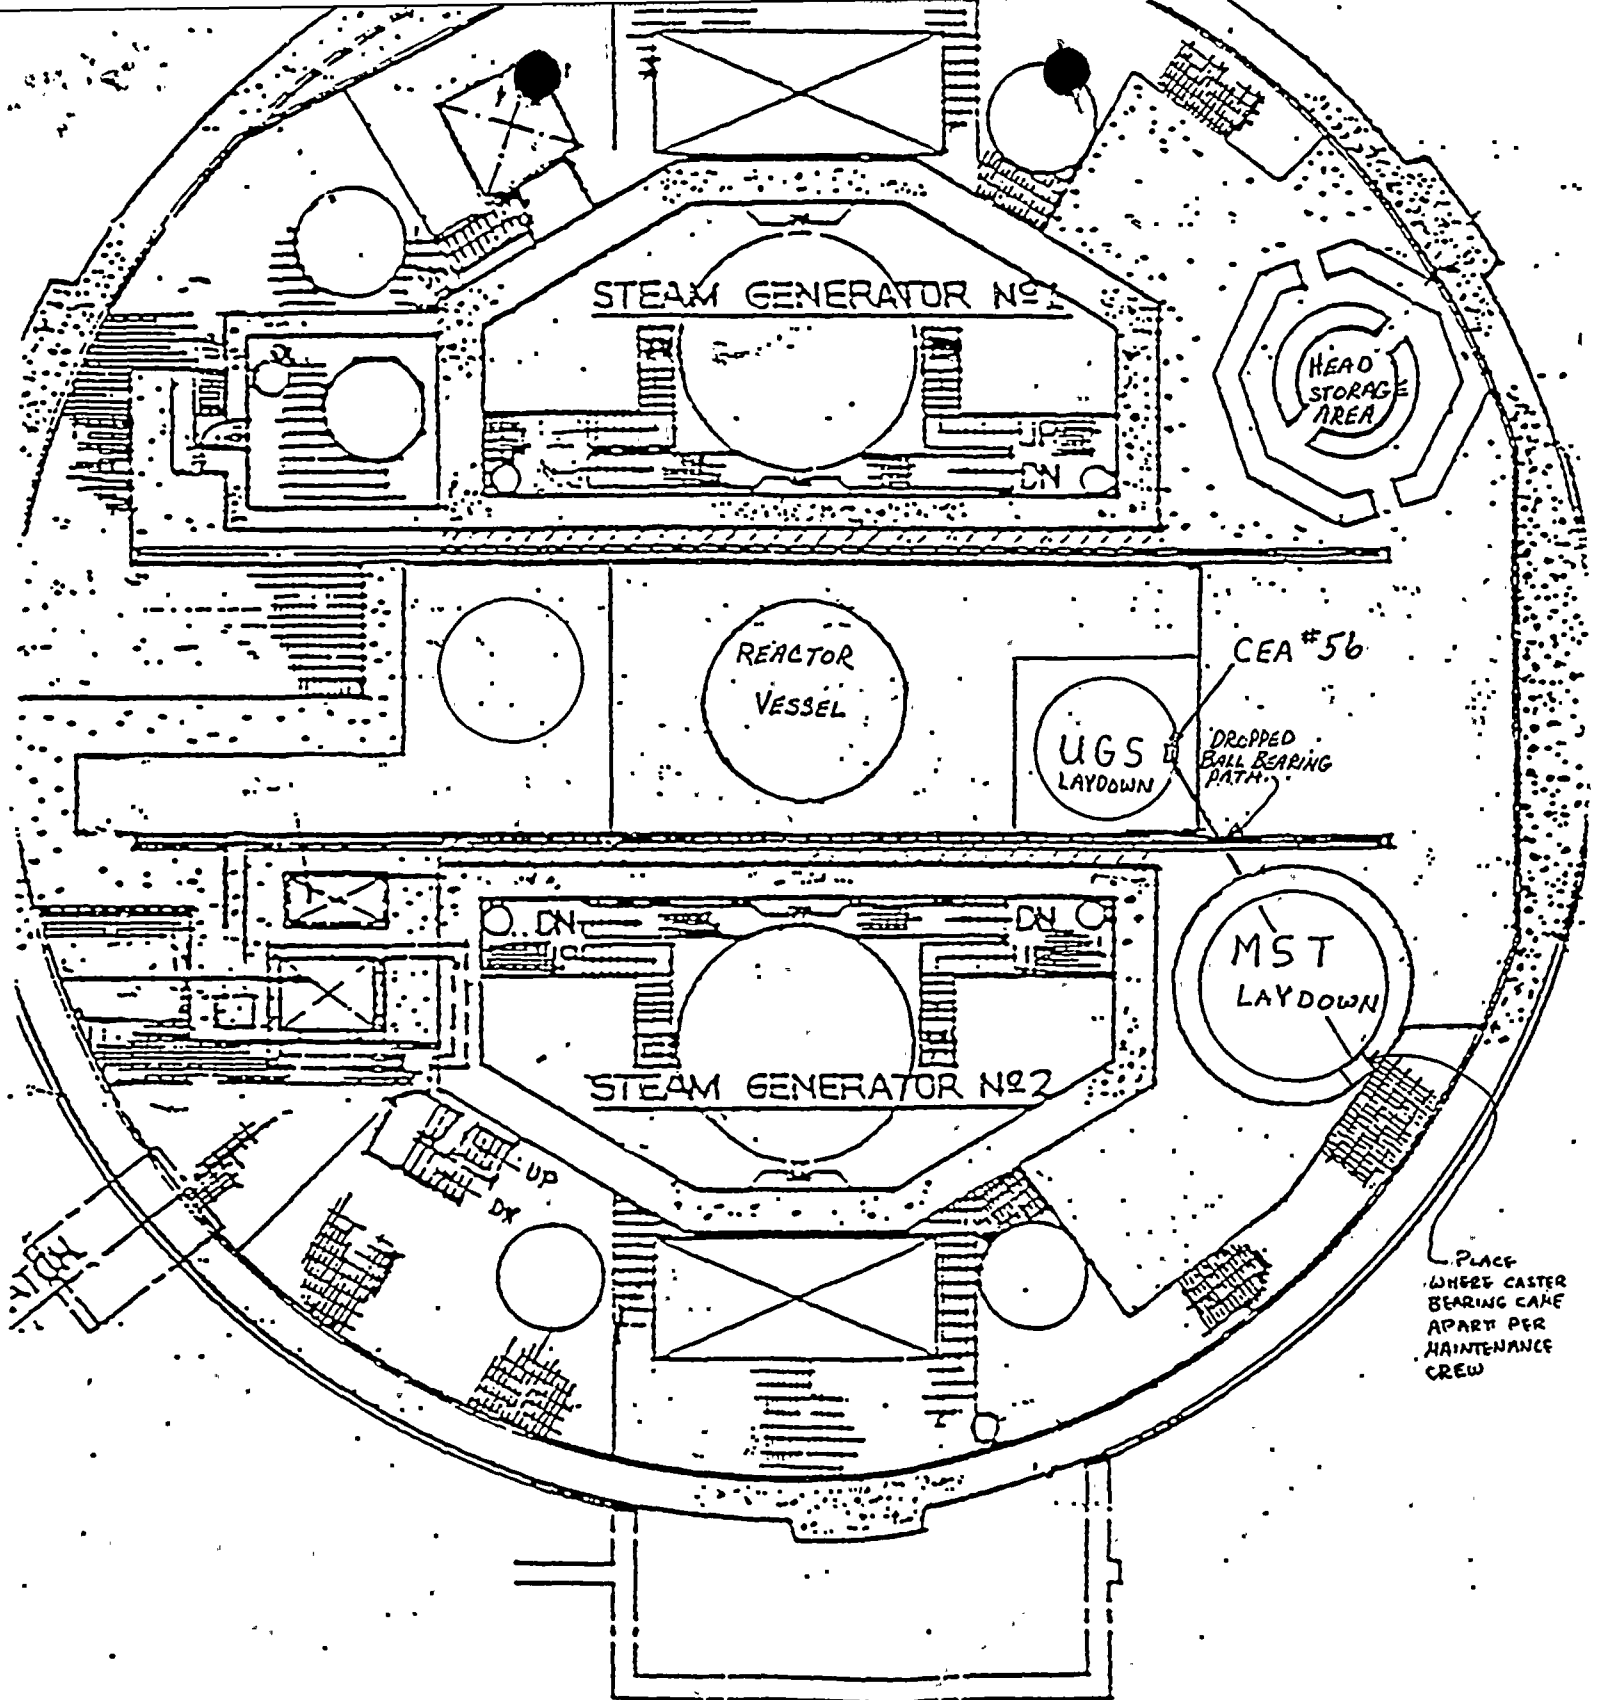
MST / UGS FLOOR LAYOUT
FIG. 1

It is possible that one of the ball bearings, lost at the time the work order was performed while the MST was on the stand, found its way into CEA 56. The investigation is continuing on Unit 1.

Results of the investigation to date have found one instance where small bearings were released to the containment during bearing caster replacement on the MST stand in October, 1987 prior to head removal. Further investigations are continuing on post maintenance activities in the units. The results of the investigation to date add weight to the conclusion reached in the JCO, Reference (a) and adds more conclusive evidence to the source of bearing release from the bearing casters. ANPP continues to believe that, as stated in the JCO, areas of concern have been identified with the foreign material exclusion program in that it was not designed or intended to exclude material from component failure e.g., MST caster bearing failure. In addition, as stated in the JCO, the caster bearings on the MST have been replaced with a new design that will eliminate a failure of this type. If any significant information becomes available during further investigation, ANPP will notify you.
