SUBJECT: Forwards info re debris (shaving, chips & filings) on upper
 guide structure, per NRC request.

Subject: Palo Verde Nuclear Generating Station (PVNGS)
Unit 2
Evaluation of Debris on Upper Guide Structure
File: 88-F-056-026

On April 19, 1988, PVNGS Unit 2 was in Mode 6, the Reactor had been refueled, the Upper Guide Structure (UGS) was in the UGS Pit (Figure 5) and CEA Extension Shaft 89 was being replaced. At approximately 6:30 a.m. on April 20, 1988, it was reported that a T-handled allen wrench and a 7/16" nut had been dropped while removing the machine which was used to cut the CEA Extension Shaft.

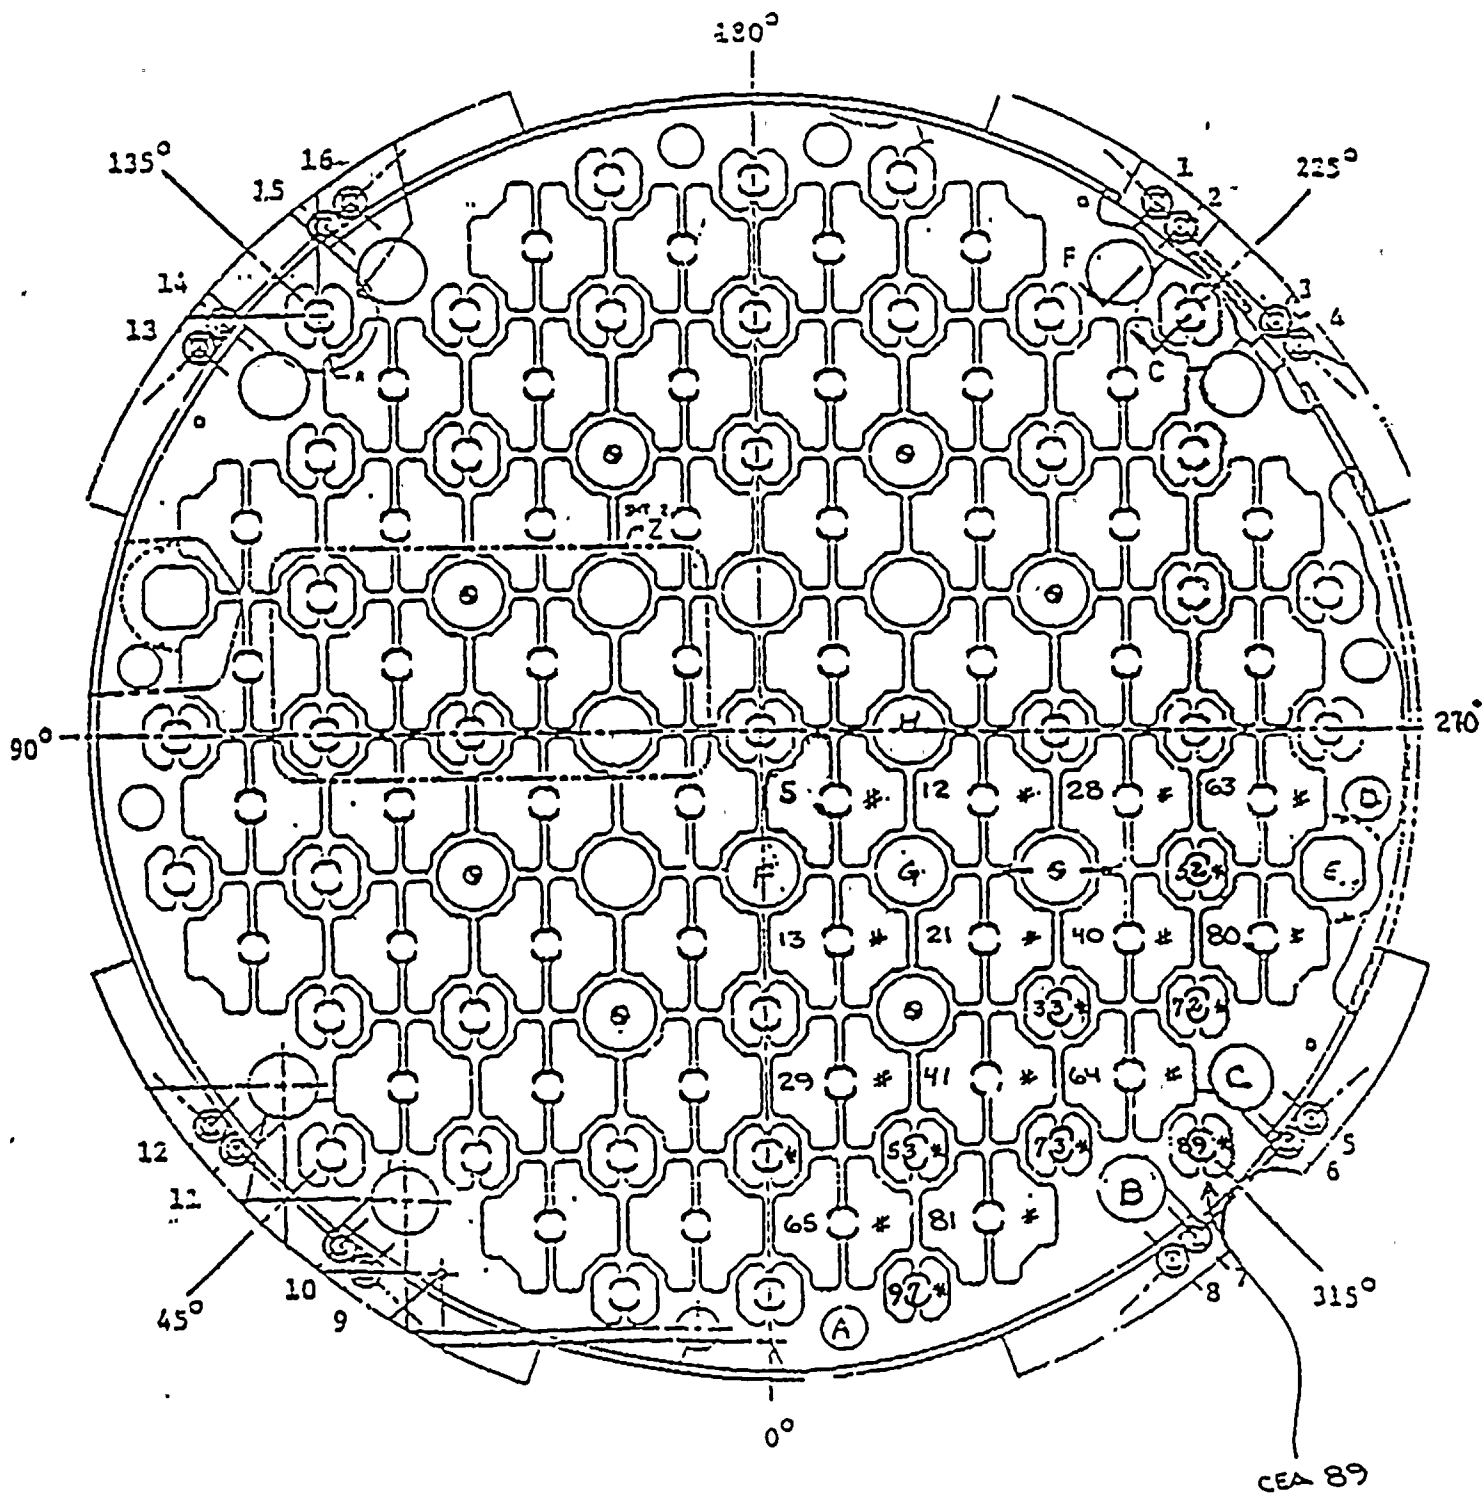
FIGURE 1

Initial efforts involved an inspection and cleaning of the visible portions of the UGS Top Hat area. Shavings were present in the area around CEA 89 and on the UGS flange near CEA 89 (Figure 1). One (1) chip was found as far away as CEA 21. Based on the personnel interviews and results of the initial observations, it was determined an inspection and cleaning of the 270° to 0° quadrant, would be conducted and results evaluated. The water level in the UGS Pit when the incident occurred was 107 feet, the elevation of the Reactor Vessel flange is 114 feet. Therefore, there was no concern that foreign material entered the Reactor Vessel.

These inspections revealed a debris dispersal pattern in which the number of chips found decreased with increased distance from CEA 89. The seven (7) 12-finger channels which form the border of the 270° to 0° quadrant were free from any debris. Table 1 indicates the approximate extent of the debris and in conjunction with Figure 1 indicates the dispersal pattern of the debris.

A T-handled allen wrench and a 7/16" nut were recovered from flow holes labeled "B" and "C" on Figure 1. All other flow holes were clean (A, D, E, F, G, H).

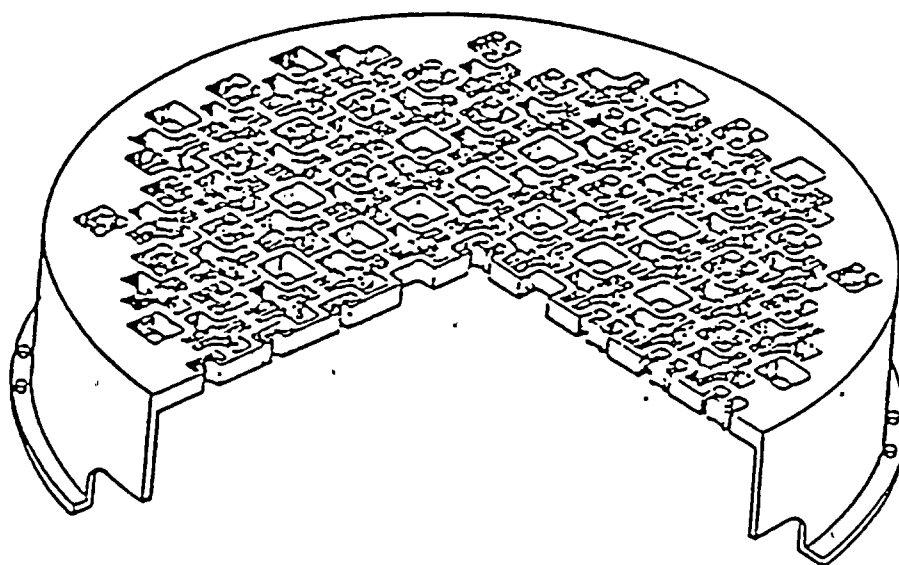
FIGURE 2

The interviews revealed that a pre-shift briefing had been conducted for the CEA Extension Shaft removal and that the debris was spread over an 18-inch to 24-inch radius onto the UGS Top Hat (Figures 1 and 2) and UGS (Figure 3). Based on the initial investigation and assessment of the event, Plant Management formulated an action plan to restore the UGS and associated equipment, as well as the surrounding area to Class B cleanliness.

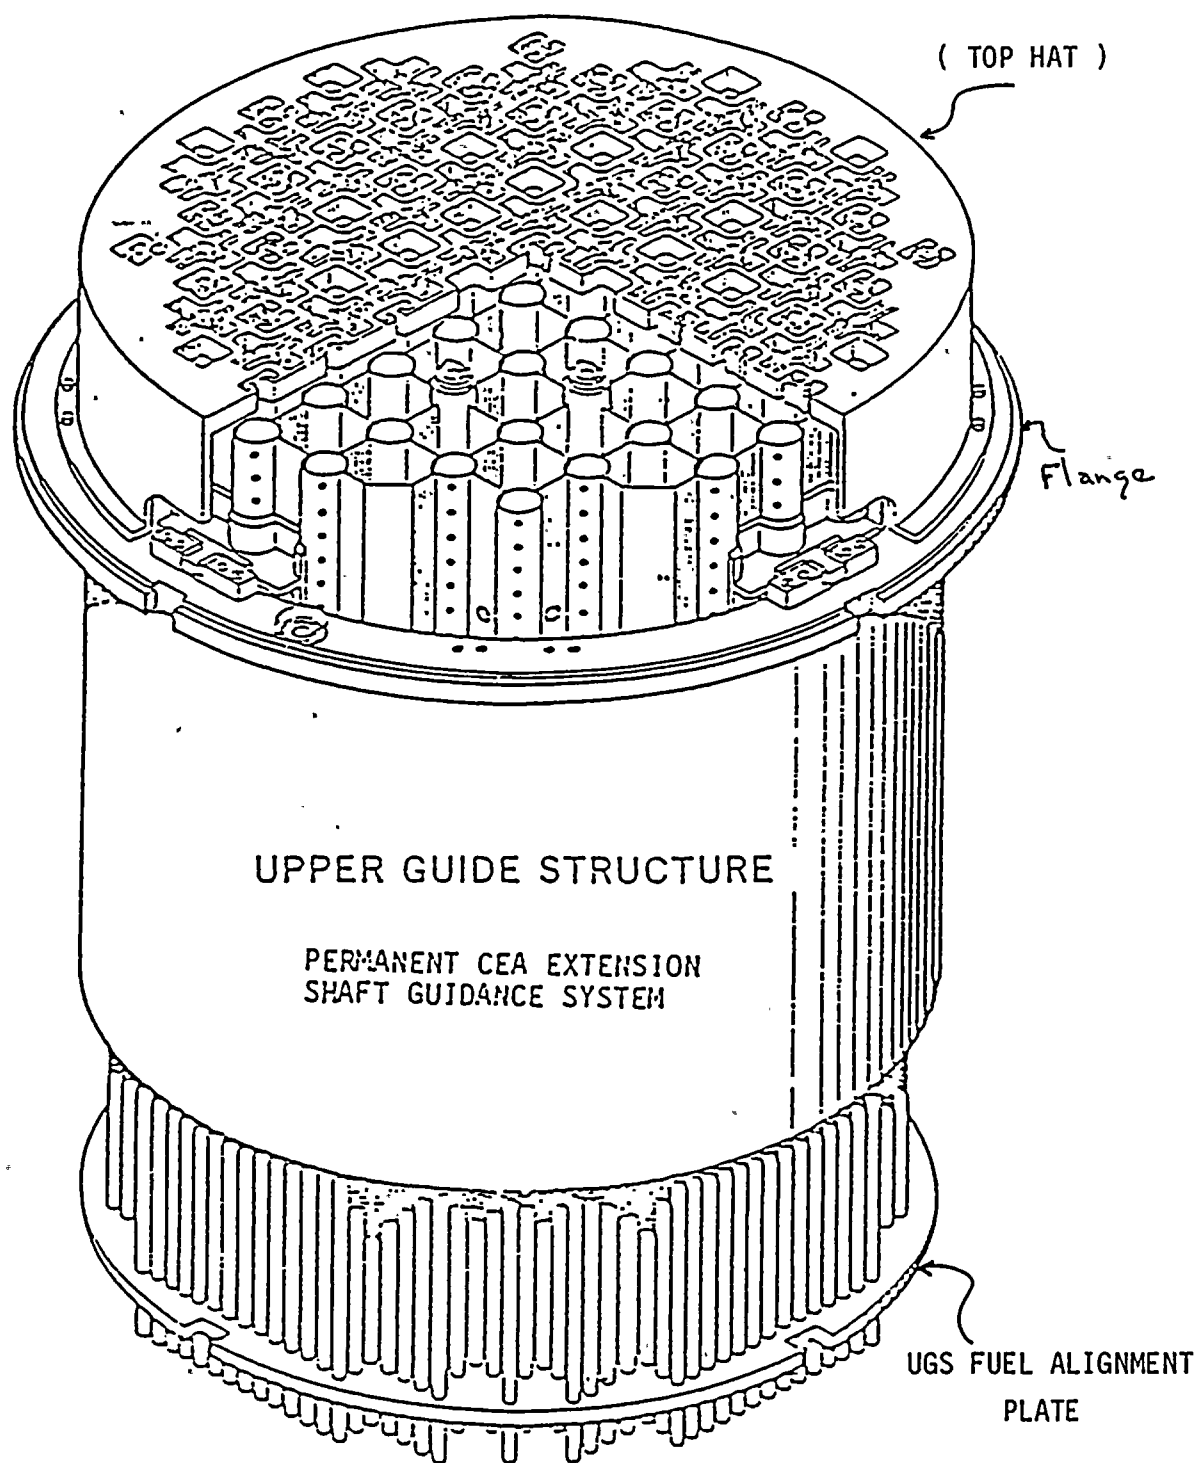
FIGURE 3

The area on top of the UGS Fuel Alignment Plate (Figure 3) was inspected and vacuummed during UGS removal from its storage pit. The floor of the UGS Pit was then vacuummed to remove debris which had fallen down the outside of the UGS.

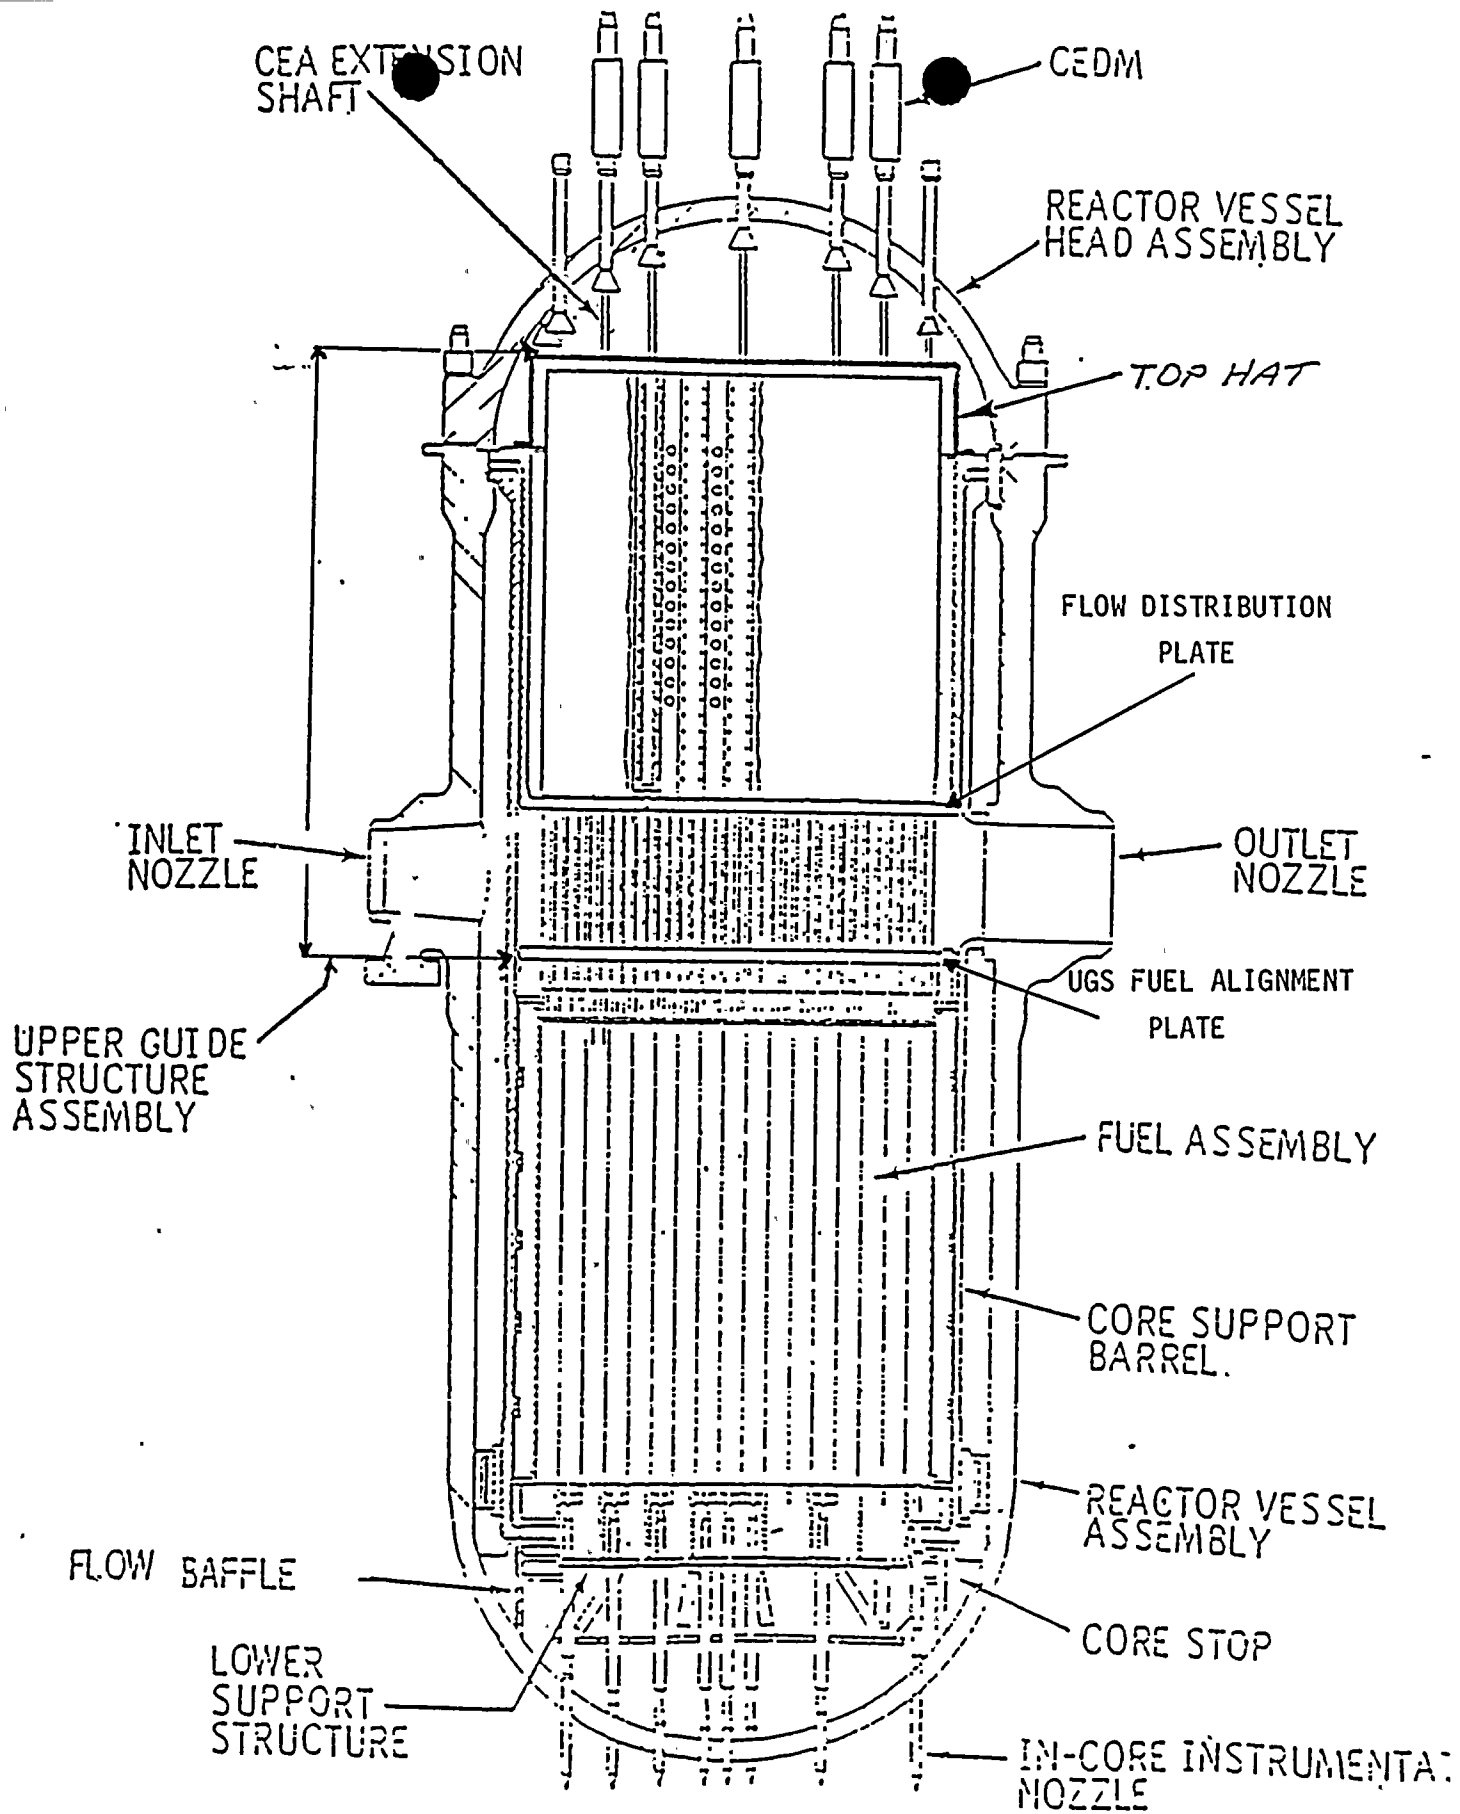
FIGURE 4

The UGS Pit was refilled to approximately 138 feet for ALARA considerations. Underwater inspections and cleanup were commenced in the 12-finger and 4-finger guide channels and flow holes of the CEA shroud in the UGS. An underwater video camera, a vacuum hose and a diver were used for this effort. While in the UGS pit the CEA area was inspected down to the Flow Distribution Plate (Figure 4).
