ARIZONA NUCLEAR POWER PROJECT
PALO VERDE NUCLEAR GENERATING STATION
UNITS 1, 2, AND 3

JUSTIFICATION FOR CONTINUED OPERATION
AUXILIARY FEEDWATER PUMPS

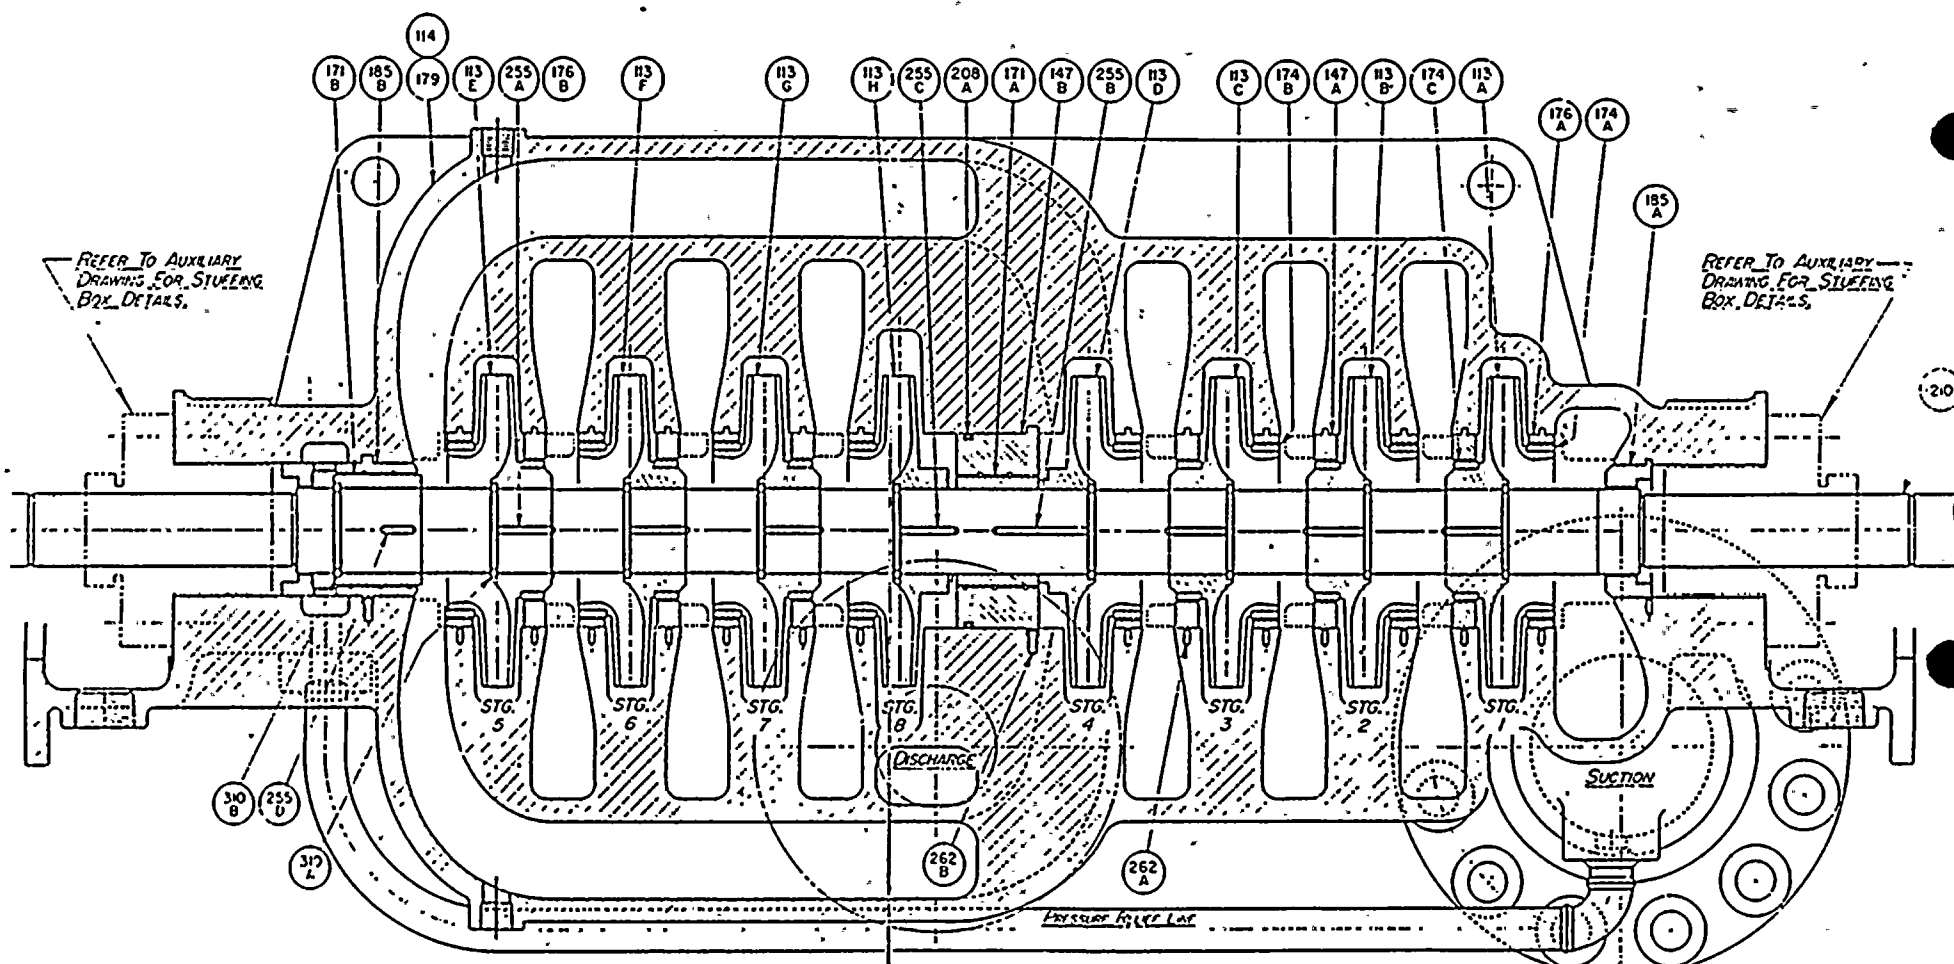
FIGURE 1. AFW PUMP CROSS SECTIONAL VIEW
4 X 6 X 10B MSD 8 STAGE

The nine AFW pumps at PVNGS were manufactured by Bingham Willamette (BW) of Portland, Oregon. The pumps are BW Model 4x6x10-1/2 B MSD eight stage units. Each essential AFW pump, AFA-PO1 and AFB-PO1, has a rated capacity of 1010 gpm at 3280 feet Total Dynamic Head (TDH). The nonessential AFW pump, AFN-PO1, has a rated capacity of 1010 gpm at 2960 feet TDH. The pumps are eight stage, single suction, double volute with a horizontal split casing. The rotating element is supported with sleeve journal bearings at both ends outboard of the stuffing box and the pump has an oil-lubricated ball thrust bearing assembly located opposite of the driver end. The configuration of the impellers on the pump shaft is commonly called the opposed impeller arrangement. The purpose of this arrangement is to reduce axial thrust loading. In this arrangement, the first four impellers are arranged on the pump shaft facing in one direction with the remaining four impellers facing in the opposite direction. This design requires an interstage bushing assembly to separate the opposed impellers at the pump center between impellers four and eight. For additional insight into the pump construction, refer to the pump cross sectional drawing shown in Figure 1.

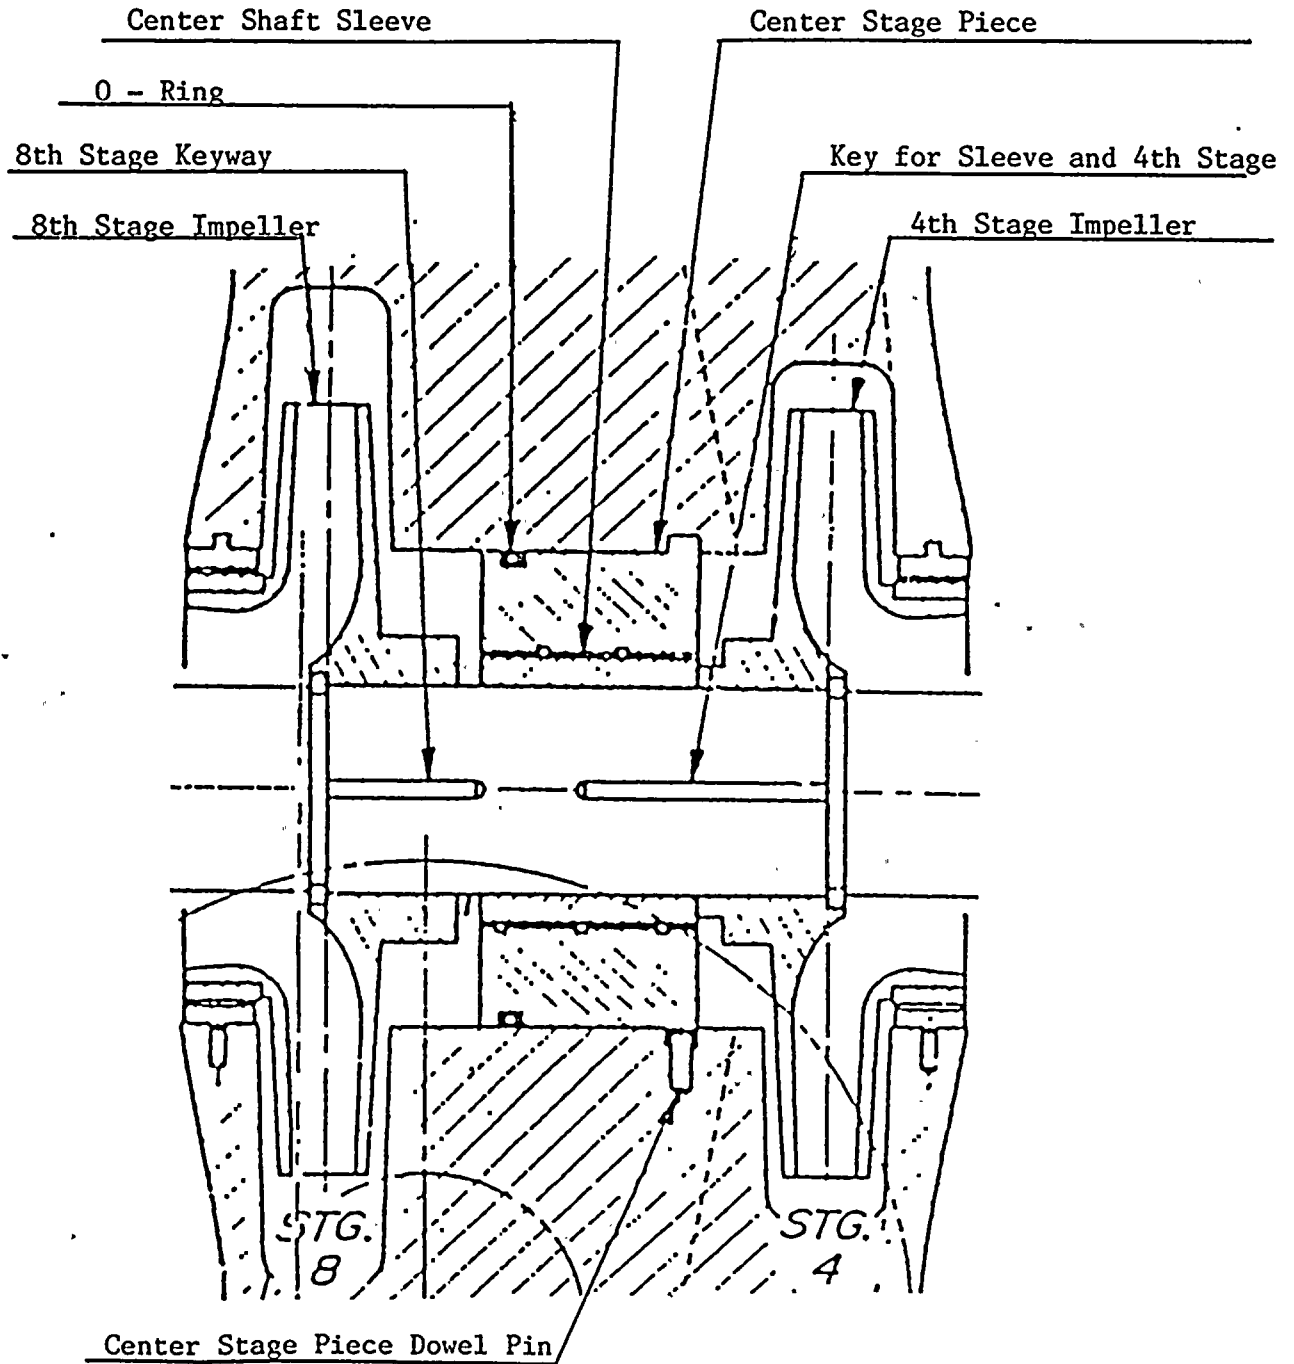
FIGURE 2 - CENTER STATE PIECE (ENLARGED)

The interstage bushing (center stage shaft sleeve) is approximately 3 inches long and 0.25 inches thick. It is manufactured from AISI 420 material, hardened to Rockwell C-50.5 hardness. The sleeve is shrunk-fit to the shaft to form a small interference fit of 2 mils or less. The sleeve is also keyed to the shaft by a key that is common with the fourth stage impeller. The sleeve is surrounded by a stage piece forming a hydrodynamic bearing. There is a groove within the center stage piece that spirals around the center stage sleeve for pumped fluid flow. While the pump is at rest, the center shaft sleeve is resting on the center stage piece. Upon startup, the rotating shaft is then supported by a film of pumped fluid that is forced through the annulus region between the center stage piece and the sleeve by the pressure differential between the eighth and fourth stages. Thus, upon startup, there is usually contact between the center stage shaft sleeve and the center stage piece. An enlarged view of the center stage piece is shown in Figure 2.
