SUBJECT: Part 21 rept re KSV standby diesel generator rocker arm failure.

Subject: KSV Standby Diesel Generator
Rocker Arm Failure
Arizona Nuclear Power Project,
Palo Verde, Arizona

Arizona Nuclear Power Project

Exhaust Rocker Arm Failure

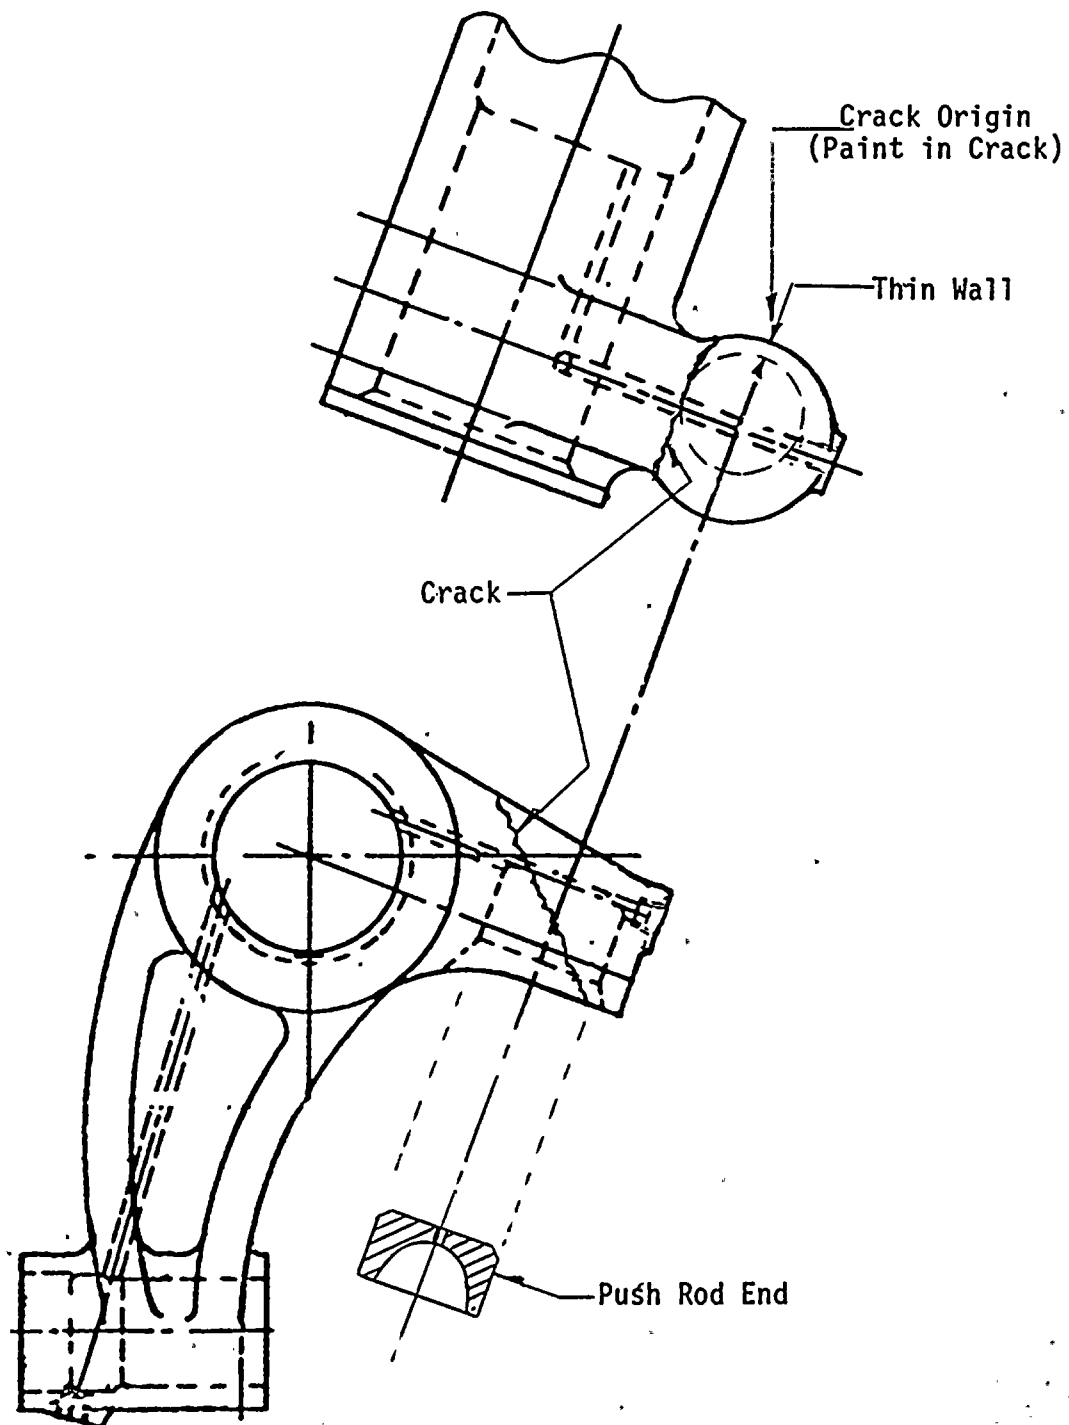
SKETCH SHOWING PORTION
OF EXHAUST ROCKER ARM
KSV-25-A

- 2.1 It was immediately obvious that the point of origin of the fracture was an "old" crack. (See the attached sketch for details). Obvious because there was evidence of a yellow sealer paint on the fracture surface at the thinnest section of the push rod boss. This yellow sealer is applied prior to machining a casting such as the rocker arm, and is "touched-up" if necessary following machining. Therefore, the crack occurred during manufacturing.

- 2.2 It was noted that there was eccentricity of the "push rod end" bore. (Exaggerated in the sketch for the sake of illustration). At first the lack of symmetry, caused mainly by a casting core shift, was considered to have influenced the formation of the original crack. However, when the 9 right exhaust rocker arm was examined by ANPP, yellow paint was also found in the crack, but the wall thickness was considerably greater at approximately 5/16". The thickness of the failed specimen was approximately 3/16".

- 2.3 The exposed "push rod end" bore for the failed piece showed that the "push rod end", which is installed with an interference fit, had "worked" loose. There was evidence of both fretting and burnishing which suggests that the failure mechanism was that of impact loading with the final fracture following the original crack.
