SUBJECT: LER 89-005-00:on 890412,atmosphere dump valve deficiencies
 noted.Caused by excessive leakage.W/890417 ltr.

LICENSEE EVENT REPORT (LER)

FACILITY NAME (1) Palo Verde Unit 1										DOCKET NUMBER (2) 0 5 0 0 0 5 2 8				PAGE (3) 1 OF 15			
TITLE (4) Atmospheric Dump Valve Deficiencies																	
EVENT DATE (5)			LER NUMBER (6)				REPORT DATE (7)			OTHER FACILITIES INVOLVED (8)							
MONTH	DAY	YEAR	YEAR	SEQUENTIAL NUMBER	REVISION NUMBER	MONTH	DAY	YEAR	FACILITY NAMES				DOCKET NUMBER(S)				
0	4	1	2	8	9	8	9	0	0	5	0	0	0	5	2	9	
									Palo Verde Unit 2				0 5 0 0 0 5 2 9				
									Palo Verde Unit 3				0 5 0 0 0 5 3 0				
OPERATING MODE (9)		THIS REPORT IS SUBMITTED PURSUANT TO THE REQUIREMENTS OF 10 CFR §: (Check one or more of the following) (11)															
4		20.402(b)				20.405(c)				50.73(a)(2)(iv)				73.71(b)			
POWER LEVEL (10)		0 0 0				20.405(a)(1)(i)				50.73(a)(2)(v)				73.71(c)

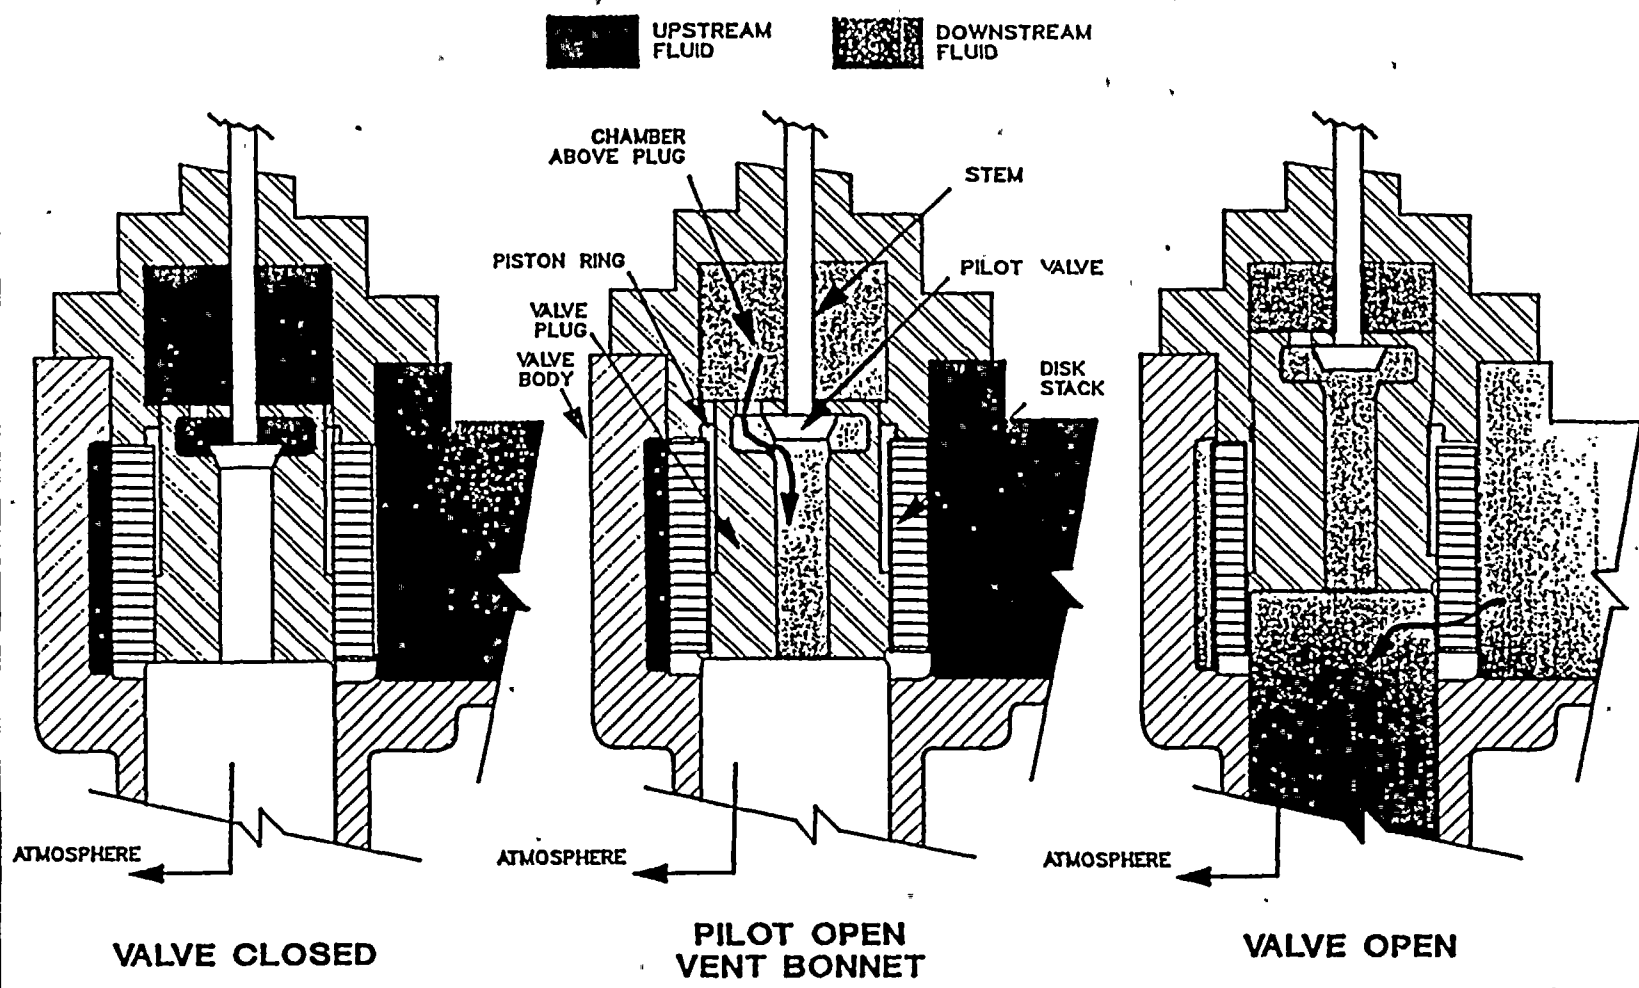
FIGURE 1

The following discussion is intended to assist the reader in understanding the ADV's principle of operation. The disk stack (Figure 1) permits changes in flow rate while limiting flow velocity through the control element. The disk stack consists of a number of disks into which labyrinth flow passages have been etched to allow a fixed impedance. Impedance in the passages is developed by a series of right-angle turns, with a specific number of turns in each passage to limit the velocity to an acceptable level. Since each disk has a known flow capacity, flow through the control element can be accurately measured and controlled. The position of the plug within the disk stack bore determines flow by exposing more or fewer disk passages.

With the valve in the closed position, upstream pressure fills the chamber above the plug by way of a controlled leak across the piston ring. This provides a seating load equal to the inlet pressure times the full area of the plug.

When a signal to open the valve is received, the actuator lifts the stem, opening the pilot seat which results in the chamber pressure above the plug equalizing with the downstream pressure. Upstream pressure acts upon the differential plug area and provides an axial biasing force which causes the plug to remain on the main seat.

As the valve stem continues to move in the opening direction, the pilot valve shoulder engages the plug to lift it off the main seat. The axial biasing force causes these opposing faces to remain in contact under all operating conditions.

ATMOSPHERIC DUMP VALVE VALVE POSITIONS
