ELECTRICAL DISTRIBUTION SYSTEM  
DESIGN ASSESSMENT

May 22, 1989

# **ELECTRICAL DISTRIBUTION SYSTEM** **DESIGN ASSESSMENT**

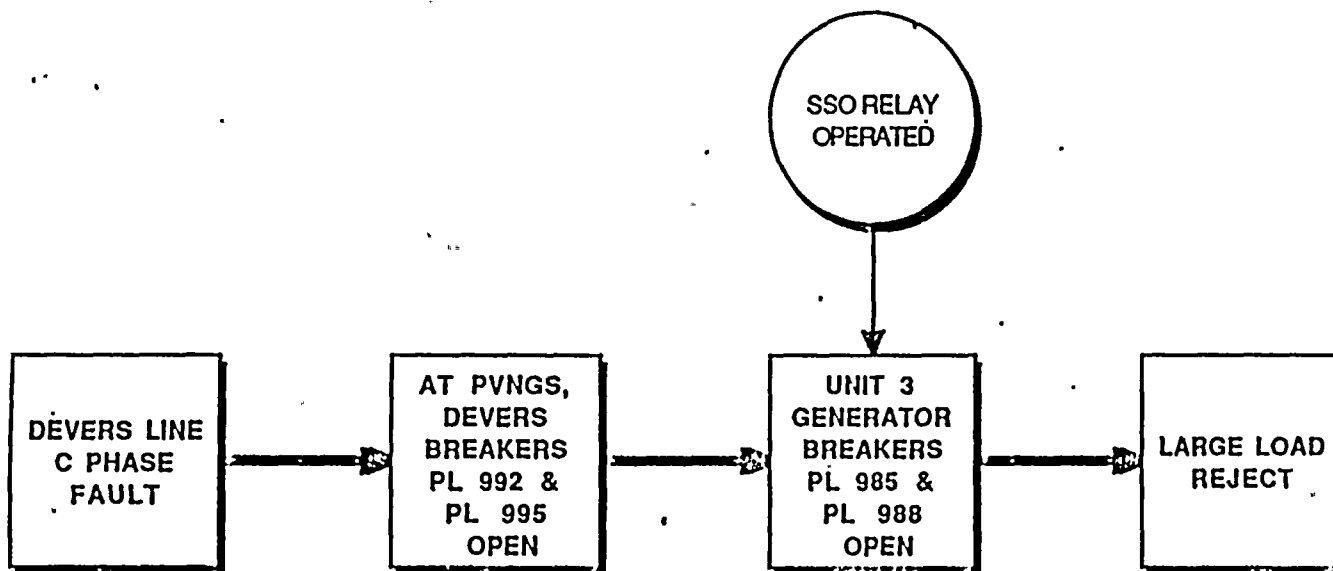
**FIGURE 2**  
**SSO RELAY**  
**EVENTS AND CAUSAL FACTORS**  
**CHART**  
**I.I.R. 2-3-89-001**

The second trip occurred on March 3, 1989, in Unit 3. Printouts from the Plant Monitoring System indicate that an SSO relay-initiated trip signal opened the main generator 525-kV breakers. Initial investigation and analysis of a simulation of the condition on the 525-kV transmission system, at the time of the event, indicated that the SSO relay should not have operated. Functional tests performed on the SSO relays at PVNGS showed no apparent failure of either relay. Based on these findings, "bench" tests were performed on the SSO relay circuit boards. The results of these tests did not indicate component malfunction or failure.

Since test results of the Unit 3 SSO relays themselves have not identified the cause of the SSO relay/relays operation, APS investigated possible sources of erroneous signals to the SSO relays. The turbine-generator Power System Stabilizer (PSS) was reviewed as a possible source of erroneous input signals to the SSO relay. A malfunction of the PSS could generate a signal which could cause SSO relay operation; however, test results indicate that the PSS is not a likely source for the problem. Additionally, APS is testing the noisy generator

current transformer circuits as a potential source of an erroneous signal. APS is also monitoring the Unit 3 SSO relay performance in its plant environment with a synthetic stimulus (i.e., a stimulus that simulates the input to the relays at the time the Unit 3 SSO relay operation occurred) being applied during the refueling outage. Upon discovery of the cause of improper SSO relay operation, APS will take action to reduce or eliminate recurrence

Based on experience and analysis, an SSO relay operation will occur in the future. The possibility of going into complicated trip situations (such as natural circulation) for these events must be minimized. This possibility can be minimized by realigning the power supplies to the reactor coolant pumps as discussed in the Electrical Distribution Alignment Alternative sections. In addition, 5 alternative actions have been identified as long term means to minimize the negative impacts of a SSO relay operation, to enhance the capability to identify the cause of a SSO relay operation, and to improve SSO relay security. These alternatives are described in the following sections. A summary of these alternatives is contained on Figure 2.

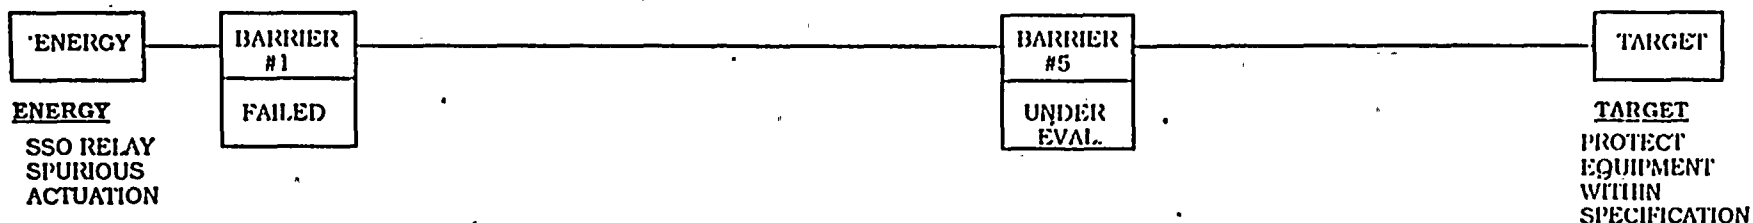
### ENERGY-BARRIER-TARGET ANALYSIS FOR IIR 2-3-89-001

1. EQUIPMENT PERFORMANCE	<input type="checkbox"/>	<input checked="" type="checkbox"/>	<input type="checkbox"/>	<input type="checkbox"/>	<input type="checkbox"/>	<input type="checkbox"/>	SSO RELAY ACTUATION

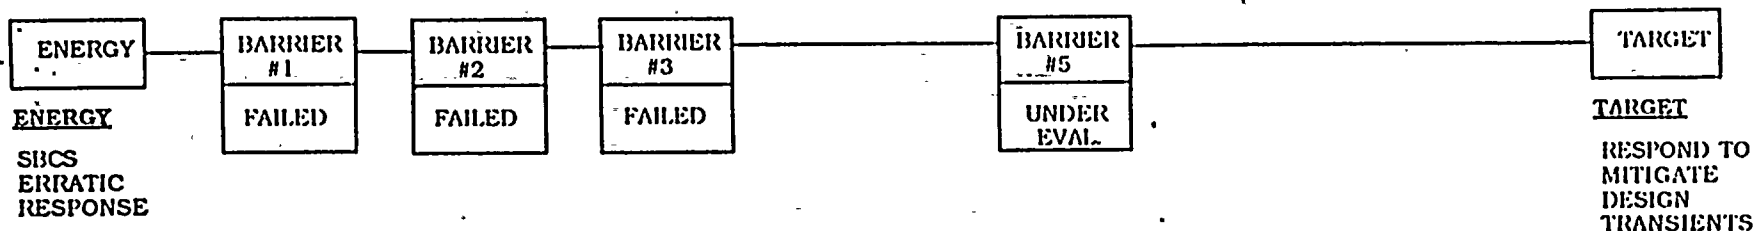
### ENERGY-BARRIER-TARGET ANALYSIS FOR IIR 2-3-89-001

1. EQUIPMENT PERFORMANCE	<input type="checkbox"/>	<input checked="" type="checkbox"/>	<input type="checkbox"/>	<input checked="" type="checkbox"/>	<input type="checkbox"/>	<input type="checkbox"/>	-RELAY TIMER CARD MALFUNCTION

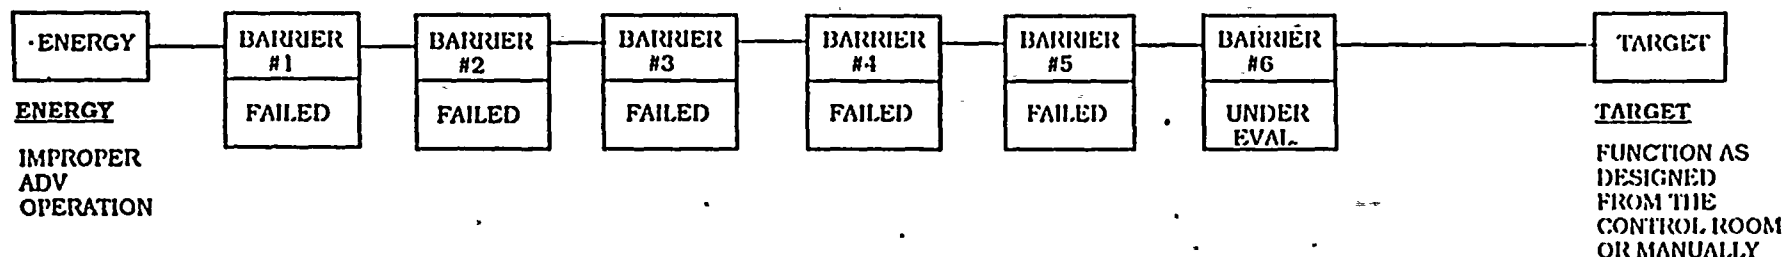
### ENERGY-BARRIER-TARGET ANALYSIS FOR IIR 2-3-89-001

1. EQUIPMENT PERFORMANCE	<input type="checkbox"/>	<input checked="" type="checkbox"/>	<input type="checkbox"/>	<input checked="" type="checkbox"/>	<input type="checkbox"/>	<input type="checkbox"/>	- DID NOT RESPOND FROM C.R OR RSP - HANDWHEEL CLEVIS

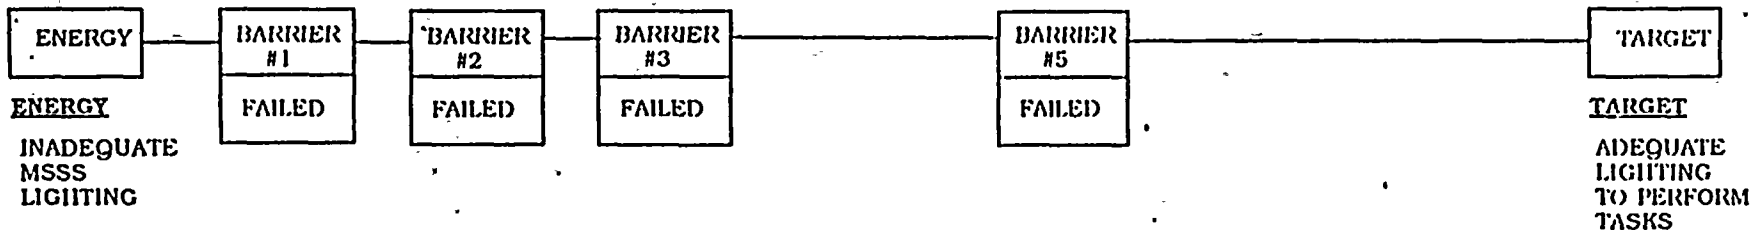
### ENERGY-BARRIER-TARGET ANALYSIS FOR IIR 2-3-89-001

1. EQUIPMENT PERFORMANCE	<input type="checkbox"/>	<input checked="" type="checkbox"/>	<input type="checkbox"/>	<input checked="" type="checkbox"/>	<input type="checkbox"/>	<input type="checkbox"/>	ESSENTIAL LIGHTING EMERGENCY LIGHTING

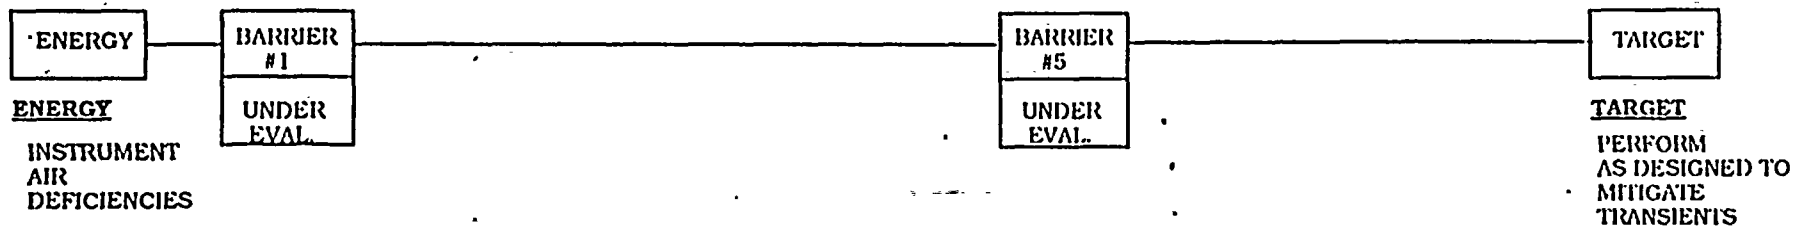
### ENERGY-BARRIER-TARGET ANALYSIS FOR IIR 2-3-89-001

1. EQUIPMENT PERFORMANCE	<input type="checkbox"/>	<input type="checkbox"/>	<input checked="" type="checkbox"/>	<input type="checkbox"/>	<input type="checkbox"/>	<input type="checkbox"/>	- AS DETERMINED BY ENGINEERING ACTION PLAN

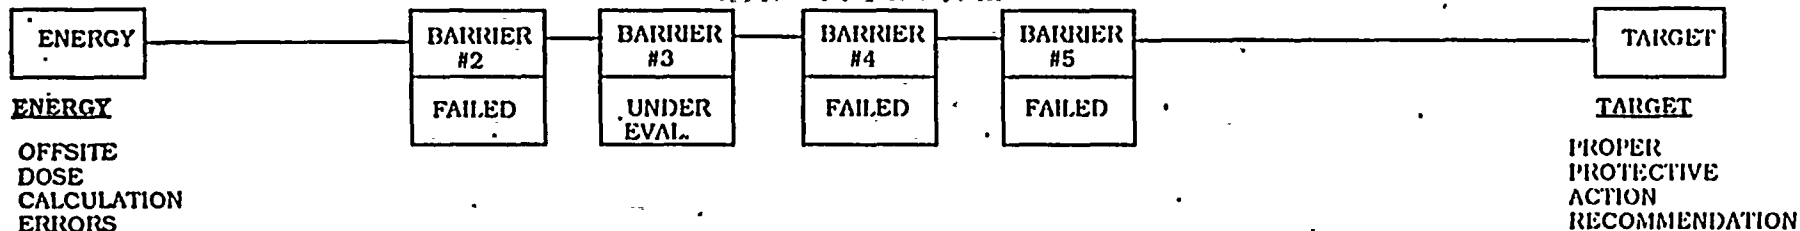
### ENERGY-BARRIER-TARGET ANALYSIS FOR IIR 2-3-89-001

1. EQUIPMENT PERFORMANCE	<input checked="" type="checkbox"/>	<input type="checkbox"/>	<input type="checkbox"/>	<input type="checkbox"/>	<input checked="" type="checkbox"/>	<input type="checkbox"/>	- CALCULATION ERRORS  - PROVIDE ENHANCEMENTS TO PROCEDURE  - MESOREM/RMS POWER SUPPLY

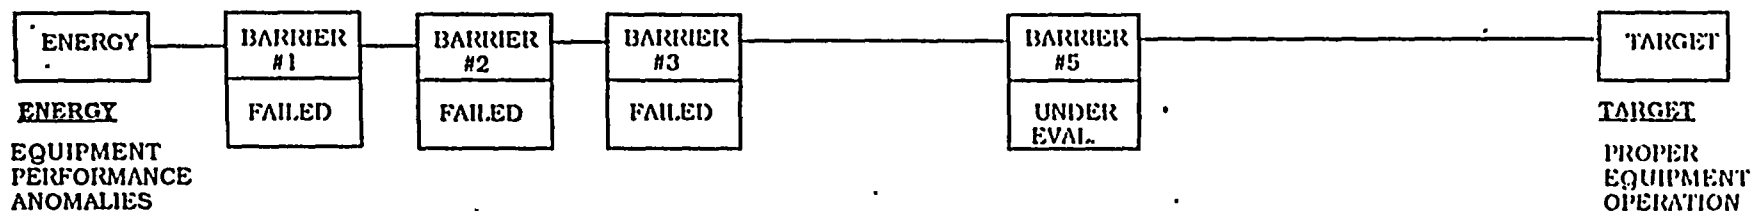
### ENERGY-BARRIER-TARGET ANALYSIS FOR IIR 2-3-89-001

1. EQUIPMENT PERFORMANCE	<input type="checkbox"/>	<input checked="" type="checkbox"/>	<input checked="" type="checkbox"/>	<input type="checkbox"/>	<input type="checkbox"/>	<input type="checkbox"/>	- 10.1, 10.2, 10.3, 10.5 10.6, 10.8, 10.10
