PALO VERDE NUCLEAR GENERATING STATION
UNITS 1, 2, AND 3

JUSTIFICATION FOR CONTINUED OPERATION
CEA DROP EVENTS

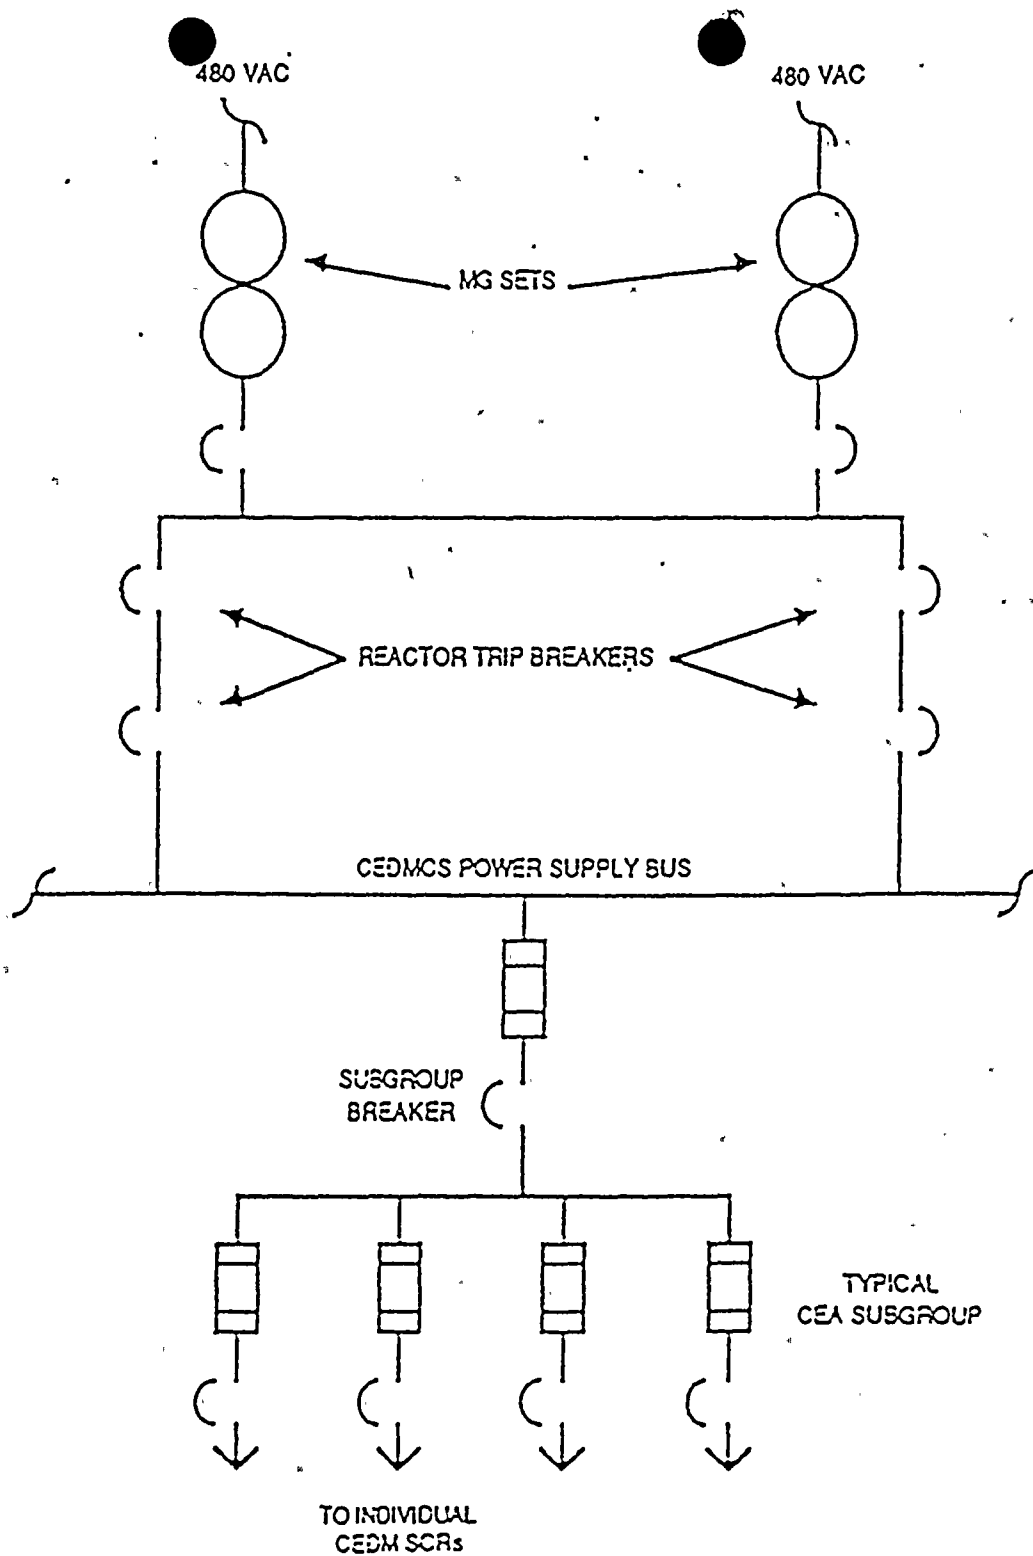
FIGURE 1 - CEDMCS POWER SUPPLY

The purpose of the CEDMCS is to provide the drive signals to the coils of the magnetic-jack Control Element Drive Mechanisms (CEDMs) which position and hold the individual Control Element Assemblies (CEAs). The CEDMCS controls the direction, rate, and duration of CEA motion in response to automatic or manual demands. The CEDMCS is a non-safety related control system. The safety function of the CEAs is to drop into the core when power is removed from the CEDMs. Power is removed from the CEDMs when the reactor trip breakers open in response to valid reactor protection signals. Refer to Appendix A, Figure 1 for a schematic of the power supply arrangement to the PVNGS CEDMCS.

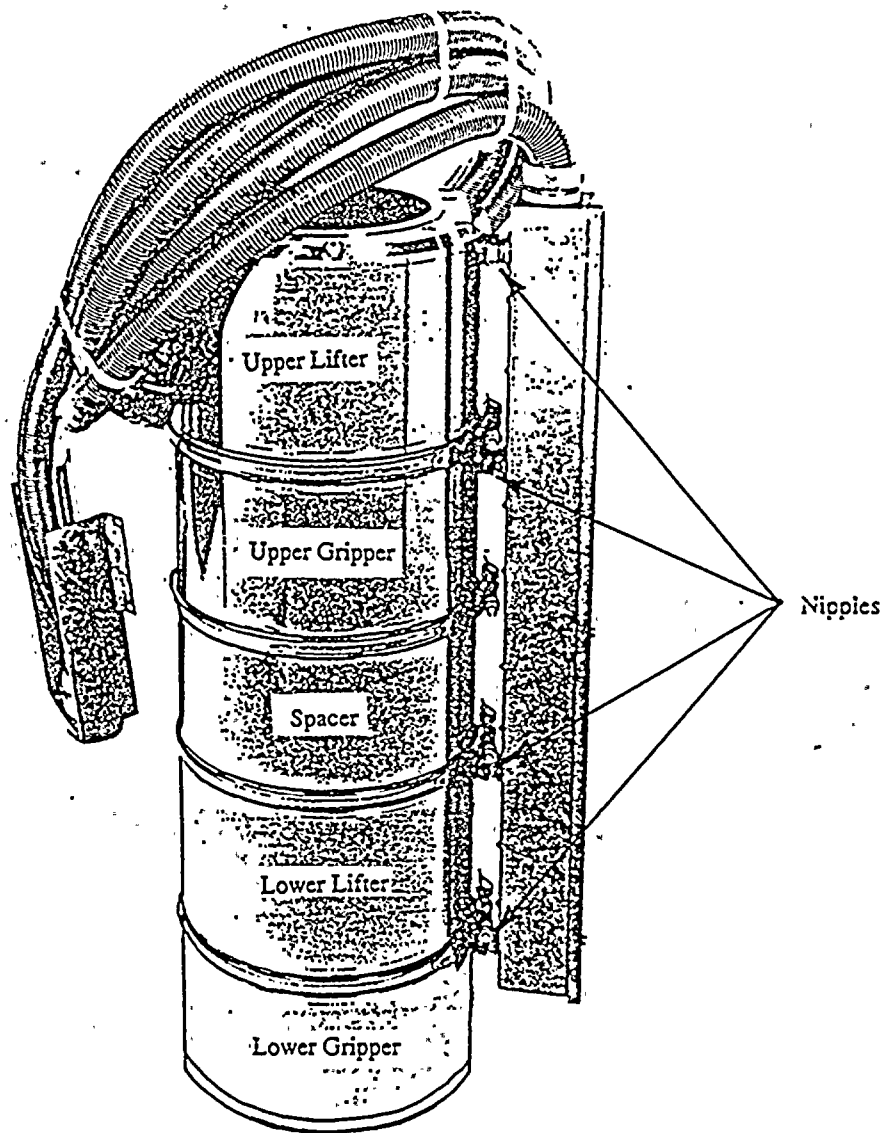
FIGURE 2 - COIL STACK ASSEMBLY

The coil stack for CEDM No. 33 was disassembled, examined, and evaluated at PVNGS by representatives of the Engineering Evaluations Department. During the examination, substantial damage was found in the area of the lower lift coil where the coil lead wires pass through the nipple assembly. The evaluation concluded that the ground fault associated with CEA No. 33 was the result of damage to the coil lead wires which was later found to have occurred during the assembly process (a manufacturing deficiency).

The coil stack for CEDM No. 19 was sent to C-E for an independent evaluation. During the evaluation, C-E identified damaged fiberglass sheathing and insulation on the coil leads. This was determined to be a manufacturing deficiency that occurred during the coil stack assembly process.

Two factors are believed to have contributed to the manufacturing deficiency becoming a pathway for a short to ground. The two factors were the observed motion of the lower lift coil leads and the orientation of the coil within its housing. These conditions combined to narrow the gap between the bare wire and the housing which allowed an intermittent ground fault, subsequent insulation deterioration over time, and subsequent arcing to the housing (nipple) assembly.

- 2) All known defective coil stacks, identified during testing, will be replaced prior to restart of the affected unit. This is expected to eliminate the source of CEA slippage problems associated with ground faults.
