SUBJECT: LER 89-004-02:on 890104,emergency diesel generator rocker  
 arm failure/ESF actuation.

Subject: Palo Verde Nuclear Generating Station (PVNGS)  
Unit 3  
Docket No. STN 50-530 (License No. NPF-74)  
Licensee Event Report 89-004-02  
File: 89-020-404

FACILITY NAME (1) Palo Verde Unit 3										DOCKET NUMBER (2) 0 5 0 0 0 5 3 0					PAGE (3) 1 OF 1 3											
TITLE (4) Emergency Diesel Generator Rocker Arm Failure/ESF Actuation																										
EVENT DATE (5)			LER NUMBER (6)				REPORT DATE (7)			OTHER FACILITIES INVOLVED (8)																
MONTH	DAY	YEAR	YEAR	SEQUENTIAL NUMBER	REVISION NUMBER	MONTH	DAY	YEAR	FACILITY NAMES				DOCKET NUMBER(S)													
0	1	0	4	8	9	8	9	0	0	4	0	2	0	6	2	7	8	9	N/A	0	5	0	0	0		
OPERATING MODE (9) 1			THIS REPORT IS SUBMITTED PURSUANT TO THE REQUIREMENTS OF 10 CFR §: (Check one or more of the following) (11)																							
POWER LEVEL (10) 1, 0, 0			20.402(b)				20.406(c)				X 50.73(a)(2)(iv)				73.71(b)

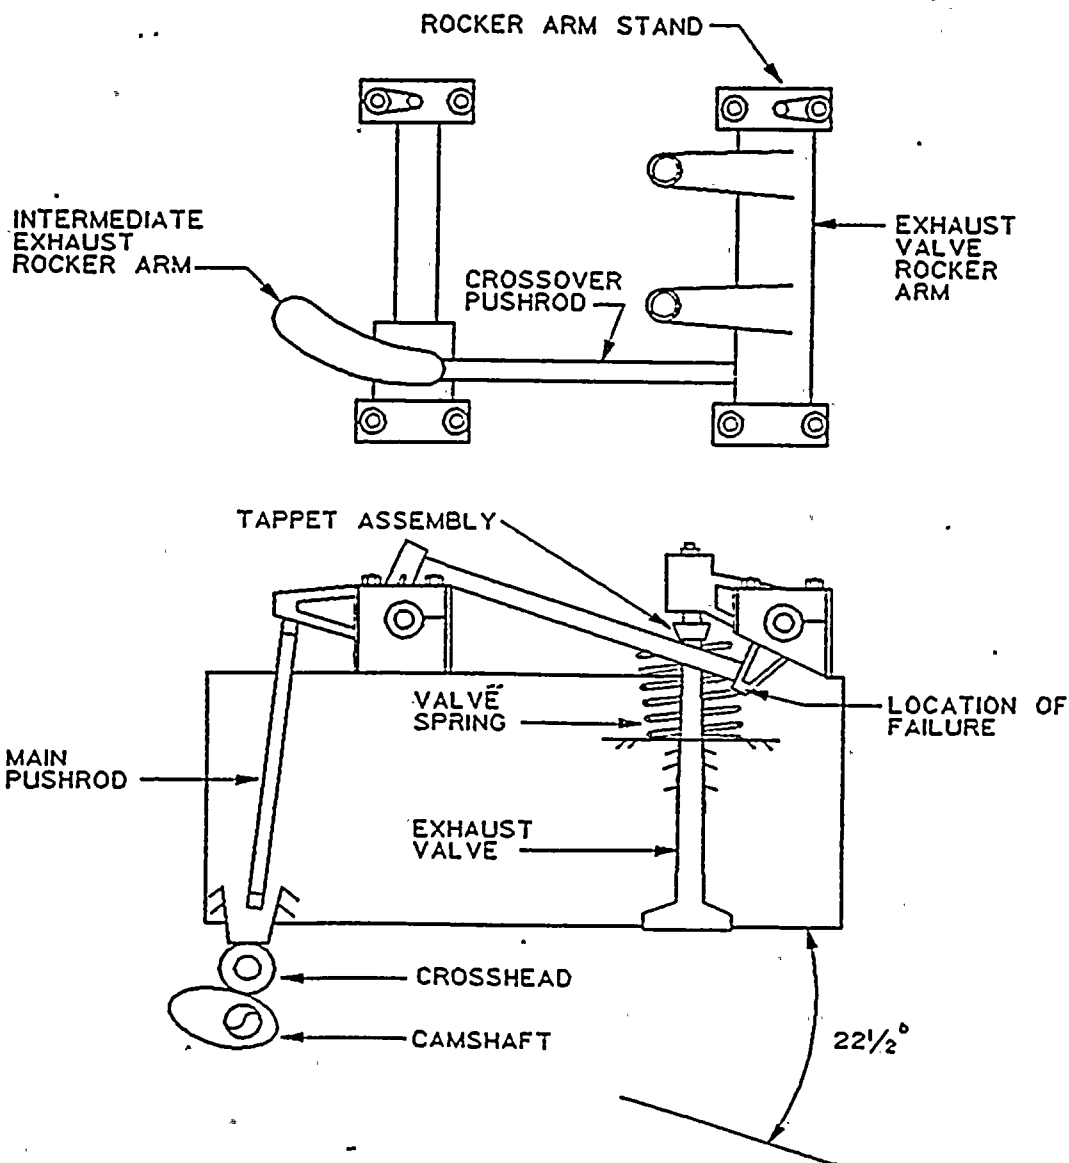
Figure 1

ANPP removed the fractured rocker arm and visually inspected the part. ANPP discussed the failure with Cooper-Bessemer on January 4, 1989, and an evaluation of the rocker arm failure was started. The 8L cylinder exhaust rocker arm failed when the end of the push rod arm fractured and separated from the main exhaust valve rocker arm (Figure 1). The push rod arm casting is machined to accept a round insert which comprises the push rod seat. The fracture occurred at the rocker arm wall on both sides of this insert and down through the base

of the push rod arm. Subsequent inspection of the fractured piece revealed evidence of paint on the fracture face. This indicates a crack had occurred prior to painting the rocker arm and the paint seeped into the crack. ANPP received the rocker arm painted from the factory. ANPP sent the failed rocker arm to Cooper-Bessemer for inspection and analysis. On January 11, 1989, discussions with Cooper-Bessemer confirmed that the rocker arm failure resulted from an original defect prior to delivery to ANPP. The specific cause of the failure is under investigation by APS and Cooper-Bessemer. The investigation is expected to be completed by November 1, 1989. A supplement to this report providing the results of the final root cause analysis is expected to be submitted by November 30, 1989.

On January 11, 1989, ANPP removed the inspection covers and visually inspected the remaining intake and exhaust rocker arms on the "A" Emergency Diesel Generator. This inspection revealed a cracked exhaust rocker arm for the 9R cylinder. An inspection of the fracture revealed evidence of paint on the fracture face. This rocker arm remained functional. The rocker arm had been cracked prior to receipt from the factory.

## EXHAUST ROCKER ARM ASSEMBLY

The failed rocker arm and damaged turbocharger components were replaced. The remaining rocker arms on the "A" Emergency Diesel Generator (EDG) have been inspected and one was replaced. These corrective actions were completed by January 12, 1989. Following the return of the "A" EDG to service, the "B" EDG rocker arms were inspected. No other failed rocker arms were identified. This action was completed by January 14, 1989.

Until final corrective actions for the rocker arm failure are established, all new replacement rocker arms will be inspected by ANPP utilizing non-destructive examination techniques prior to installation. The non-destructive examination will provide assurance that the new rocker arms utilized at Palo Verde are free from cracks in the press fitted area. Further determination of corrective action to prevent recurrence will be developed in association with Cooper-Bessemer based upon the results of the root cause investigation described in Section I.D.1. A supplement to this report is expected to be submitted by November 30, 1989 to describe the long term corrective actions.
