PALO VERDE NUCLEAR GENERATING STATION  
UNITS 1, 2, AND 3

JUSTIFICATION FOR CONTINUED OPERATION  
CEA DROP EVENTS

REV. 1

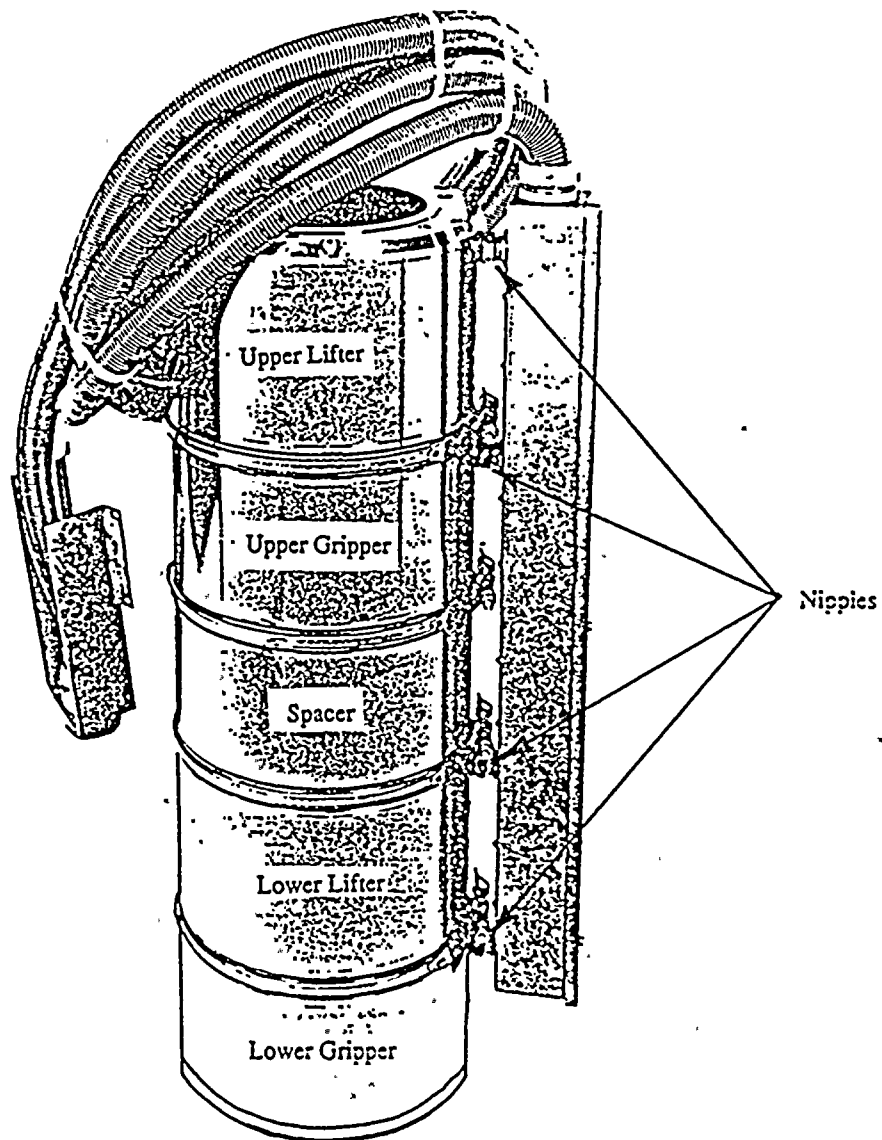
FIGURE 2 - COIL STACK ASSEMBLY

The coil stack for CEDM No. 33 was disassembled, examined, and evaluated at PVNGS by representatives of the Engineering Evaluations Department. During the examination, substantial damage was found in the area of the lower lift coil where the coil lead wires pass through the nipple assembly. The evaluation concluded that the ground fault associated with CEA No. 33 was the result of damage to the coil lead wires which was later found to have occurred during the assembly process (a manufacturing deficiency).

The coil stack for CEDM No. 19 was sent to C-E for an independent evaluation. During the evaluation, C-E identified damaged fiberglass sheathing and insulation on the coil leads. This was determined to be a manufacturing deficiency that occurred during the coil stack assembly process.

Two factors are believed to have contributed to the manufacturing deficiency becoming a pathway for a short to ground. The two factors were the observed motion of the lower lift coil leads and the orientation of the coil within its housing. These conditions combined to narrow the gap between the bare wire and the housing which allowed an intermittent ground fault, subsequent insulation deterioration over time, and subsequent arcing to the housing (nipple) assembly.

2) All known defective coil stacks, identified during refueling shutdown or post reload startup testing, will be replaced prior to restart of the affected unit. This is expected to eliminate the source of CEA slippage problems associated with ground faults.
