SUBJECT: Advises that corrective action plan re atmospheric dump
 valve failures & compressed gas sys expected by 890929.

Subject: Palo Verde Nuclear Generating Station (PVNGS)
Units 1, 2, and 3
Docket No. STN 50-528 (License No. NPF-41)
STN 50-529 (License No. NPF-51)
STN-50-530 (License No. NPF-74)
Reply to Inspection Report 50-528/89-29
File: 89-019-026

**Nuclear Safety Department
Independent Case Study of
Compressed Gas and ADV Events**

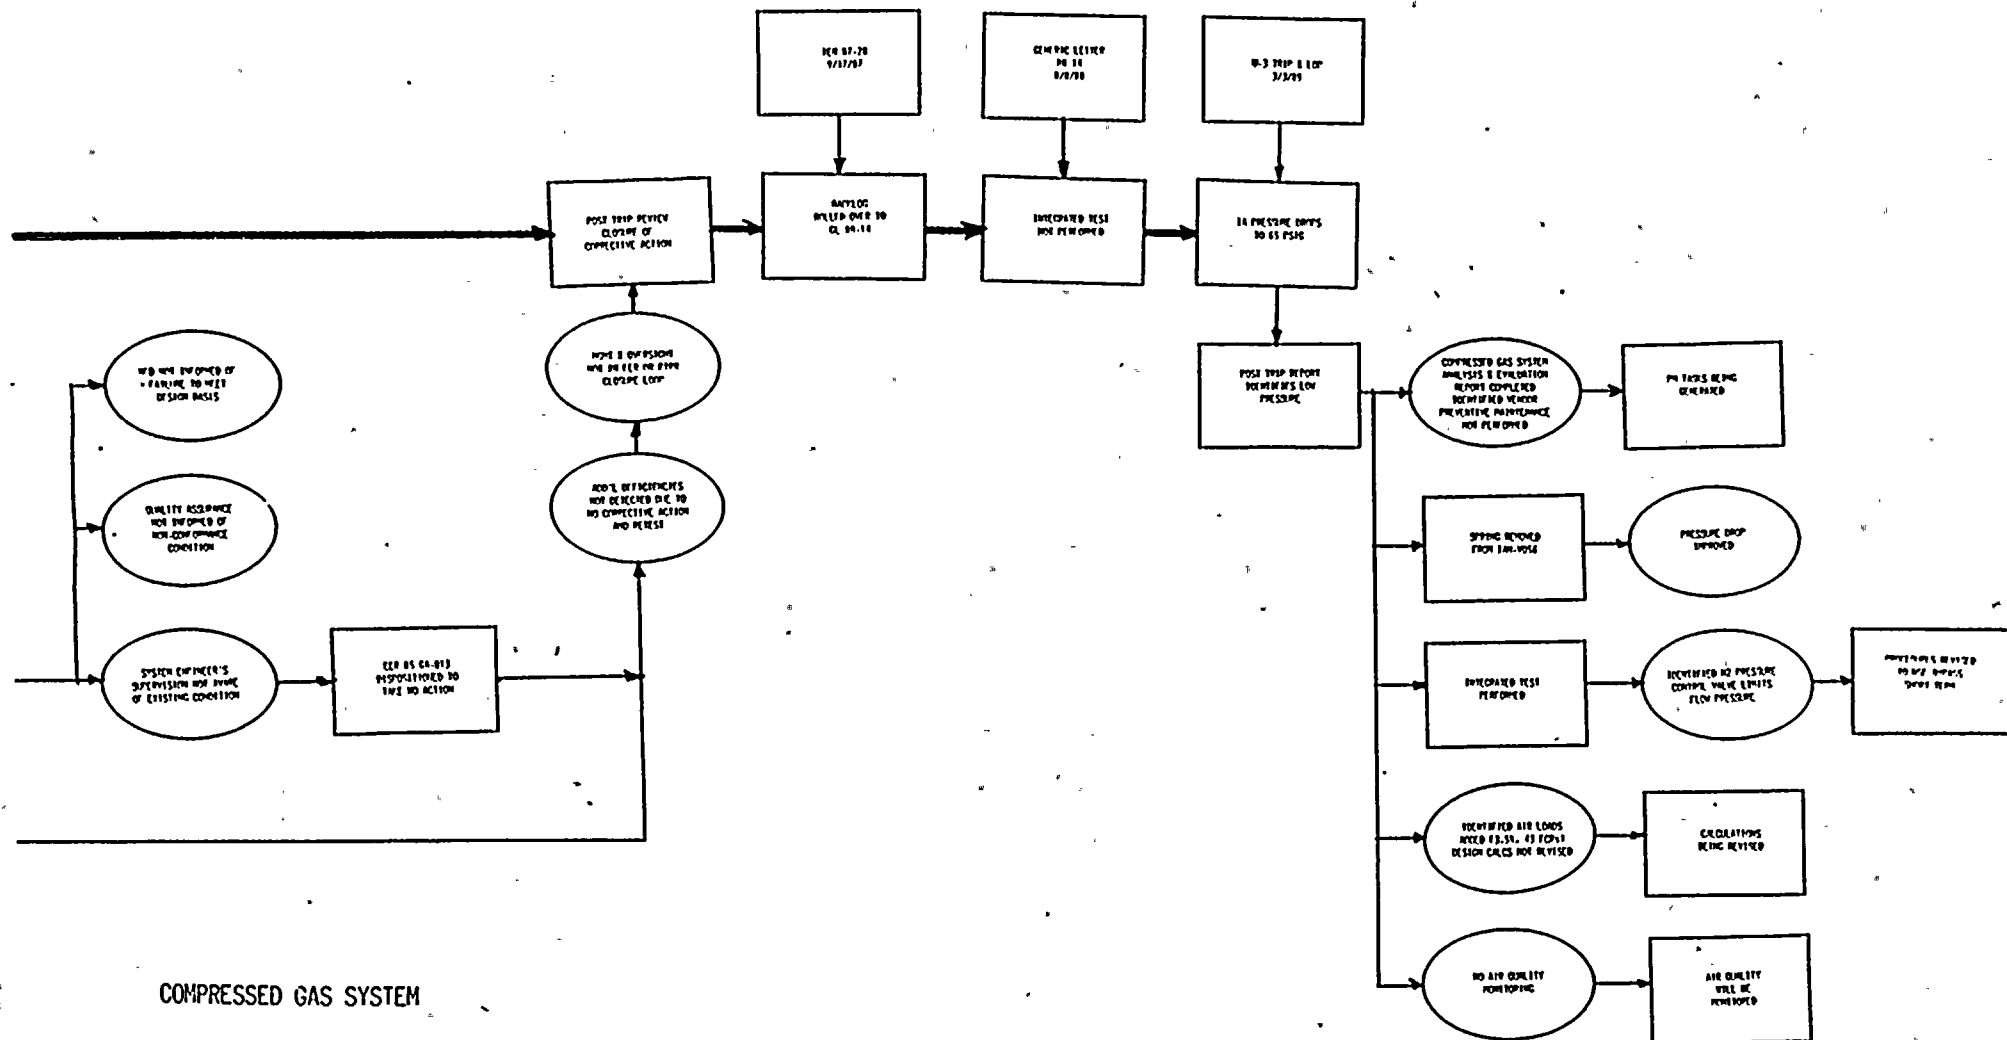
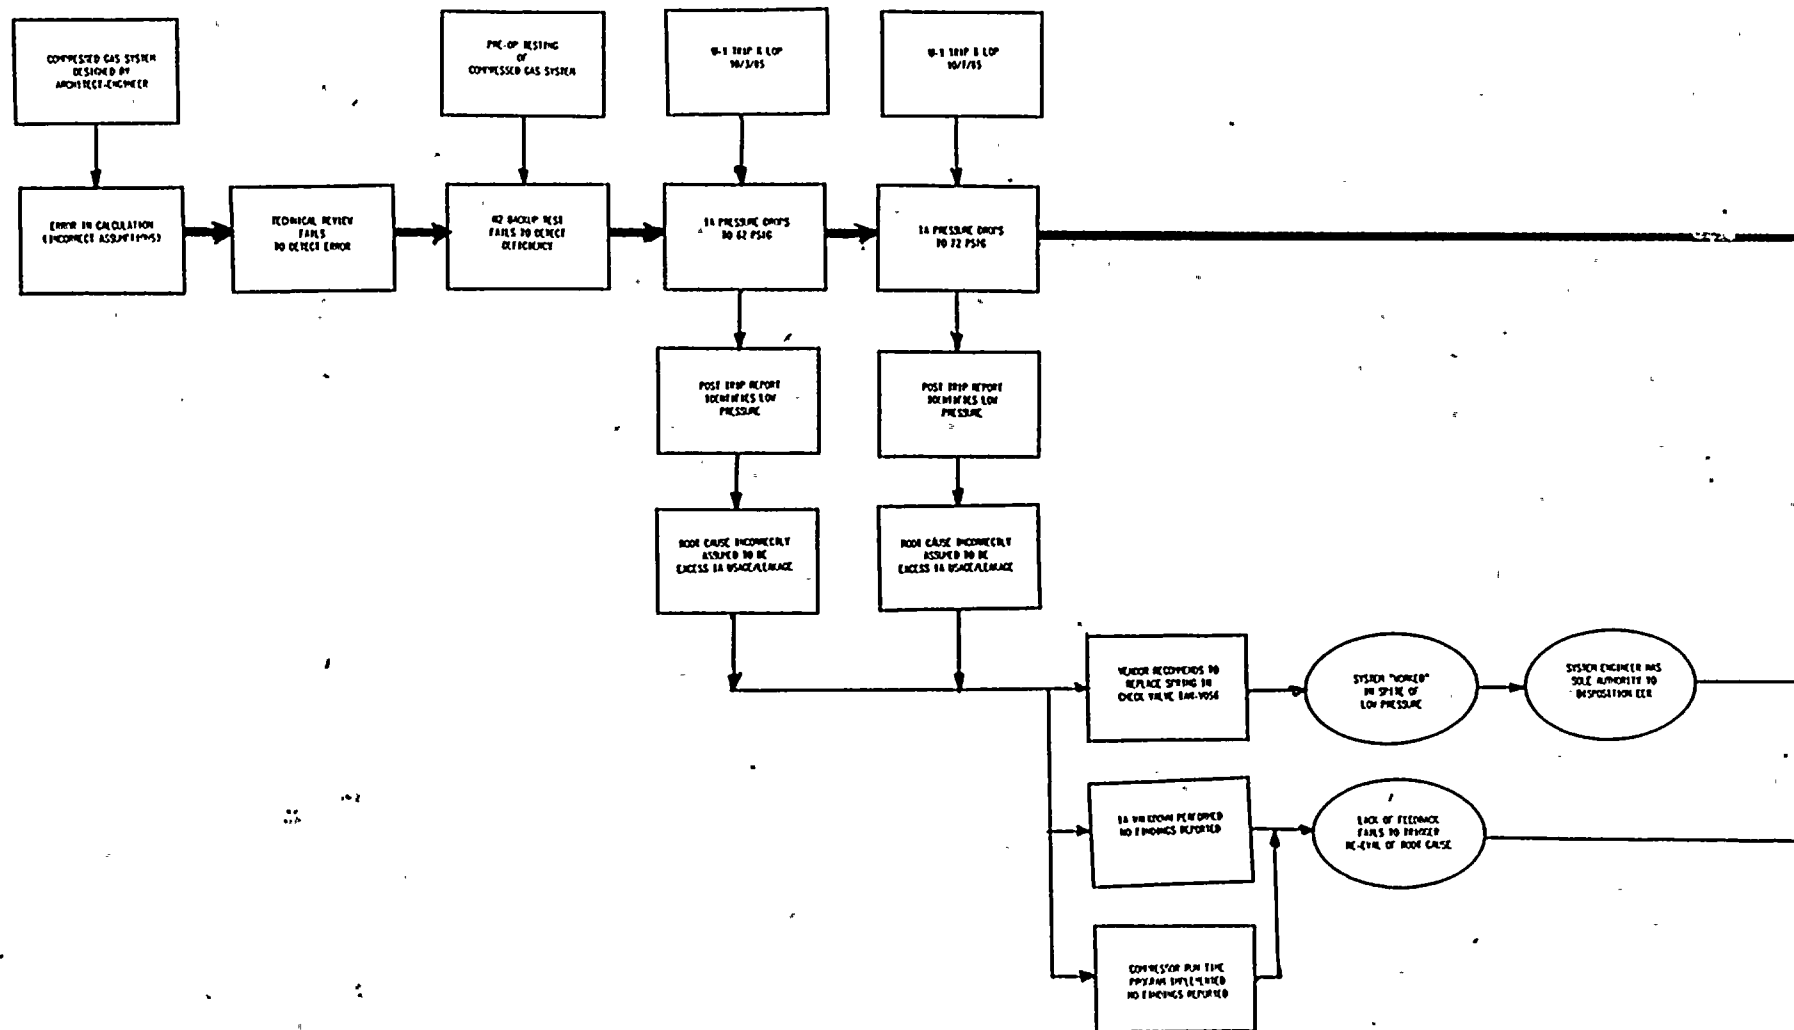
ATTACHMENT 1 - PAGE 8

- o Integrated flow/capacity test performed.
- o Check valve spring identified in 1985 was investigated and found to only partially contribute to root cause.
- o Additional investigation identified design errors in sizing of N₂ pressure regulating valves.
- o Design changes added air loads (3.5%, 43 FCRs) without identifying to NED the need to re-evaluate the design calcs.
