CONDENSATE PIPING
OVERPRESSURE
EVALUATION

AUGUST 16, 1989

NUCLEAR
ENGINEERING

ABSTRACT

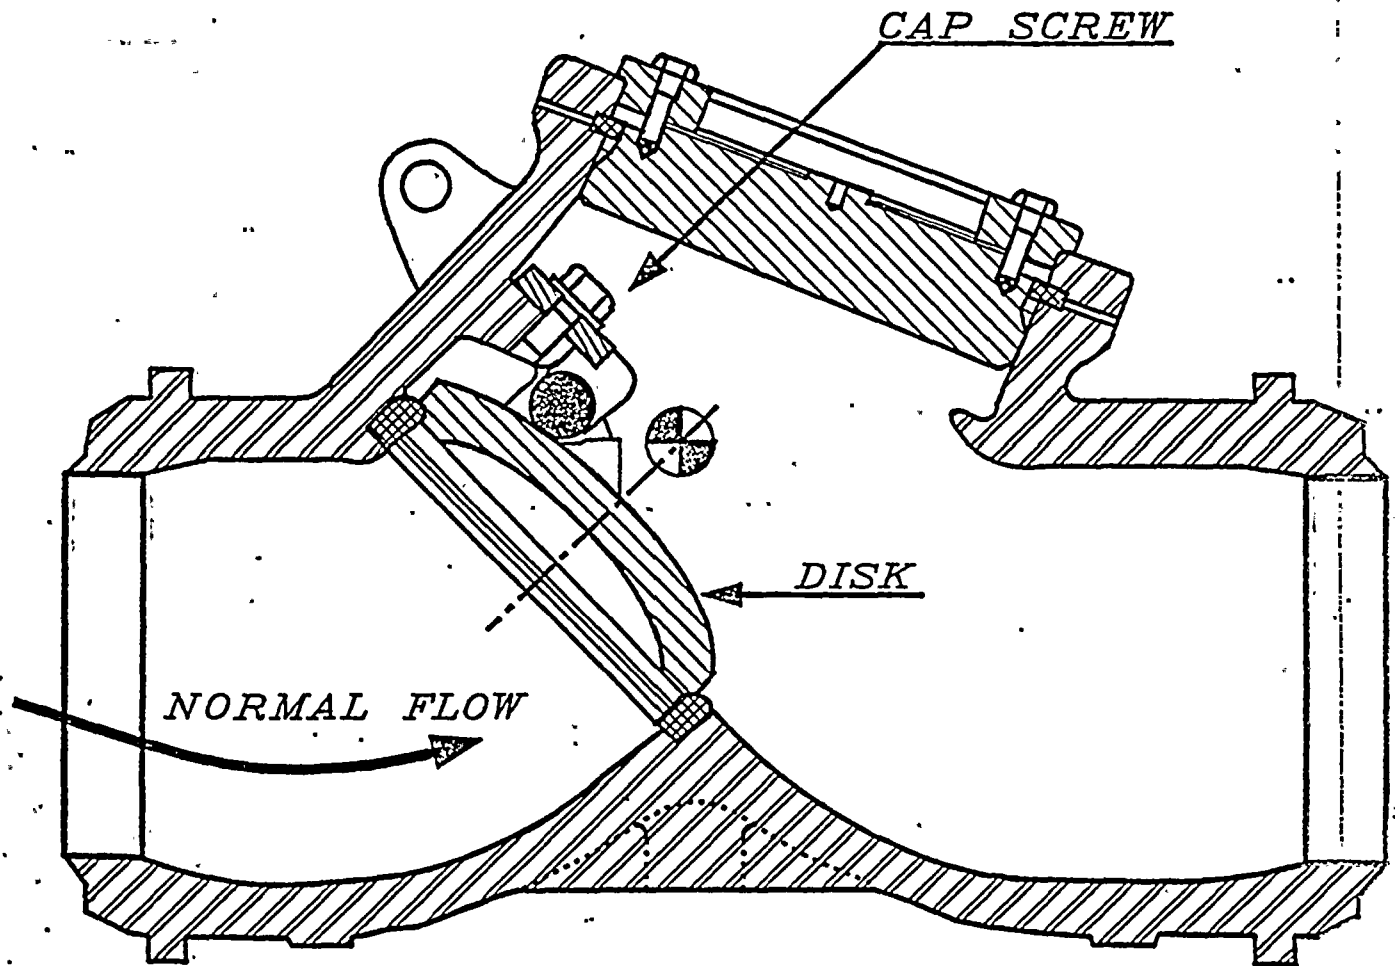
(2PSGNV431)

Following the trip on July 13, EED tested check valve SGN-V431, Figure 1.2-2, verified that it allowed backleakage, and requested rework of the valve, which was performed to work order 00369951. The rate of the backleakage through the check valve was unknown, and the operator did hear an unusual noise when cracking open the FWP bypass valve, FWN-V013, to initiate long path recirculation. The system lineup, Figure 1.2-1, has been reconstructed from the operators logs and interviews. The system engineer was able to redevelop the scenario of the system alignments and identified the following system piping that experienced the overpressurization;

FEEDWATER CHECK VALVE
