PALO VERDE
NUCLEAR GENERATING STATION

ATMOSPHERIC DUMP VALVE
ENGINEERING ANALYSIS

March/April, 1989

REVISION 2

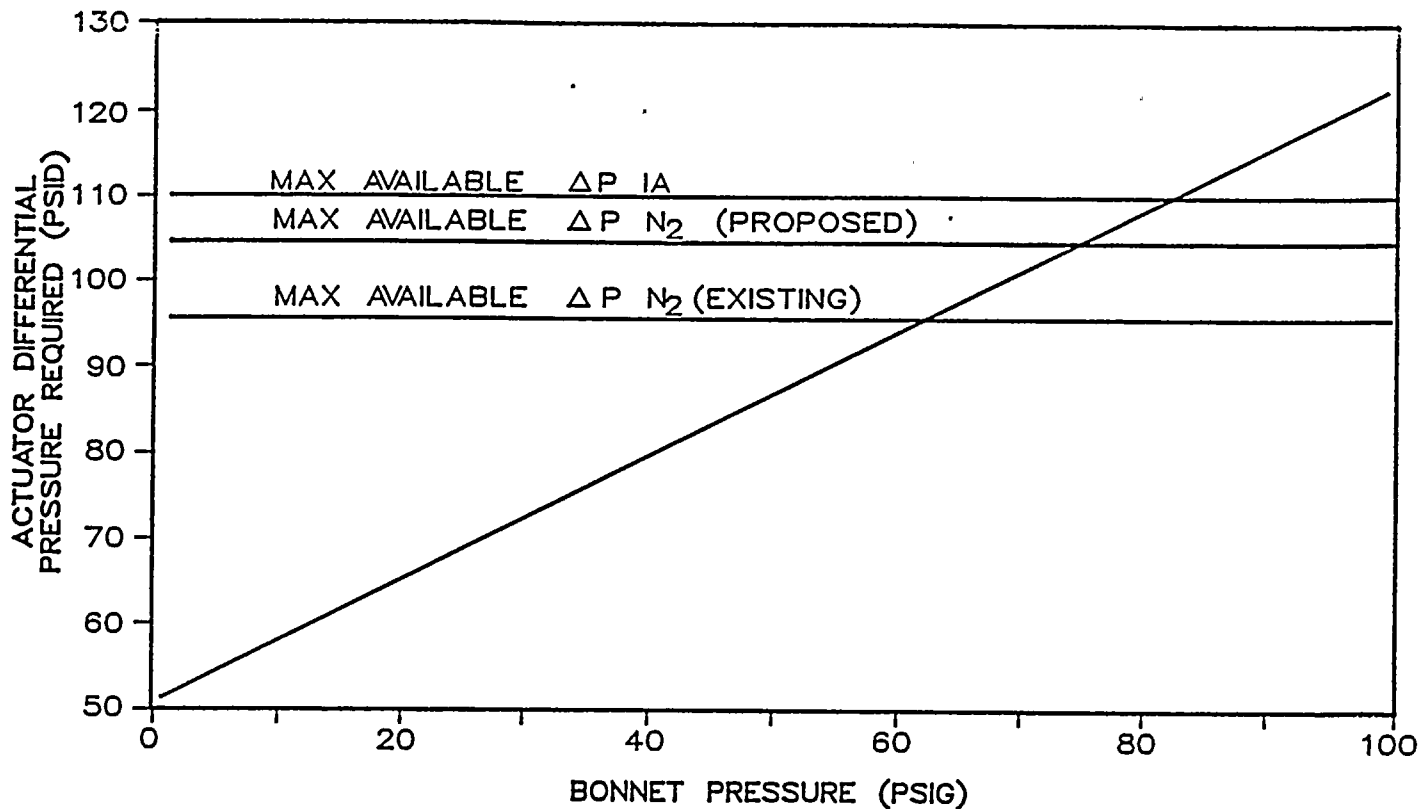
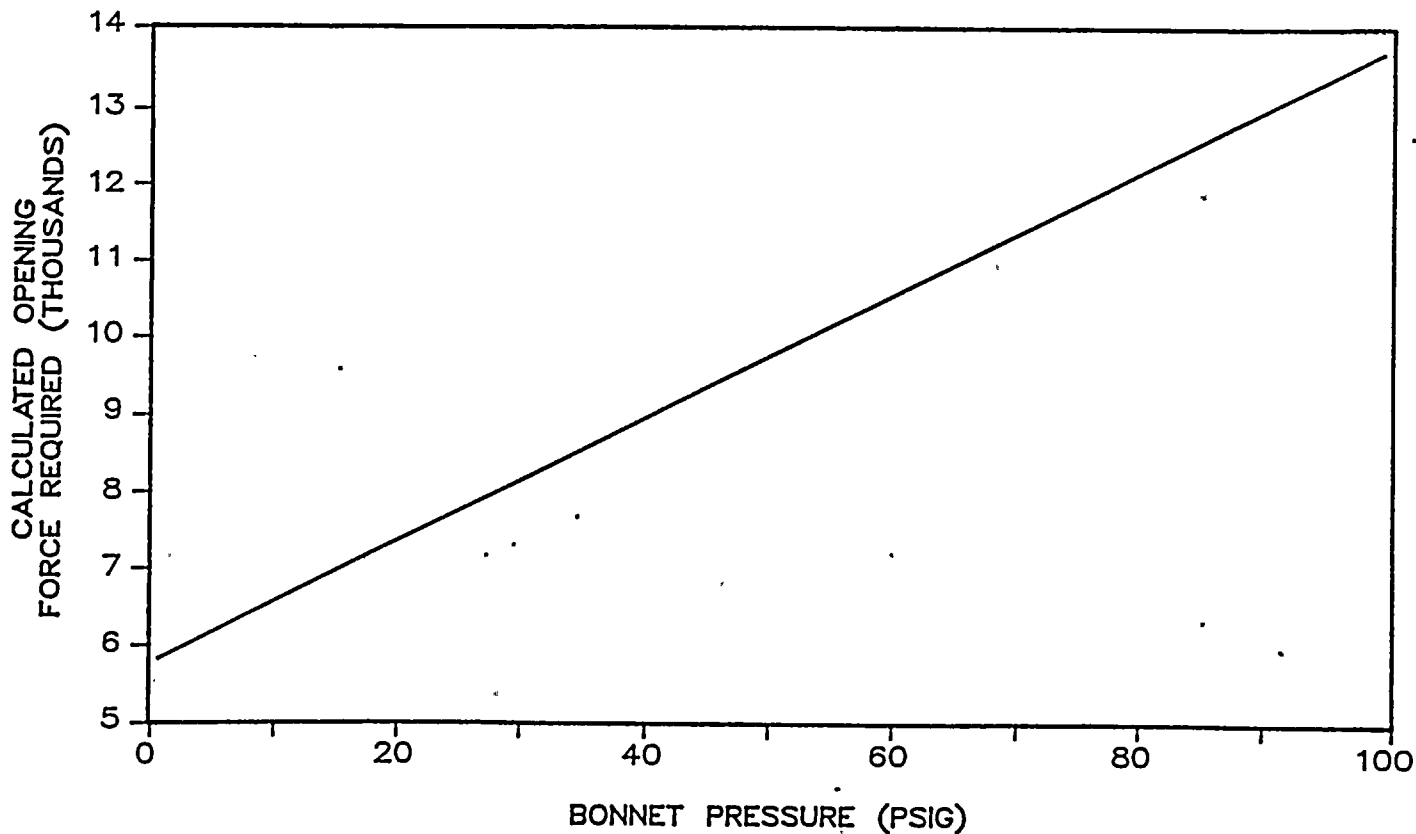
FIGURE VI-2 & VI-3

- 2) A 20% demand was placed into the CR controller. The pilot valve opened. This allowed the bonnet pressure to depressurize and the condition of the seal ring to be determined. Bonnet pressure decreased to 60 psig and then slowly increased to 110 psig which is approximately 6 to 10 times greater than design.

The failure of ADV-184 to open was due to an abnormally high bonnet pressure. High bonnet pressure may be caused by either the failure of the pilot valve to function or excessive leakage around the piston ring. Proper functioning of the pilot valve was verified by the opening of the pilot valve to the correct position. Thus, the cause of the high bonnet pressure is attributable to excessive leakage around the piston ring. The ring design utilized in this ADV is a self-energizing piston ring. This means the force to seat the ring is a result of the differential pressure across the piston ring. When the ring is energized, it is held tightly against the plug and upper portion of the bonnet, forming a seal. If anything interferes with the ring moving up into position against its sealing surfaces, a high bonnet pressure may result. Two scenarios have been proposed whereby this can happen:

**Calculated Force and Actuator D/P
Required to Open a Typical
ADV vs. Bonnet Pressure**

1. A modification will be implemented during the current outages which will increase the pilot valve capacity and install an improved two-piece piston ring. These changes will result in not only less steam leakage to the bonnet area, but an increased ability to depressurize the bonnet chamber.

3. Nitrogen supply pressure is also being increased to mitigate oscillations observed during the testing program (see Section VI.E.2). This increased nitrogen pressure will also provide added margin in the available force the actuator can develop. Therefore, a higher bonnet pressure could be overcome by the actuator.

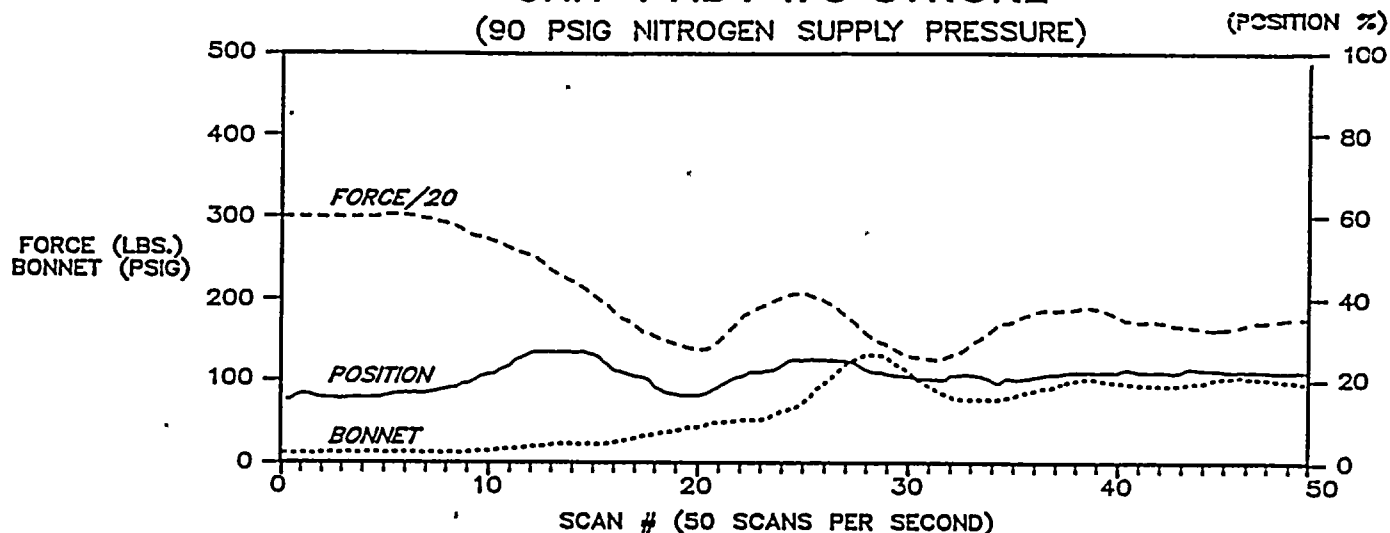
FIGURE VI-4 **UNIT 1 ADV-178 STROKE**

The rate of acceleration is a function of the velocity of the plug when it enters the C_v transition and the response of the positioner to the acceleration. Thus, a small change in the velocity of the plug or the response of the positioner may explain the random nature noted in the occurrence of oscillations and the amount of dampening present. This larger forcing function makes the rate at which it is applied less important in exciting an oscillation. The preliminary results of the modeling study show that the magnitude of the forcing function required to produce an oscillation is reduced by approximately half if it occurs at a rate near the natural frequency of the system.

In order to show the effect of actuator pressure on the oscillations, ADV-178 was tested using nitrogen supply pressures of 90, 100, and 110 psig. It should be noted that when these supply pressures were changed, the nitrogen regulator was recalibrated using a new procedure which specified a calibration flow rate for the pressure setpoint. FIGURE VI-4 shows that when the valve was given a 30%

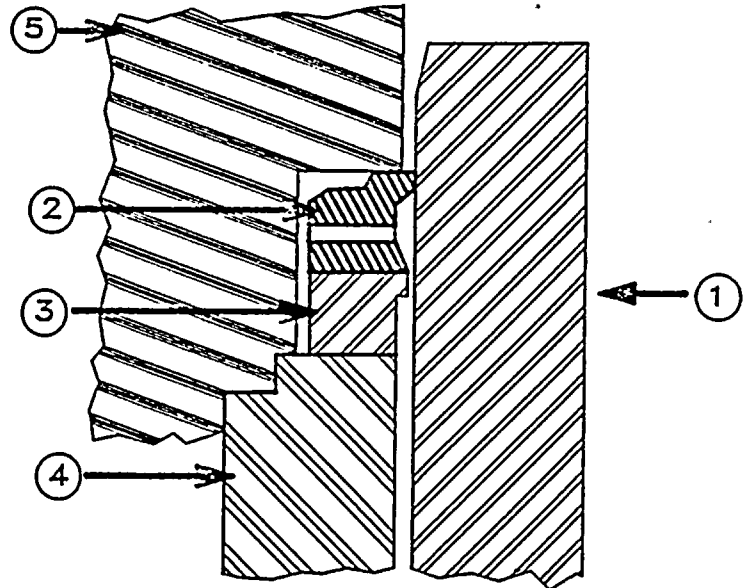
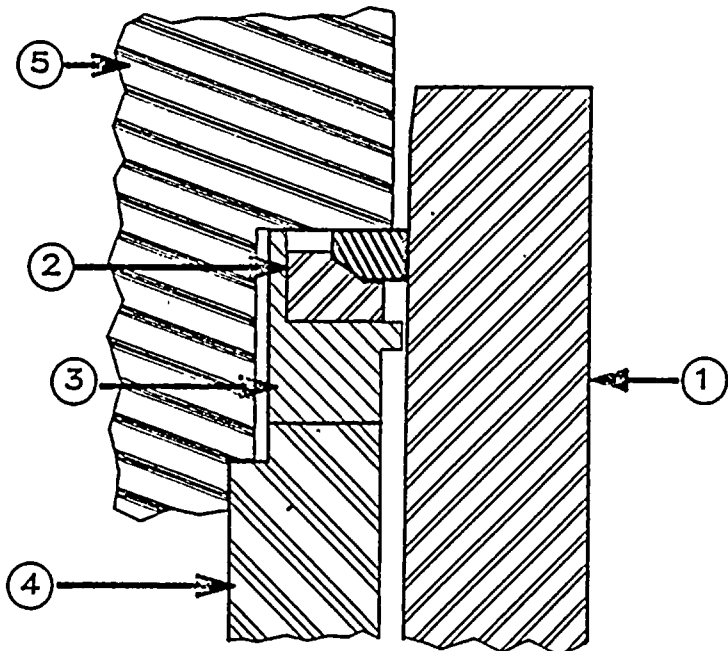
- 1) Corrosion products or other foreign material buildup on the sealing surfaces of the piston ring and valve while the valve is closed and there is no pressure differential across the piston ring. These corrosion products interfere with the seal ring forming the close tolerance, metal-to-metal seal, and allow excessive steam leakage past the piston ring.

- ① PLUG ASSEMBLY
- ② TWO-PIECE PISTON RING (NEW)
- ③ GUIDE BUSHING
- ④ DISK STACK
- ⑤ SPACER
