PALO VERDE NUCLEAR GENERATING STATION

UNITS 1, 2, AND 3

JUSTIFICATION FOR CONTINUED OPERATION
CONTROL ELEMENT ASSEMBLY (CEA) DROP EVENTS

REV. 3

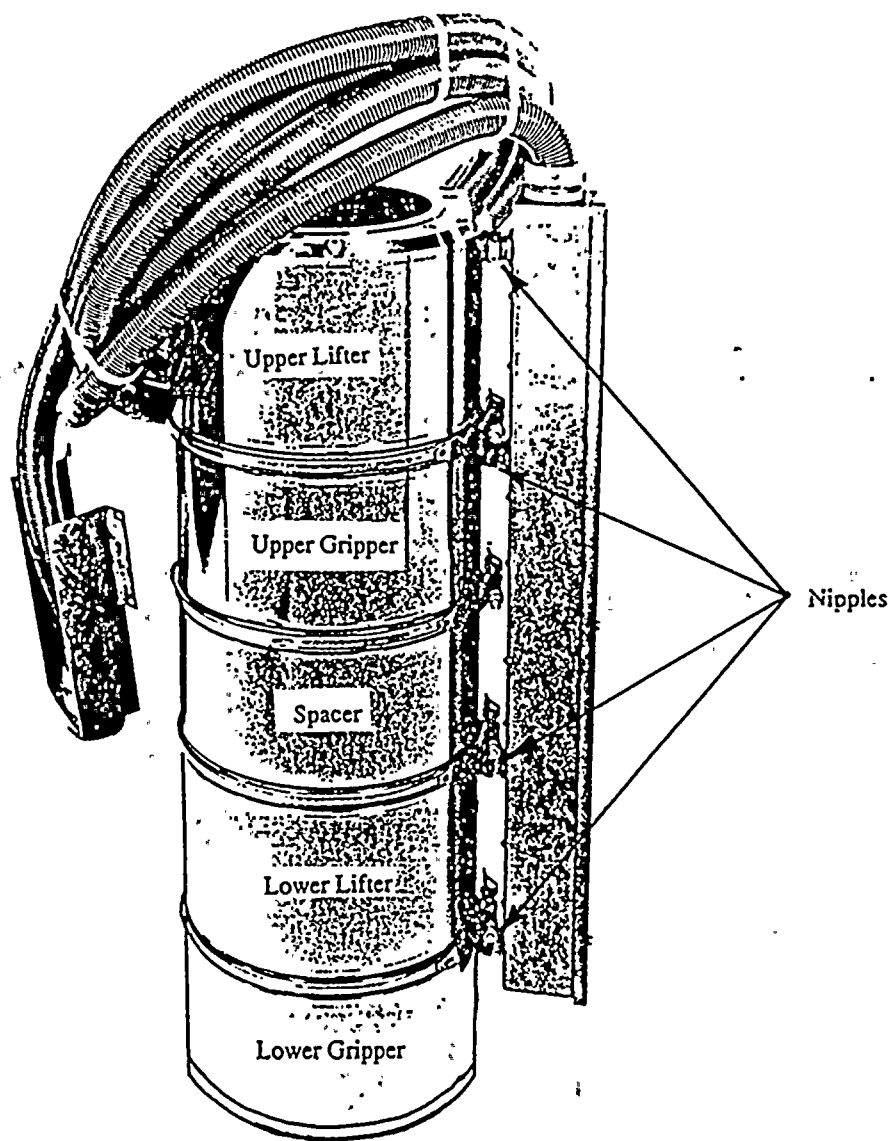
FIGURE 2 - COIL STACK ASSEMBLY

The coil stack for CEDM No. 33 was disassembled, examined, and evaluated at PVNGS by representatives of the Engineering Evaluations Department. During the examination, substantial damage was found in the area of the lower lift coil where the coil lead wires pass through the nipple assembly. The evaluation concluded that the ground fault associated with CEA No. 33 was the result of damage to the coil lead wires which was later found to have occurred during the assembly process (a manufacturing deficiency).

Two factors are believed to have contributed to the manufacturing deficiency becoming a pathway for a short to ground. The two factors are the observed motion of the lower lift coil leads and the orientation of the coil within its housing. These conditions combined to narrow the gap between the bare wire and the housing which allowed an intermittent ground fault, subsequent insulation deterioration over time, and subsequent arcing to the housing (nipple) assembly.

The coil stack for CEDM No. 19 was sent to C-E for an independent evaluation. During the evaluation, C-E identified damaged fiberglass sheathing and insulation on the coil leads. This was determined to be a manufacturing deficiency that occurred during the coil stack assembly process and the contributing factors outlined above.

- 2) All known defective coil stacks, identified during the previous cycle or refueling shutdown will be replaced prior to restart from refueling of the affected unit. This is expected to minimize potential sources of CEA slippage problems associated with ground faults.

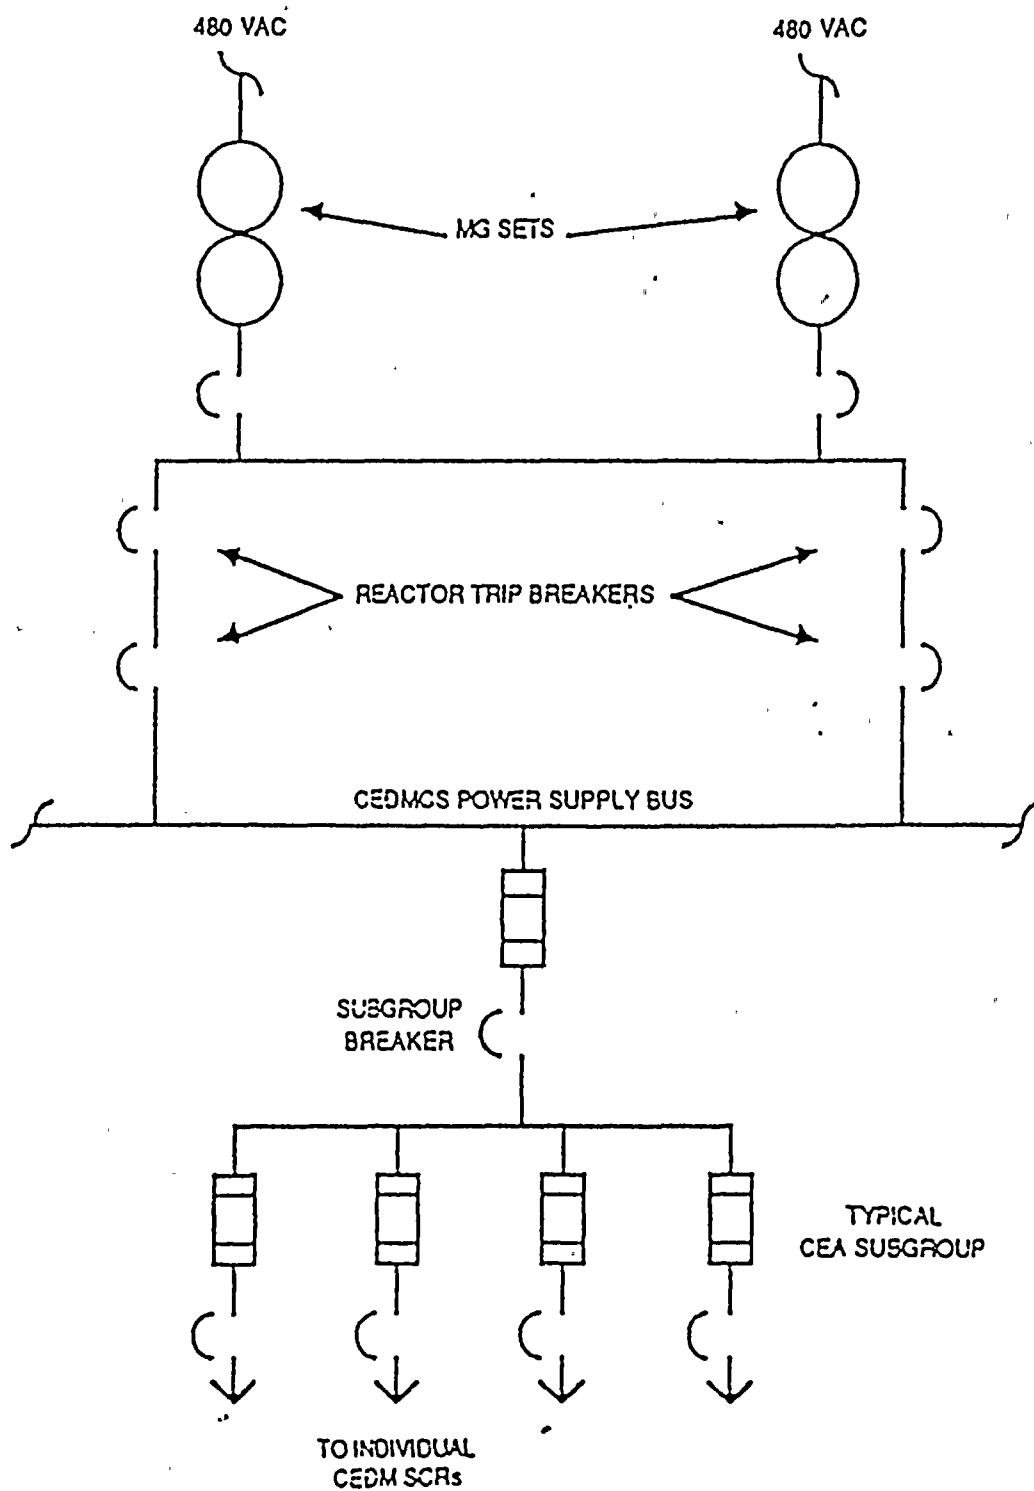
FIGURE 1 - CEDMCS POWER SUPPLY

The purpose of the CEDMCS is to provide the drive signals to the coils of the magnetic-jack Control Element Drive Mechanisms (CEDMs) which position and hold the individual Control Element Assemblies (CEAs). The CEDMCS controls the direction, rate, and duration of CEA motion in response to automatic or manual demands. The CEDMCS is a non-safety related control system. The safety function of the CEAs is to drop into the core when power is removed from the CEDMs. Power is removed from the CEDMs when the reactor trip breakers open in response to valid reactor protection signals. Refer to Appendix A, Figure 1 for a schematic of the power supply arrangement to the PVNGS CEDMCS.
