PALO VERDE NUCLEAR GENERATING STATION
UNIT 3 STEAM GENERATOR EDDY CURRENT EXAMINATION
1ST REFUELING OUTAGE
APRIL 1989

ARIZONA NUCLEAR POWER PROJECT
P. O. BOX 52034
PHOENIX, AZ 85072

UNIT 3 STEAM GENERATOR EDDY CURRENT EXAMINATION

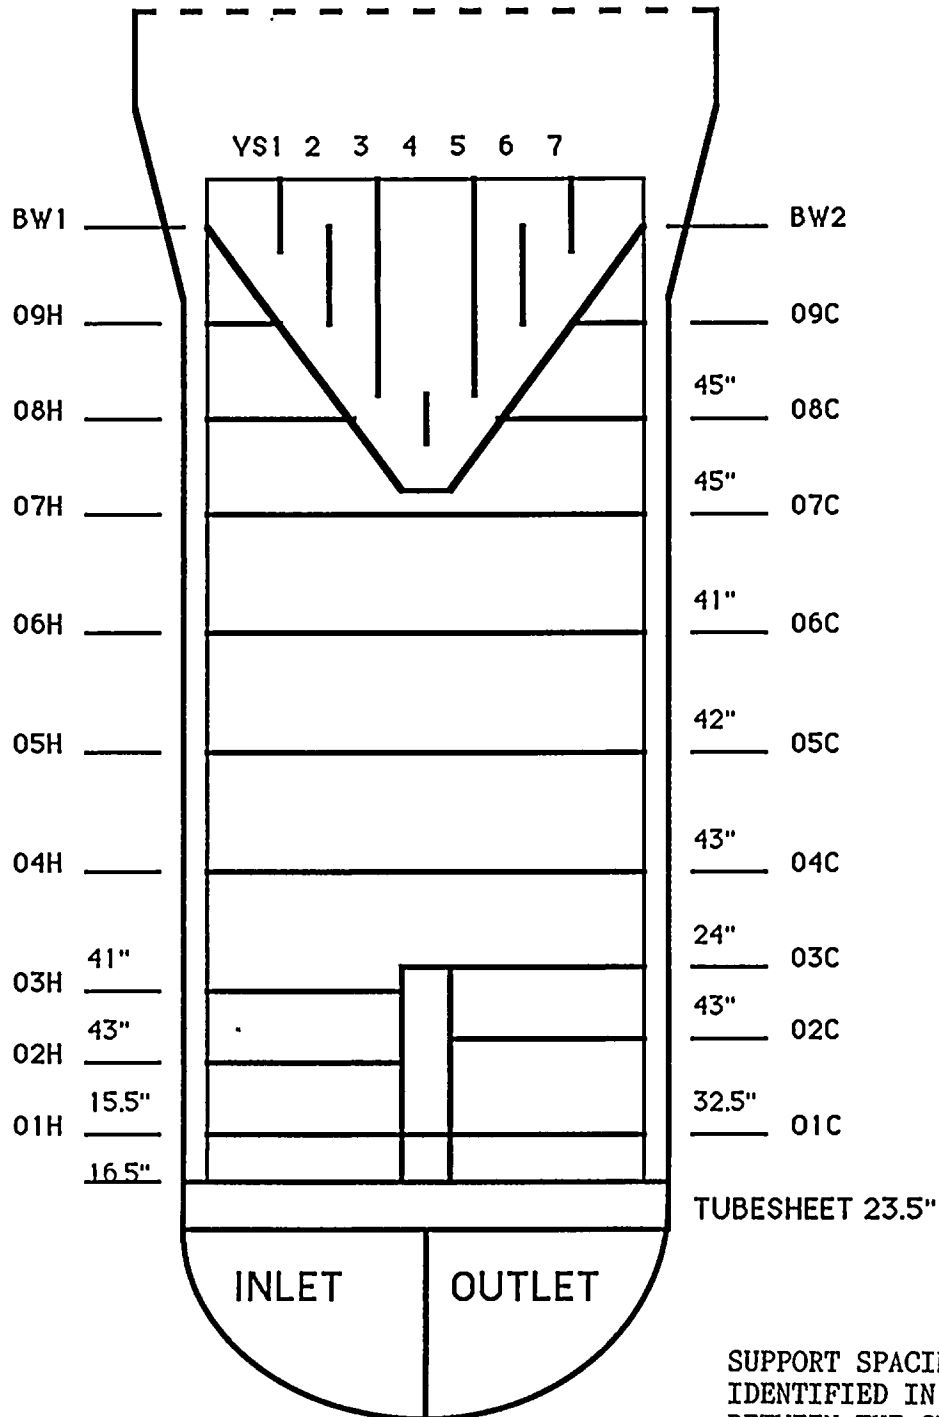
CE SYSTEM 80 STEAM GENERATOR TUBE SUPPORT DIAGRAM

Approximately 11,000 tubes were examined in each of the steam generators. The majority of tube degradations were observed in regions where vertical support straps intersect the tubing, (see Appendix A). The total numbers of degraded tubes for this region were 5 and 6, for steam generators 31 and 32, respectively. All indications at vertical support straps were compared with the preservice baseline examinations and while none of these tubes were defective, as defined by the Technical Specifications, those exhibiting indications with a potential for accelerated growth were plugged.

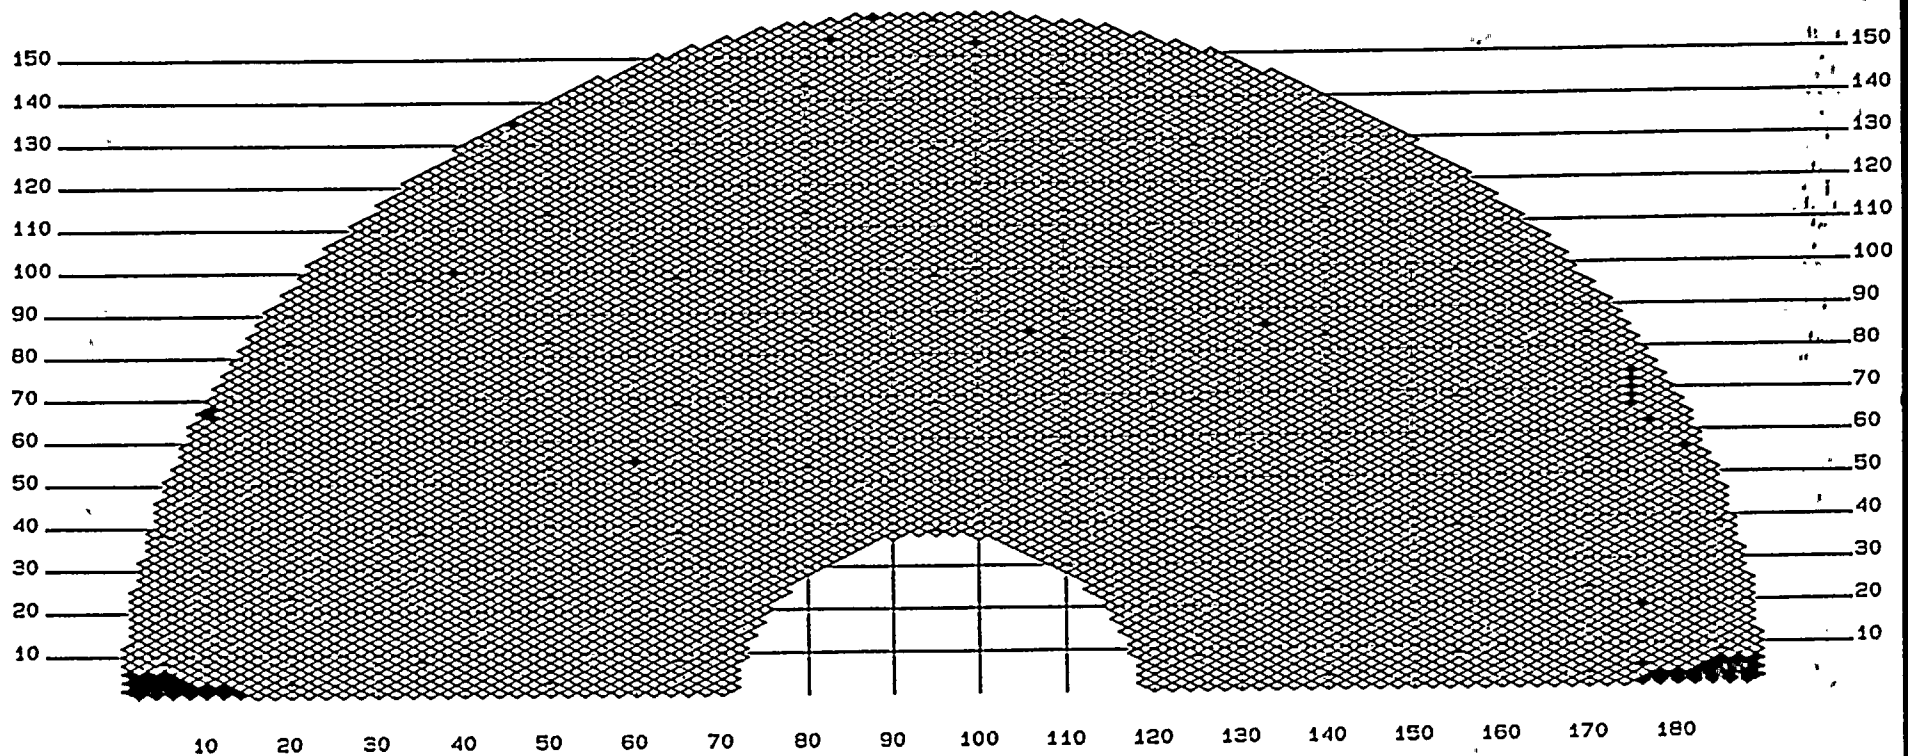
STEAM GENERATOR: 31

S/G 31: R67L10, R66L11, R68L11, R154L83, R159L88, R153L100, R86L133.
S/G 32: R49L06, R51L06, R50L07, R52L07, R99L106, R150L127, R100L151, R106L159, R91L170, R93L170

The examination resulted in plugging an additional 7 (seven) tubes in steam generator 31 and 10 (ten) tubes in steam generator 32. Combustion Engineering welded type plugs were used for all tube ends and Engineering Evaluation Requests numbers 89-RC-058 and 89-RC-059 were initiated to track the examination results and subsequent plugging. The tube sheet maps in Appendix C show the total tubes plugged in each steam generator to date. Appendix B contains the summary data sheets which list all tubes in each steam generator with thru-wall indications from 0-100% and possible loose parts (PLP). The NIS-1 form in Appendix D lists each of the tubes, by row and line, plugged as a result of this examination.
