Arizona Nuclear Power Project

NDE Summary Report

UNIT 1 STEAM GENERATOR EDDY CURRENT EXAMINATION

2ND REFUELING OUTAGE

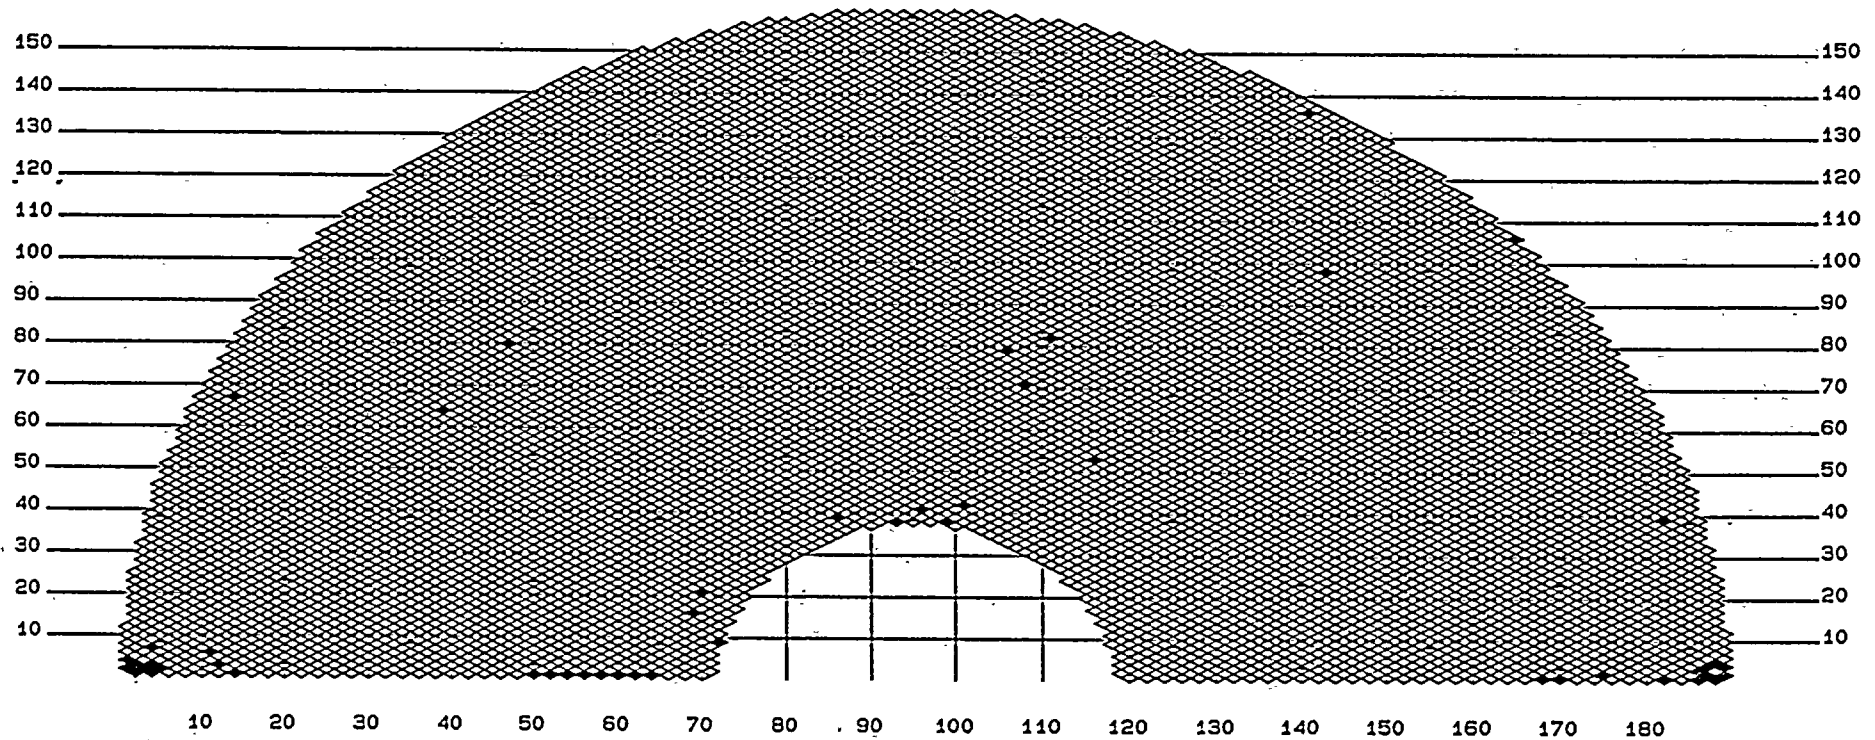
STEAM GENERATOR: 11

The examination resulted in plugging an additional twelve tubes in steam generator 11 and seven (plus one tube where a plug was installed in the wrong location) tubes in steam generator 12. The tubesheet maps in Appendix B show the total tubes plugged to date. Engineering Evaluation Request (EER) numbers 89-RC-173, 89-RC-174, 89-RC-179, and 89-RC-180 were initiated to track the examination results and subsequent plugging. The NIS-1 form in Appendix C lists each of the tubes, by row and line, plugged as a result of this examination.

S/G 11: R67 L14, R80 L47, R9 L72, R38 L93, R41 L96, R38 L99, R82 L111, R53 L116, R106 L165, R39 L182, R3 L186, and R136 L141
