REGULATORY INFORMATION DISTRIBUTION SYSTEM (RIDS)

SUBJECT: Responds to ltr re violations noted in Insp Repts
 50-528/89-36, 50-529/89-36 & 50-530/89-36.

Subject: Palo Verde Nuclear Generating Station (PVNGS)
Units 1, 2, and 3
Docket No. STN 50-528 (License No. NPF-41)
STN 50-529 (License No. NPF-51)
STN 50-530 (License No. NPF-74)
Reply to Notice of Violation - 50-528/89-36-01, 530/89-36-03,
529/89-36-01, and 530/89-36-01
File: 89-070-026

REPLY TO NOTICE OF VIOLATION 50-528/89-36-01

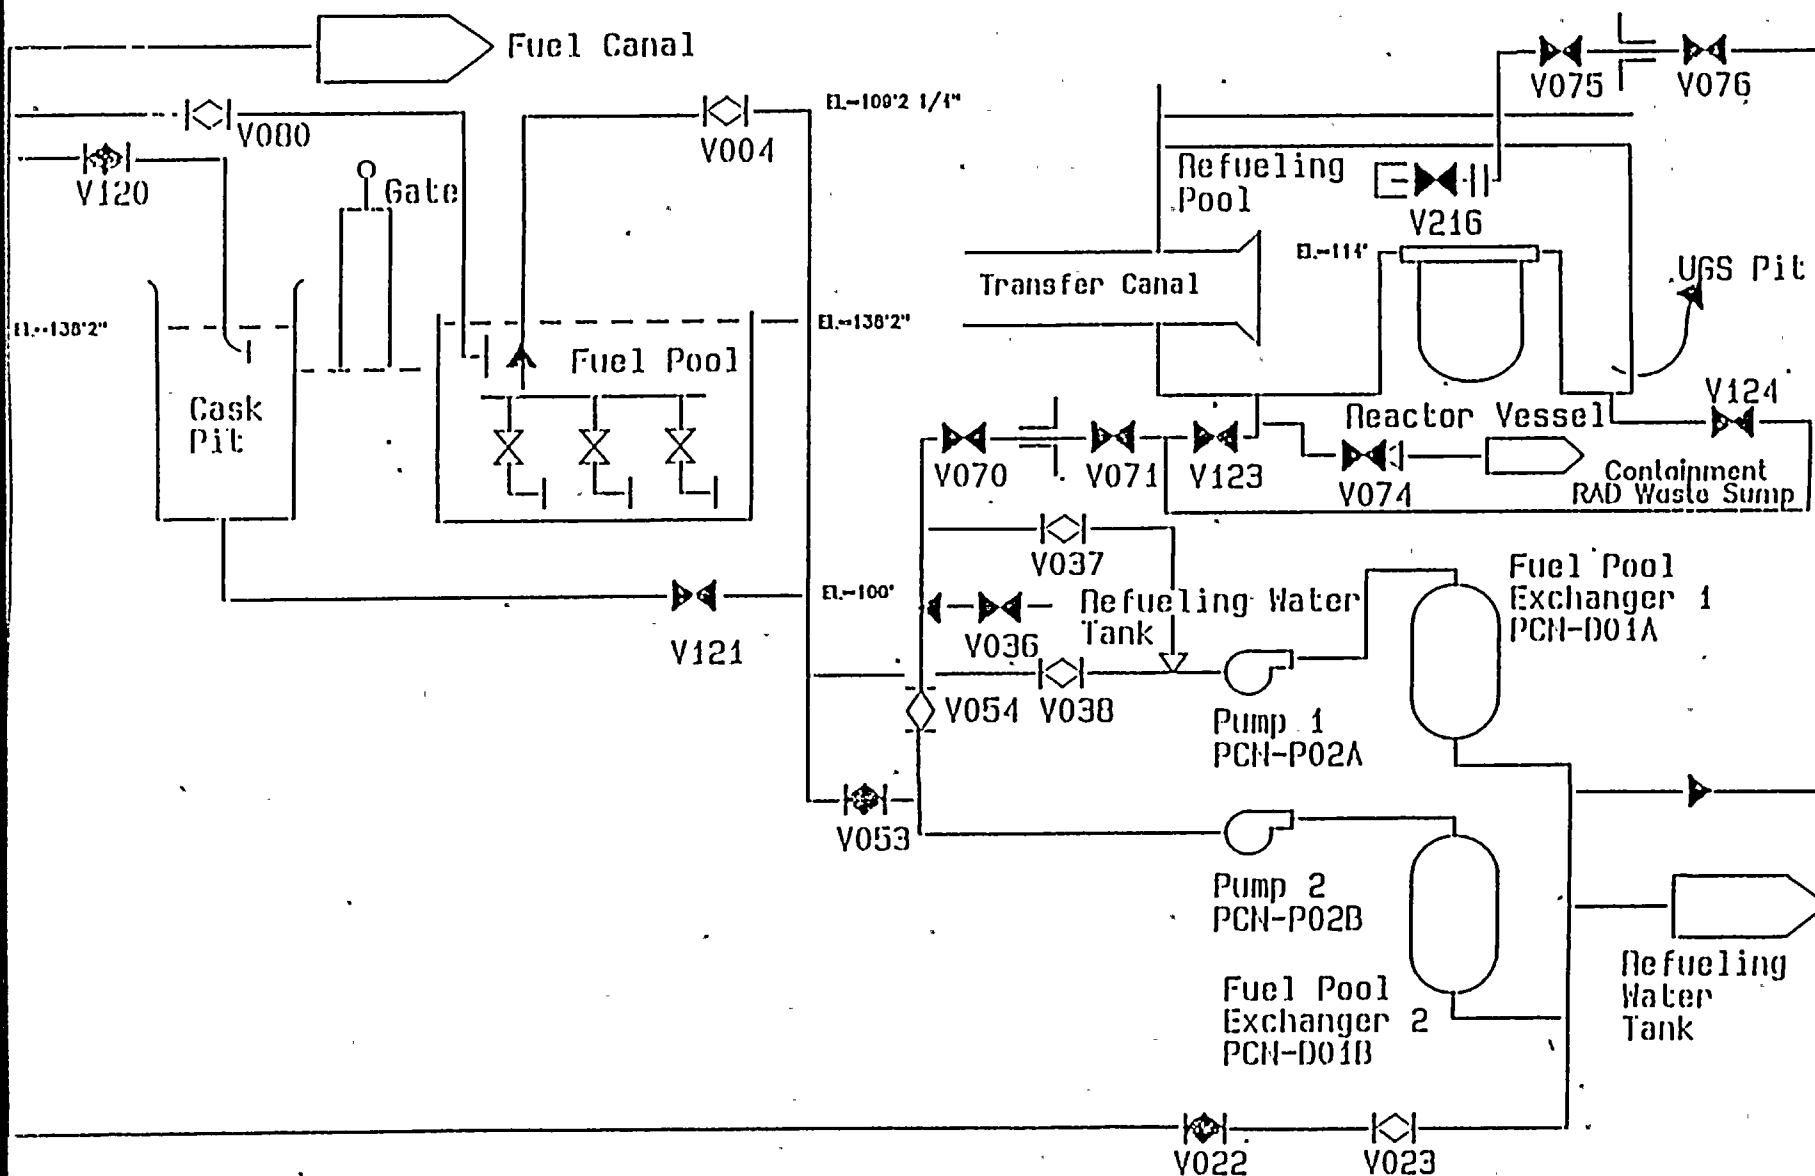
Simplified FUEL POOL CLEANUP SYSTEM

The flow path specified by the temporary valve lineup was from the Cask Pit through valves V121 (the controlling valve), V053, V054, V070, V071 and V123 into the Refueling Pool Transfer Canal (see attached simplified drawing). Note that valve V004 was not a part of the temporary lineup or the intended flow path.

The AOs were directed to position their respective valves in the required configuration with explicit instructions that valve V121 (the controlling valve) would be opened only when the containment valve lineup had been verified complete. At the completion of the valve lineup (with the exception of V121), the AO in the Fuel Building proceeded to the 100' level to await direction to open V121. The operators were unaware at this point that due to differences in elevation, an inadvertent gravity flow path had been established between the SFP and RPTC via the normally open SFP suction valve, V004.

Upon receipt of a "Fuel Pool and Refueling Pool Status Trouble" alarm and confirmation of an actual "LO-LO" level alarm locally in the Fuel Building, the AO was directed to shut valves V053 and V004. Upon closure of V053, the gravity drain flow was stopped. The level in the SFP was raised to the Technical Specification minimum level and the event was terminated.

Each valve within the planned flow path for the temporary valve lineup for the gravity drain evolution was actually verified in its correct position as required by the Night Order issued on May 25, 1989. As noted, valve V004 was intentionally not part of the valve lineup nor was it part of the desired flow path and was intentionally left open. Accordingly, the event did not involve violation of the Night Order which is the basis for the Notice of Violation. Nevertheless, the event should not have occurred and is of concern to APS management. The contributory causes to this event have been determined to be:

1. The failure by the Shift Supervisor to adequately consider all the potential gravity drain paths when planning the temporary lineup, specifically, path V004 through V053.
2. The independent review by the Assistant Shift Supervisor also failed to identify valve V004 as a potential gravity drain path.
3. The failure by the operators to monitor Spent Fuel Pool level

remotely prior to initiating the valve lineup.

4. Operating procedures did not provide guidance for the path selected by operations personnel or an alternate makeup path to the RPTC when the primary source, the Refueling Water Tank, is unavailable.

Based on the above, APS has determined the root cause of this event was that management did not ensure adequate proceduralized guidance in place to control the multiple flow paths in the Spent Fuel Pool Cleanup System for various types of evolutions.

A briefing plan which addresses the contributory causes has been developed for presentation by the Shift Supervisor of each Unit Operating crew which includes the following:

1. A description of the relative elevations between the spent fuel pool normal level, piping which extends below the spent fuel pool normal level, and their isolation valves illustrating where gravity flow is possible.

2. A summary description of this event:
3. An outline methodology for the sequence of conducting system alignments which emphasizes:
 - a. Identification of key parameters to be monitored during the alignment which would provide indications of undesired consequences and successful results.
 - b. Identification of expected conditions which could cause undesirable effects while changing the position of valves to the desired alignment.
 - c. Verification of desired position of all valves in branch paths as well as the desired flow path.

Operations Procedure 4xOP-xPC01, "Fuel Pool Cooling and Cleanup" is

being revised as separate procedures, each addressing a different mode of operation of the system which is normally used during refueling and power operation. These changes will provide better system control and more easily understood directions.
