SUBJECT: LER 89-024-00:on 891212,ESF actuation during reactor coolant  
 pump test.

Subject: Palo Verde Nuclear Generating Station (PVNGS)  
Unit 1  
Docket No. STN 50-528 (License No. NPF-41)  
Licensee Event Report 1-89-024-00  
File: 90-020-404

Engineered Safety Feature Actuation During Reactor Coolant Pump Test

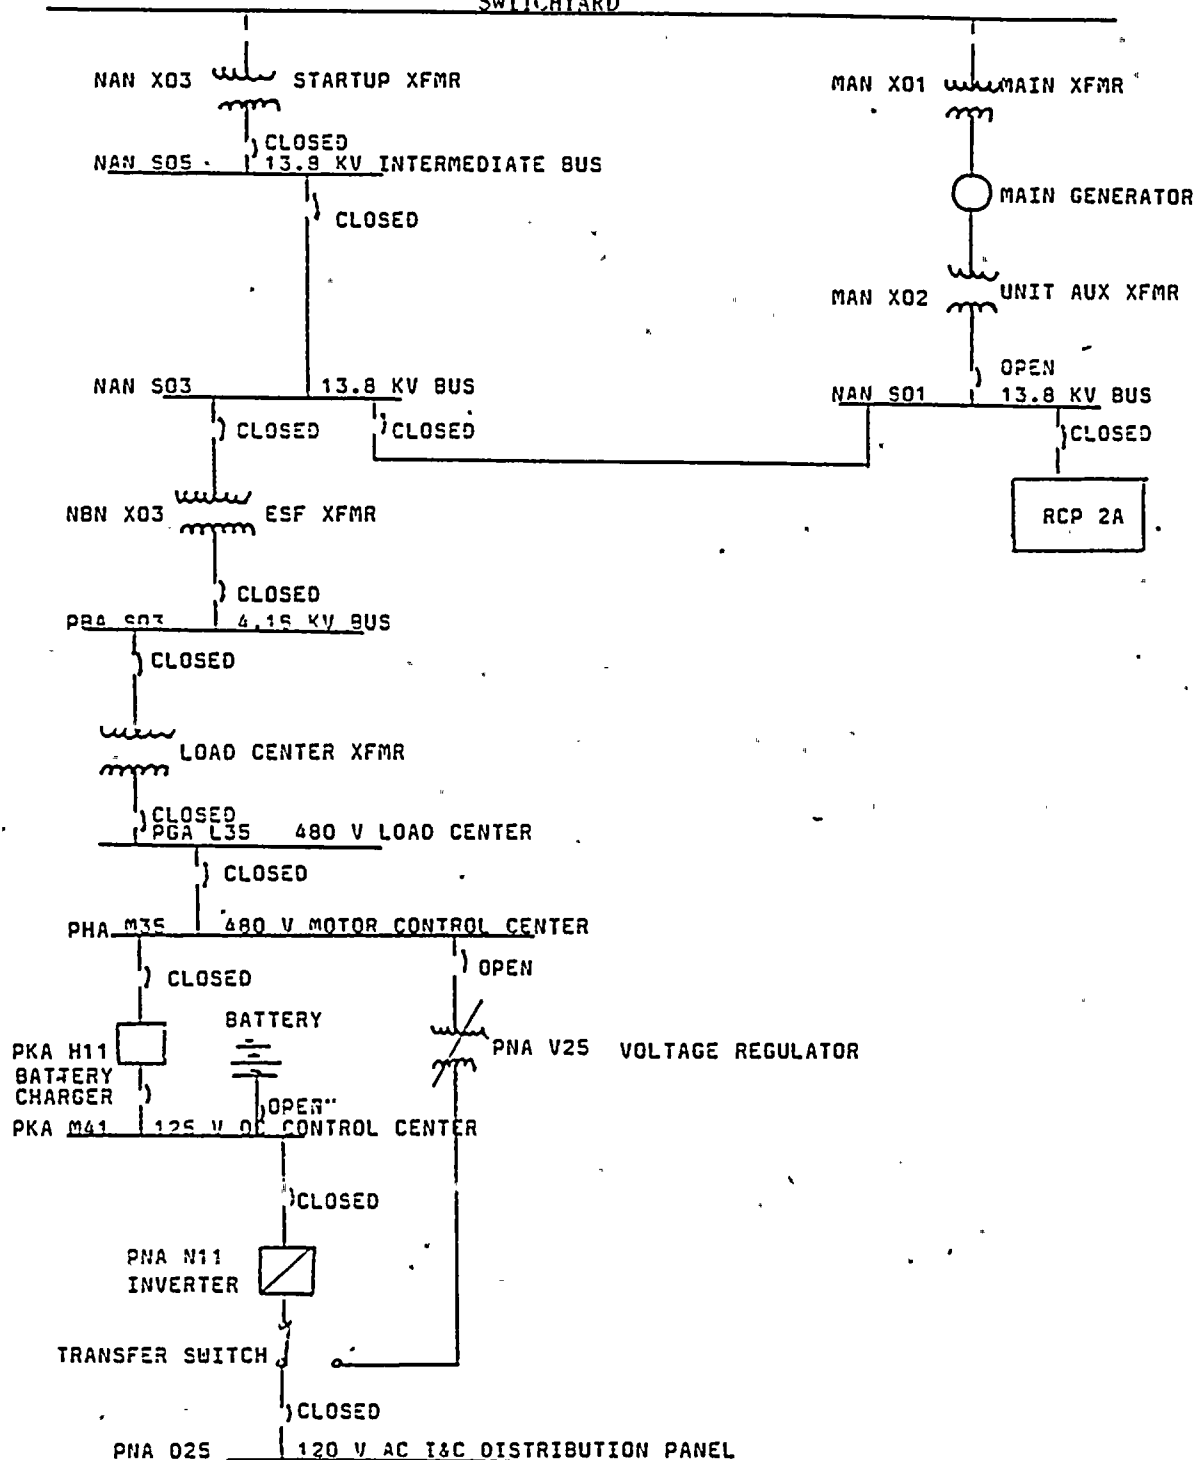
ATTACHMENT  
SWITCHYARD

Prior to the event on December 12, 1989 at approximately 0615 MST, the emergency power supply (the "A" class 1E battery (EI)(BTRY)) was disconnected from the 125 volt DC control center (EJ) in order to support outage work. The normal power supply to the 125 volt DC control center (battery charger (BYC)) remained connected. The battery charger was powered via the 480 volt AC Motor Control Center (ED), the 13.8 kv AC bus (BU) NAN-S03 (EA), and ultimately from the startup transformer (NAN-X03)(EA)(XFMR). (See attached sketch.)

The RCP 2A motor was powered from 13.8 kv AC bus NAN-S01 (EA). Since Unit 1 was not in operation, the 13.8 kv AC bus NAN-S01 was powered via the 13.8 kv AC bus NAN-S03 and from the startup transformer (NAN-X03). (See attached sketch.)

At approximately 1055 MST, RCP 2A motor was started causing a voltage perturbation in the AC electrical system. This perturbation propagated from the 13.8 kv busses (NAN-S01 & S03), through the ESF transformer (NBN-X03), the load center transformer, the battery charger (PKA-H11), the 125 VDC bus, and the 120 VAC inverter (PNA-N11), and finally to the 120 VAC distribution panel. This perturbation caused an undervoltage condition on the 120 volt AC instrument and control distribution panel (EF). The undervoltage condition on the 120 volt AC instrument and control distribution panel deenergized (tripped) the actuation relays for the containment purge effluent radiation monitor (RU-37)(IL), control building effluent radiation monitor (RU-29)(IL) and the fuel building area radiation monitor (RU-31)(IL) and initiated a CREFAS, FBEVAS, and CPIAS. Upon receipt of the CREFAS, the "B" train essential chiller (CHU)(KM), essential cooling water (CC) pump (P), and essential spray pond (BS) pump started. The "A" train essential chiller, essential cooling water, and essential spray pond systems were in service prior to the event.
