SUBJECT: LER 89-024-01:on 891212,ESF actuation during reactor coolant pump test.

Subject: Palo Verde Nuclear Generating Station (PVNGS)
Unit 1
Docket No. STN 50-528 (License No. NPF-41)
Licensee Event Report 1-89-024-01
File: 90-020-404

Engineered Safety Feature Actuation During Reactor Coolant Pump Test

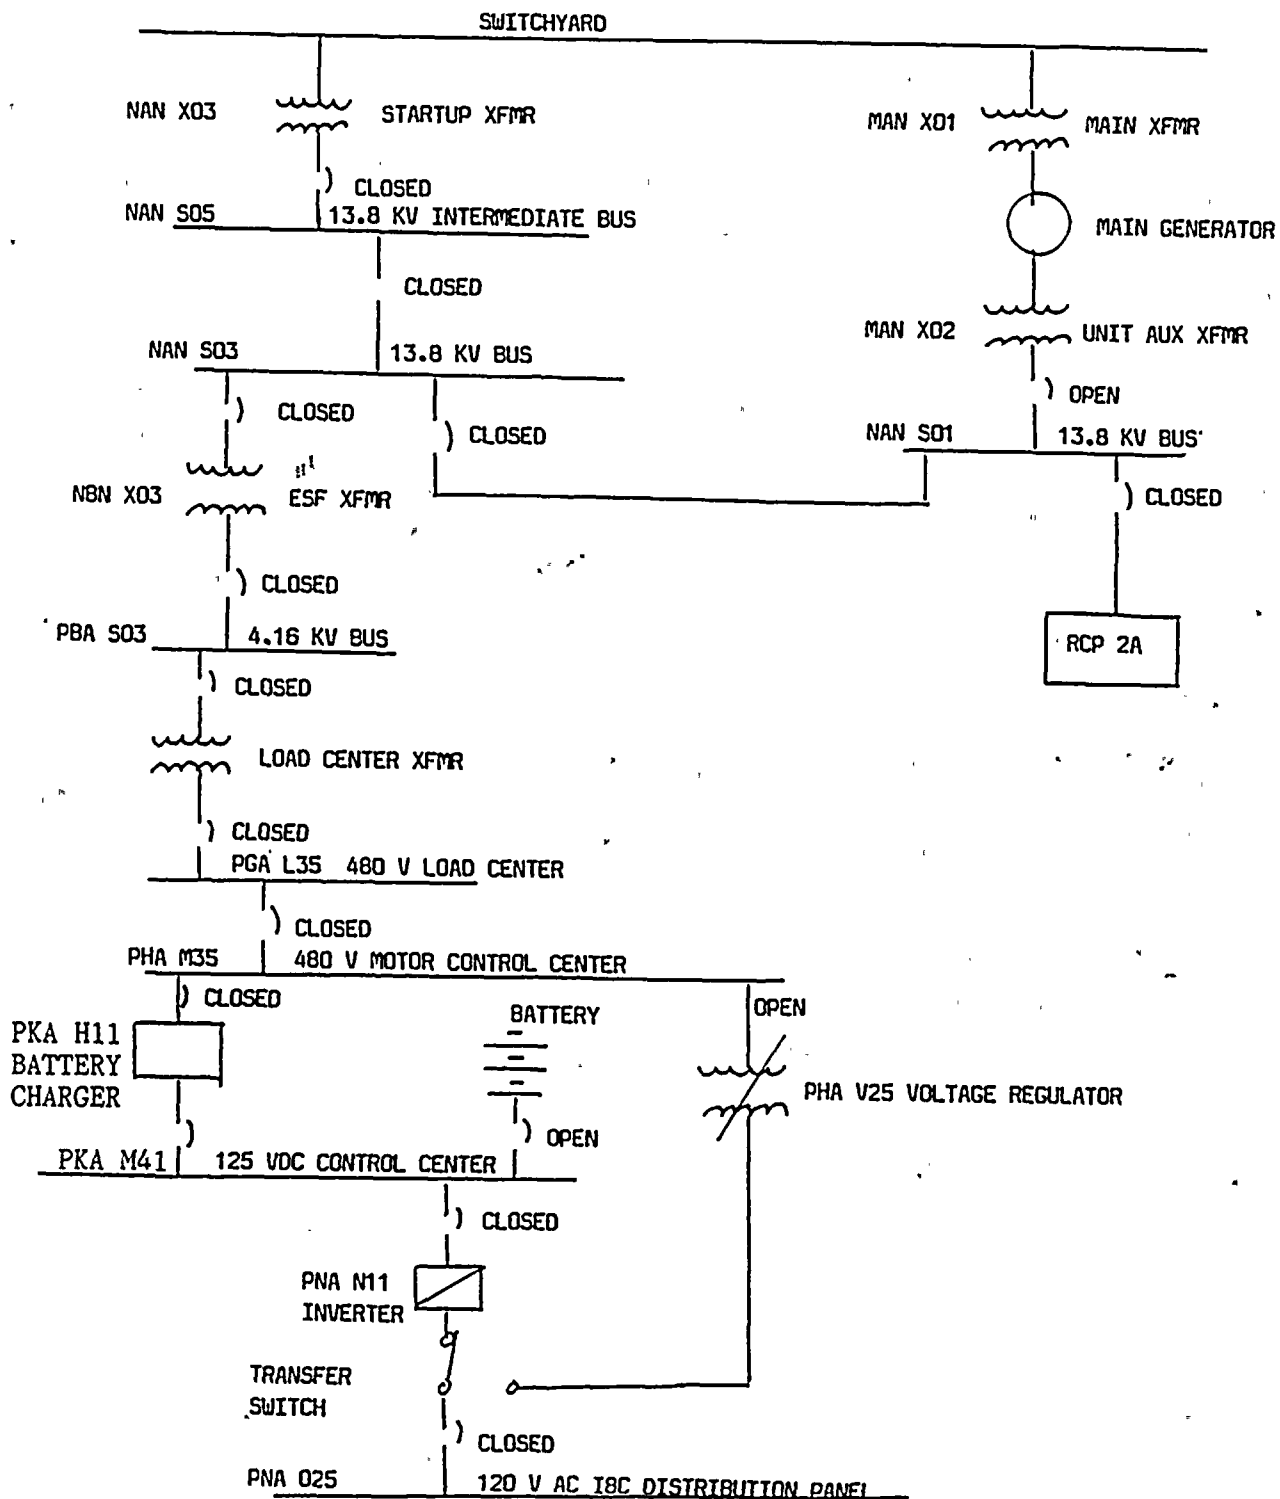
Prior to the event on December 12, 1989 at approximately 0615 MST, the emergency power supply (the "A" class 1E battery (EI)(BTRY)) was disconnected from the 125 volt DC control center (EJ) in order to support outage work. The normal power supply to the 125 volt DC control center (battery charger (BYC)) remained connected. The battery charger was powered via the 480 volt AC Motor Control Center (ED), the 13.8 kv AC bus (BU) NAN-S03 (EA), and ultimately from the startup transformer (NAN-X03)(EA)(XFMR). (See attached sketch.)

The RCP 2A motor was powered from 13.8 kv AC bus NAN-S01 (EA). Since Unit 1 was not in operation, the 13.8 kv AC bus NAN-S01 was powered via the 13.8 kv AC bus NAN-S03 and from the startup transformer (NAN-X03). (See attached sketch.)

At approximately 1055 MST, RCP 2A motor was started causing a voltage perturbation in the AC electrical system. This perturbation propagated from the 13.8 kv busses (NAN-S01 & S03), through the ESF transformer (NBN-X03), the load center transformer, the battery charger (PKA-H11), the 125 VDC bus, the 120 VAC inverter (PNA-N11), and finally to the 120 VAC distribution panel. This perturbation caused an undervoltage condition on the 120 volt AC instrument and control distribution panel (EF). The undervoltage condition on the 120 volt AC instrument and control distribution panel deenergized (tripped) the actuation relays for the containment purge effluent radiation monitor (RU-37)(IL), control building effluent radiation monitor (RU-29)(IL) and the fuel building area radiation monitor (RU-31)(IL) and initiated a CREFAS, FBEVAS, and CPIAS. Upon receipt of the CREFAS, the "B" train essential chiller (CHU)(KM), essential cooling water (CC) pump (P), and essential spray pond (BS) pump started. The "A" train essential chiller, essential cooling water, and essential spray pond systems were in service prior to the event.

On January 5, 1990, voltage data from the 480 volt AC system to the battery charger and voltage regulator, the battery charger to the 125 volt DC distribution panel, the inverter to the 120 volt AC instrumentation and control distribution, and the voltage regulator to the 120 volt instrumentation and control distribution panel were recorded during the reperformance of the RCP 2A uncoupled impeller motor run. Evaluation of the recorded data indicated that the 480 volt AC system voltage decreased to approximately 424 VAC during the initial current surge when the RCP motor was started. This 424 VAC input to the battery charger was less than the 432 VAC minimum input voltage specification for the battery charger. The lower input voltage (424 VAC) to the battery charger resulted in a decrease in the output of the battery charger from a normal 130 VDC to approximately 96 VDC.

The 96 VDC output of the battery charger was below the minimum 105 VDC input to the inverter, therefore the inverter automatically shutdown. The inverter shutdown deenergized the 120 VAC instrumentation and control distribution panel which supplies power to the radiation monitor actuation relays. When the battery charger voltage recovered, the inverter automatically started.

The RCP operating procedures have been revised to include precautions on the possible power interruption to the instrument and control distribution panel if any 1E battery is disconnected from the DC distribution panel. Circulating water pump operating procedures will have a precaution added to warn of possible power interruption to the instrument and control distribution panel if any 1E battery is disconnected from the DC distribution panel. This should be completed by March 31, 1990.
