REGULATORY INFORMATION DISTRIBUTION SYSTEM (RIDS)

SUBJECT: LER 92-004-00: on 920619, Unit 2 & Unit 3 loss of power ESFAS.
 Caused by moisture intrusion in sliced section of one of
 Phase A cables. Phase A cable A respliced & megged.
 W/920716 ltr.

LICENSEE EVENT REPORT (LER)

TITLE (4) Unit 2 and Unit 3 Loss of Power (LOP) ESFAS

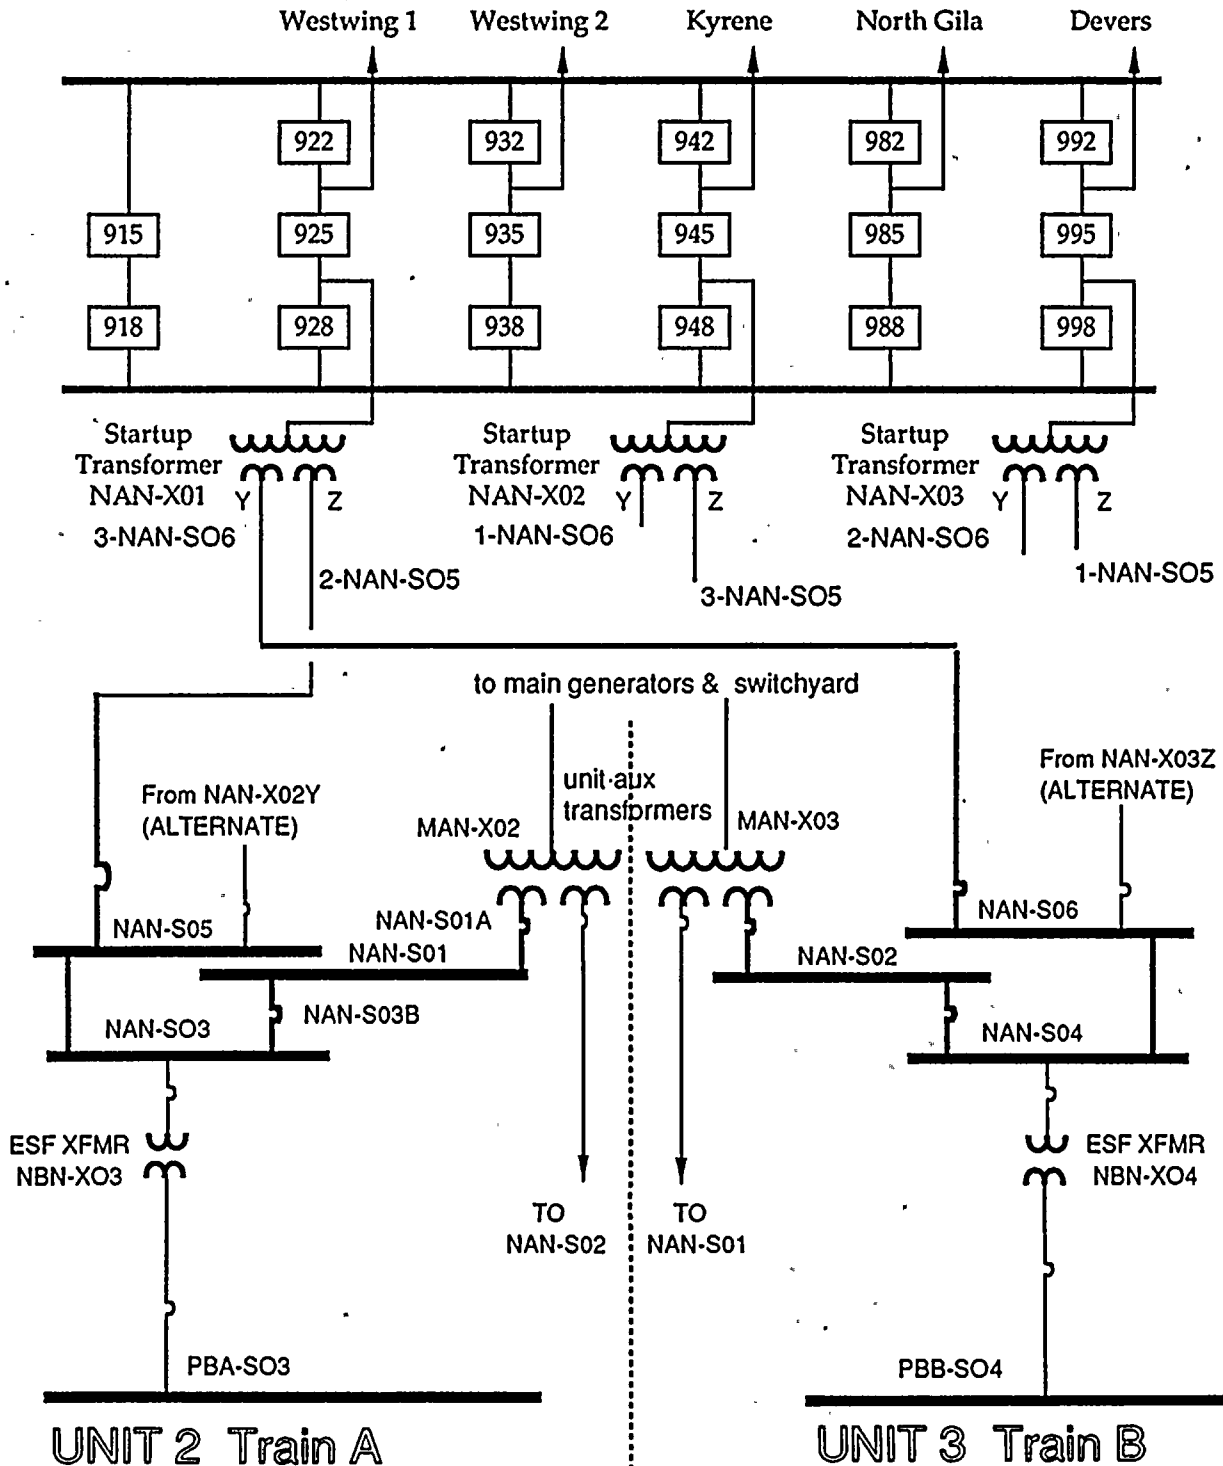
Immediately prior to the LOP ESFAS actuations, Startup Transformer (NAN-X01) (EA)(XFMR) phase winding ground differential trip alarms (ALM) came into the Units 1, 2, and 3 Control Rooms (NA). The NAN-X01 breakers 925 and 928 were observed to be open, indicating that the source of the fault current (i.e., NAN-X01) had been isolated. [NOTE: see the figure on page 8.]

Unit 2's Train A non-Class 1E 13.8 kV Switchgear Buses (NAN-S03 and NAN-S05) were deenergized as a result of the NAN-X01 breakers 925 and 928 opening. This resulted in the loss of offsite power to the Train A 4.16 kV Class 1E bus (PBA-S03) and a Train A LOP ESFAS actuation. The ESF signal automatically load shed the Train A Class 1E bus and started the Train A Emergency Diesel Generator (EDG). The Train A EDG started and assumed the loads as designed. Unit 2 Control Room personnel (utility, licensed) entered Technical Specification Limiting Condition for Operation (TS LCO)

The NAN-X01 breakers 925 and 928 opening also deenergized Unit 3's Train B non-Class 1E 13.8 kV Switchgear Buses (NAN-S04 and NAN-S06). This resulted in the loss of offsite power to the Train B 4.16 kV Class 1E bus (PBB-S04) and a Train B LOP ESFAS actuation. The ESF signal automatically load shed the Train B Class 1E bus and started the Train B EDG. The Train B EDG started and assumed the loads as designed. The Unit 3 Control Room personnel (utility, licensed) entered TS LCO 3.8.1.1 ACTION a when one circuit from the switchyard to the onsite Class 1E distribution system was declared inoperable.

related fault was due to a phase-to ground fault on a Phase A cable. The Phase A cable minimum acceptable insulation resistance was low when megged, and the Phase B and C cables megged within the acceptance range. There was no indication of a phase-to-phase fault. The fault was discovered at a spliced section in the cable located within a manhole between NAN-X01 and Unit 3's Train B non-Class 1E 13.8 kV Switchgear Bus (NAN-S06).

The investigation determined that moisture intrusion occurred in a spliced section of one of the Phase A cables located within a manhole between NAN-X01 and Unit 3's Train B non-Class 1E 13.8 kV Switchgear Bus (NAN-S06), resulting in a phase-to-ground fault on Phase A and a current differential between Phase A and Phases B and C. This resulted in the actuation of the transformer phase winding ground differential trip.

[NOTE: Startup Transformer NAN-X01 normally supplies offsite power to the Unit 2 Train A non-Class 1E 13.8 kV Switchgear Buses (NAN-S03 and NAN-S05) from the Z winding, and to the Unit 3 Train B non-Class 1E 13.8 kV Switchgear Buses (NAN-S04 and NAN-S06) from the Y winding.]

The cable fault resulted in the Unit 2 non-Class 1E 13.8 kV Intermediate Switchgear Bus NAN-S05 and Unit 3 non-Class 1E 13.8 kV Intermediate Switchgear Bus NAN-S06 experiencing a zero sequence voltage, and neutral amperage (amp) increasing on the 525 kV and the 13.8 kV Y winding sides of NAN-X01. At approximately 0520 MST, the 525 KV switchyard (FK) circuit breakers PL925 and PL928 opened and isolated NAN-X01. This was immediately followed by the opening of Unit 3's Train B non-Class 1E 13.8 kV Intermediate Switchgear Bus NAN-S06 normal supply breaker NAN-S06C (resulting in a loss of power to Unit 3's NAN-S06 and NAN-S04) and Unit 2's Train A non-Class 1E 13.8 kV Intermediate Switchgear Bus NAN-S05 normal supply breaker NAN-S05D (resulting in a loss of power to Unit 2's NAN-S03 and NAN-S05).

A visual inspection of the Phase A cable disclosed physical damage (i.e., burn marks). The Phase A cable was respliced and megged.

During the next NAN-X01 outage, APS Engineering will perform additional testing to determine if other cables were inadequately spliced. APS regards this to be an isolated event and that had the cable been spliced appropriately, this event would not have occurred. Therefore, no additional action is being taken.
