Subject: R. E. Ginna Nuclear Power Plant
Docket No. 50-244
SEP Topics III-3.A, II-3.A, II-3.B, II-3.B.1
& II-3.C

Response to NRC Correspondence on SEP Topics
III-3.A (3/24/81) and II-3.A, II-3.B, II-3.B.1 & II-3.C (4/10/81)

SUBJECT: Trip Report Concerning Stone Revetment at R.E. GINNA Nuclear Generating Plant

R.E. GINNA NUCLEAR GENERATING PLANT
GEOTECHNICAL APPENDIX

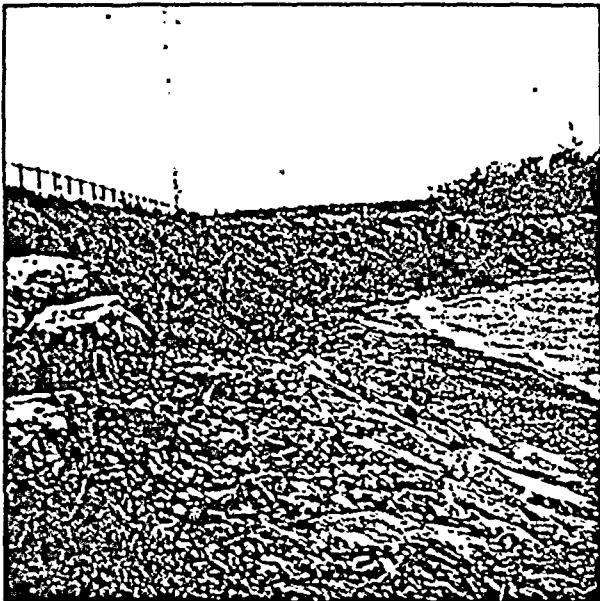
WEST END OF WEST REVETMENT -
LOOKING WEST. NOTE SMALL STONE
FILL OBSCURING TOP ARMOR STONES.

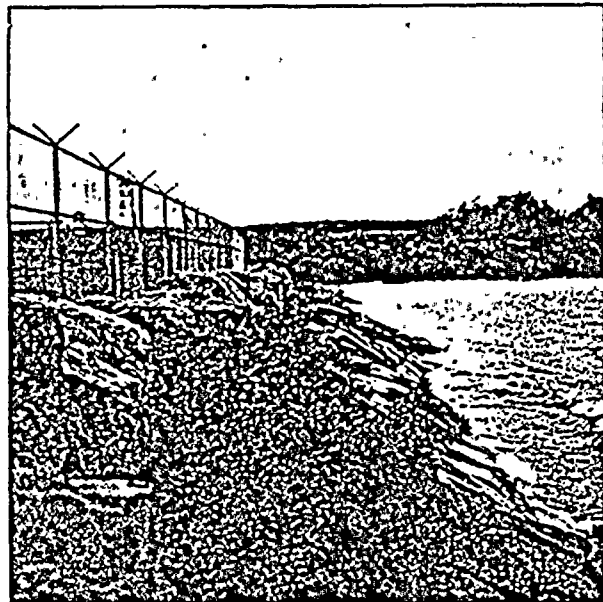
NEAR CENTER OF WEST REVETMENT -
LOOKING WEST. NOTE LAID-UP REVETMENT
ON RIGHT AND CAP STONES ON LEFT.

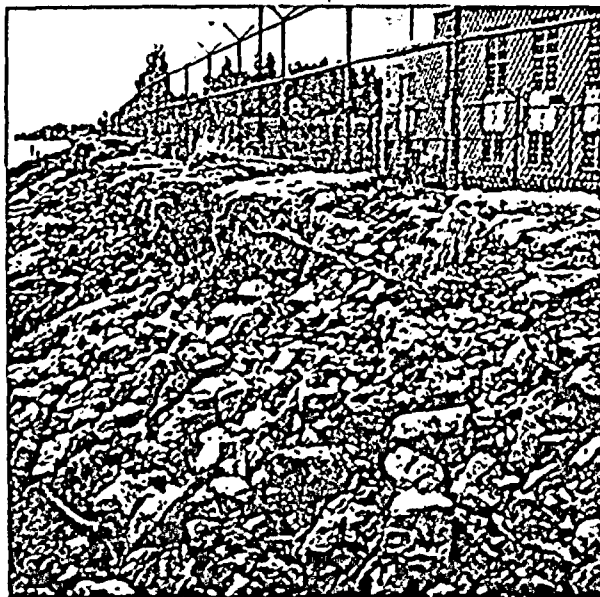
WEST REVETMENT NEAR EAST END -
LOOKING EAST. NOTE SMALL STONE
FILL OBSCURING TOP ARMOR STONES.
SCREEN HOUSE IS AT RIGHT.

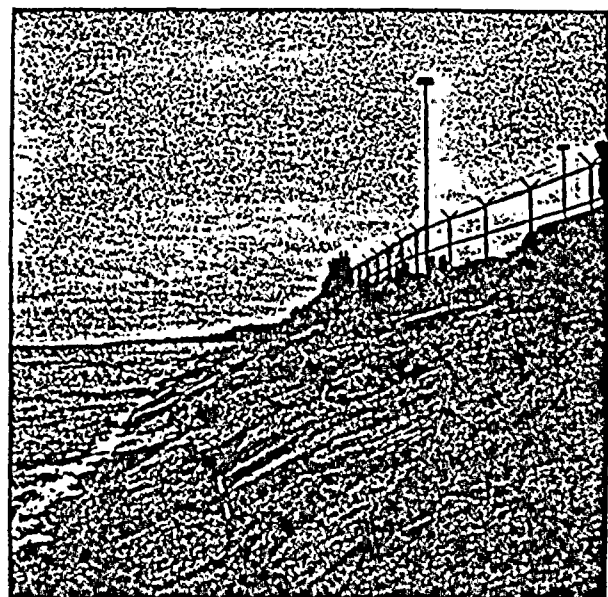
ENCLOSURE E
WEST REVETMENT NEAR EAST END.
LOOKING EAST. NOTE LAID-UP REVETMENT.

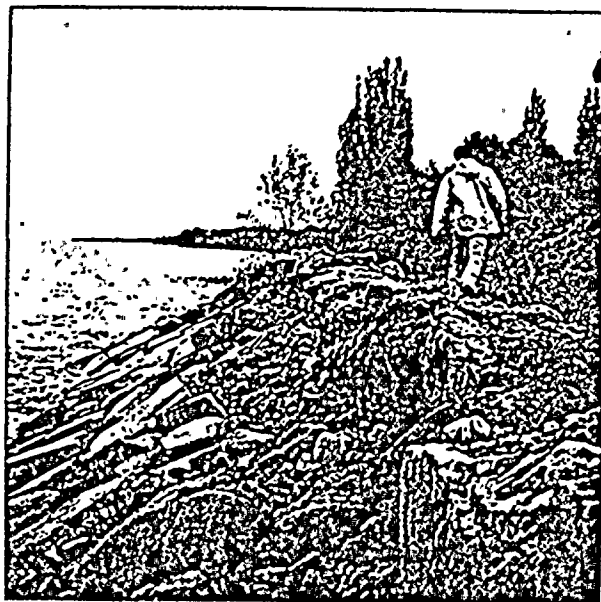
EAST REVETMENT NEAR EAST END - LOOKING EAST. NOTE SMALL STONE FILL OBSCURING TOP ARMOR STONES LAID UP REVETMENT @ LEFT, CAP STONES @ RT.

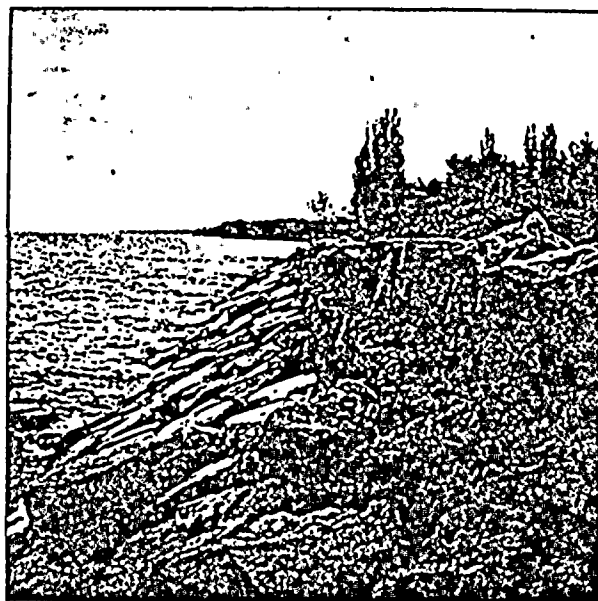
ENCLOSURE F
EAST REVETMENT - LOOKING EAST, NEAR EAST END. NOTE LAID-UP REVETMENT, ROW

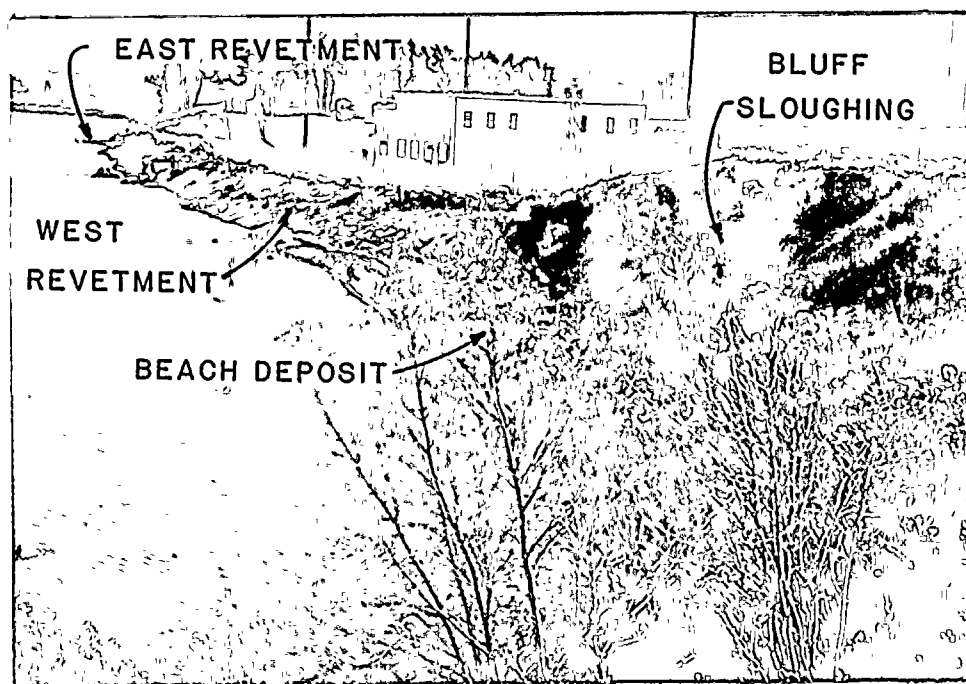
(b) Bluff Stability. Failure scarps in soil are present in the bluffs both updrift and downdrift of the West and East Revetment (Photographs 1, 2 and 4). At the terminus of the West Revetment the scarps are within several feet of the perimeter fence. Recession rates of the bluffs appear to be only slight to moderate.

Photograph 1 - East and West Revetments with adjacent bluff at right (looking east).

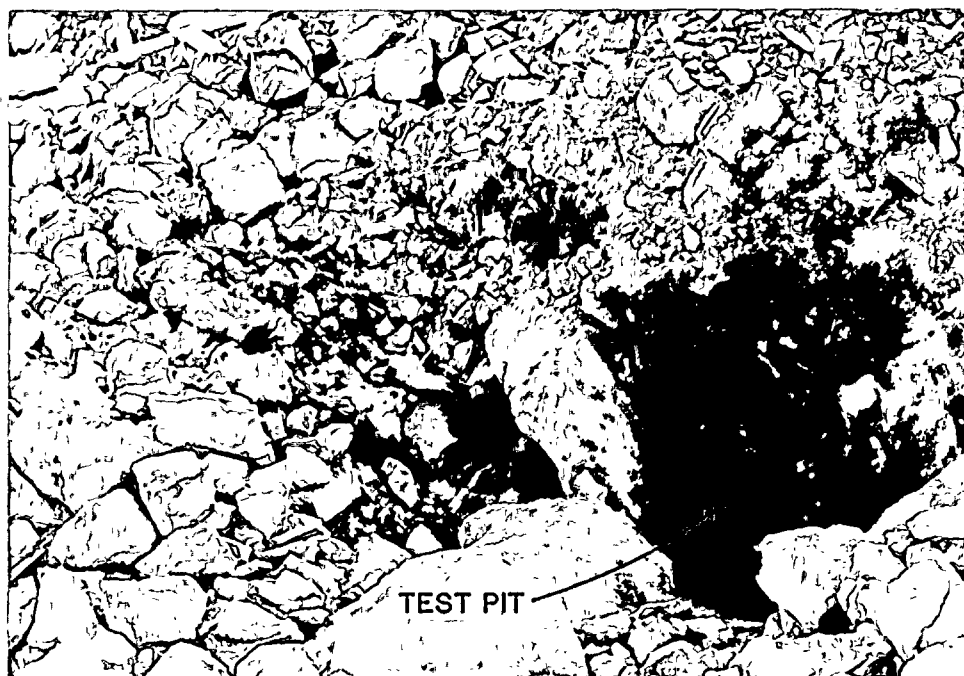
b. Test Pits. Two test pits were excavated near the west end of the West Revetment to verify the presence of armor stone beneath an obscuring layer of 4 to 9-inch stone.

Photograph 9 - Test Pit in West Revetment revealing continuity of armor stone.

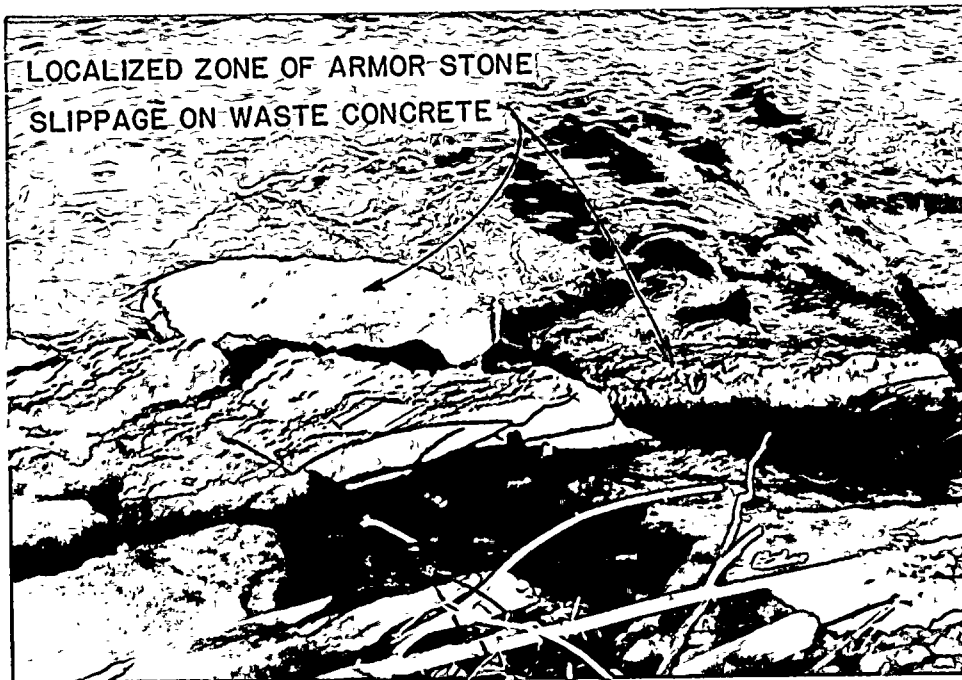
A second anomaly is a localized zone of slippage on the West Revetment. A few armor stones have migrated down the slope on waste concrete placed during construction (Photograph 11). The stones have displaced down the slope several feet in some cases resulting in a minor loss of rock to rock contact.

No signs of significant distress were observed. The only indication of structural instability is the slight displacement of armor stone (second anomaly). This poses no serious threat to the integrity of the West Revetment. There was no evidence of loss of fines from the underlying revetment zones due to the effects of wave action. No significant displacements of armor, toe or cap stone were evident, implying that adequate structural stability exists in the zone beneath the armor layers.

Figure 11 - Localized slippage of armor stones in West Revetment.

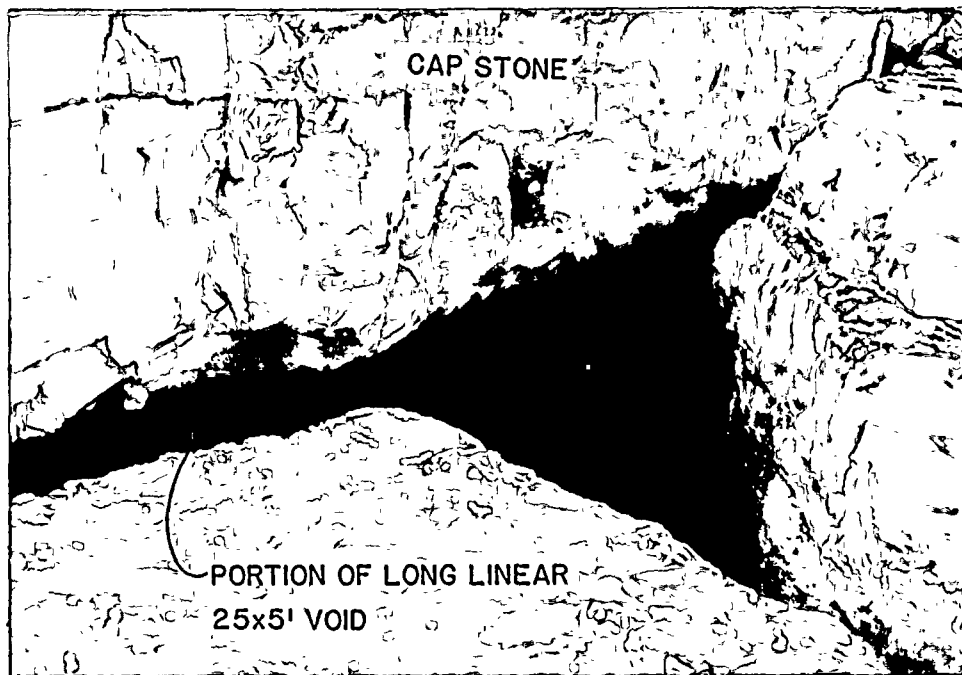
A third anomaly is located on the East Revetment. A rather long linear void (about 25 X 5 feet) is present directly under the cap stones (Photographs 12, 13, and 14). The void is located some 100 feet from the west end of the revetment. The utility stated that the void was a construction oversight; i.e., the void was present at end of construction. This appears to be the case; there was no evidence to indicate removal of fines from the interior of the revetment. Also, there was no distress in the overlying cap stone.

Photograph 13 - Closeup of long void in East Revetment beneath cap stones.

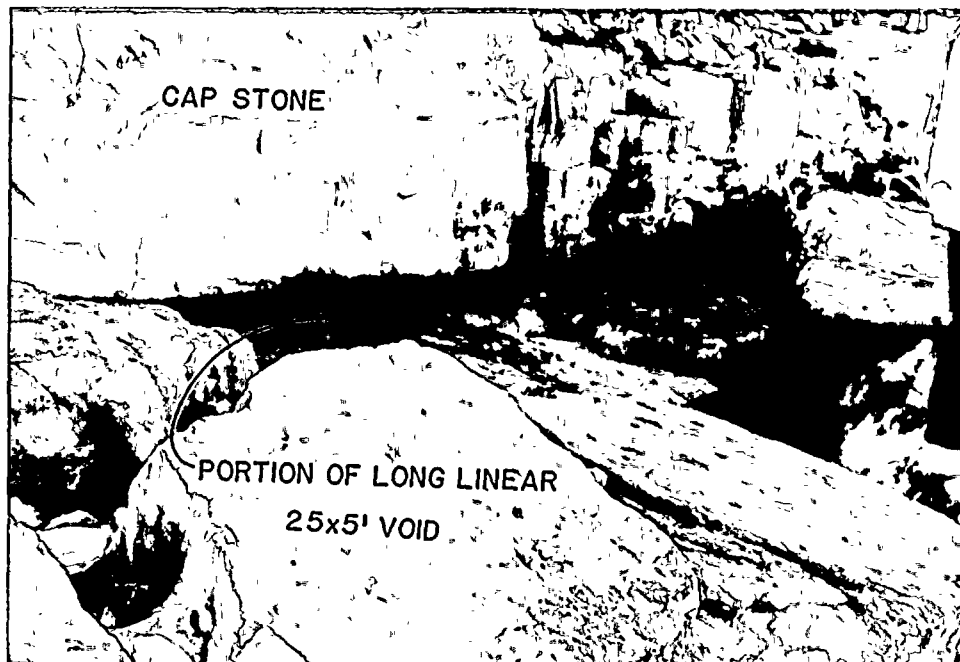
Photograph 14 - Closeup of long void in East Revetment beneath cap stones.

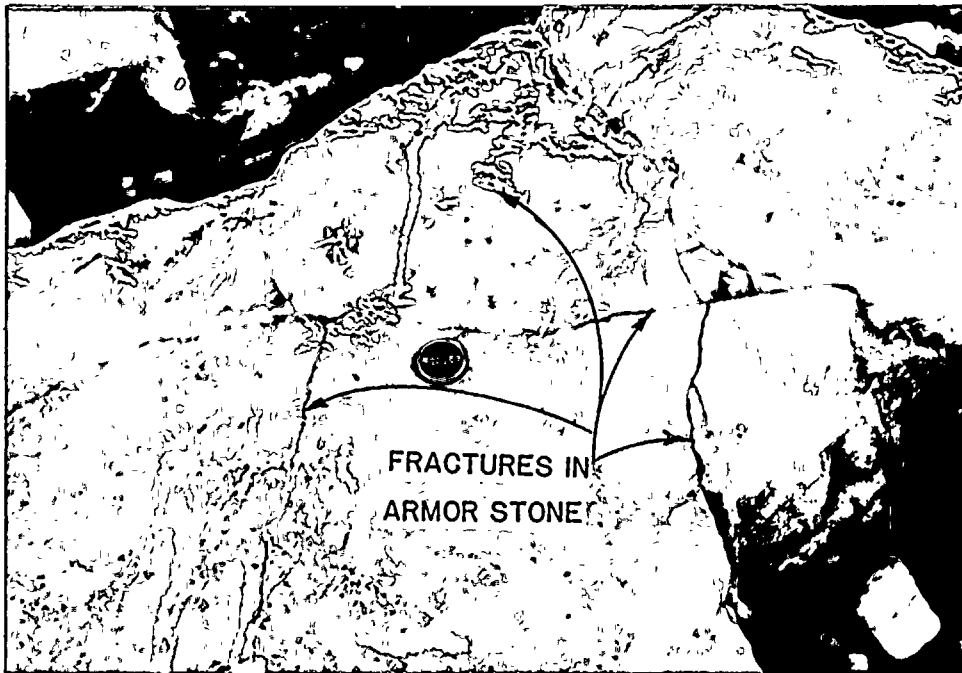
(a) Armor Stone Layers. Over most of the West and East Revetments the armor stone has good rock to rock contact with only a minimum amount of voids (Photographs 5, 6, and 7). The armor face is relatively uniform; the slope has good to excellent penetration at the water line (Photographs 5 and 7). The second layer of armor stone can be seen at numerous inspection points (voids - see Photograph 8). The outer layer of armor stone contains a fairly high amount of cracked stones. Although no counts were made, about one-third or more of the stones contained fractures that penetrate the interior of the stones (Photographs 15 and 16).

Photograph 15 - Typical fractures in armor stone.

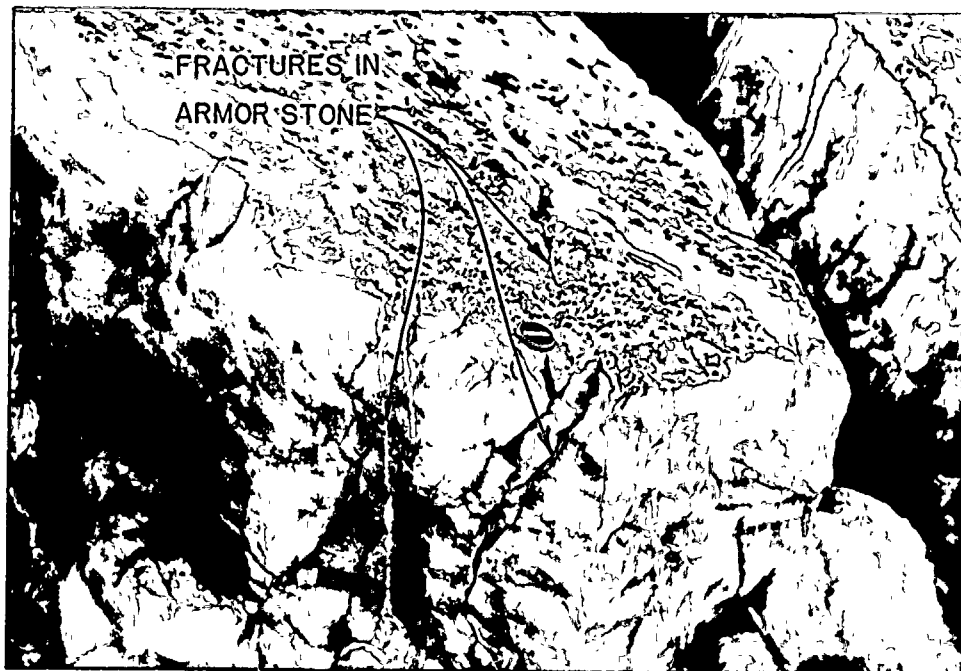
Photograph 16 - Typical fractures in armor stone.

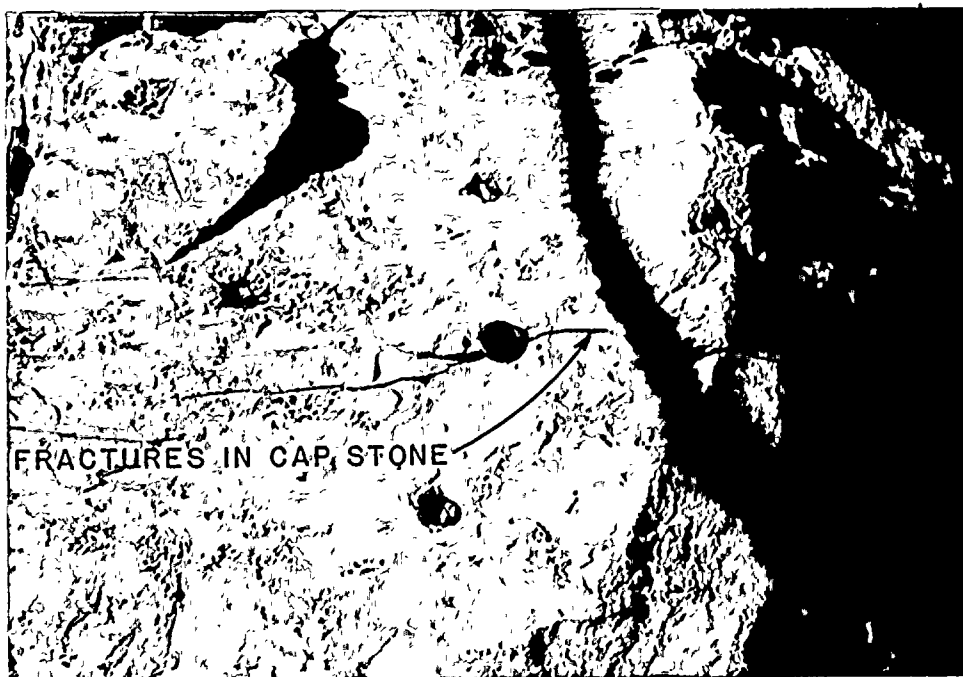
(b) Cap Stone Layer. A row of cap stones were placed at the original revetment crest for added protection. The stones appear fairly uniform in alignment and show no signs of distress that would be indicative of settlement or migration of armor stone down the slope (Photographs 2, 5, 6, and 7). The cap stone layer contains a very high percentage of cracked stones. Although no counts were taken, the vast majority of the stones contained fractures that penetrate the interior of the stones (Photographs 17 and 18).

'Photograph 17 - Typical fractures in cap stone.
