DEPARTMENT OF THE ARMY
BUFFALO DISTRICT, CORPS OF ENGINEERS
1776 NIAGARA STREET
BUFFALO, NEW YORK 14207

SUBJECT: R.E. GINNA Nuclear Generating Plant, Town of Ontario, NY

2. This letter report presents the results, conclusions, and recommendations arising from inspections of the engineering and operational aspects of the existing stone revetment along the lakeshore on Lake Ontario at the R.E. GINNA Nuclear Generating Plant.

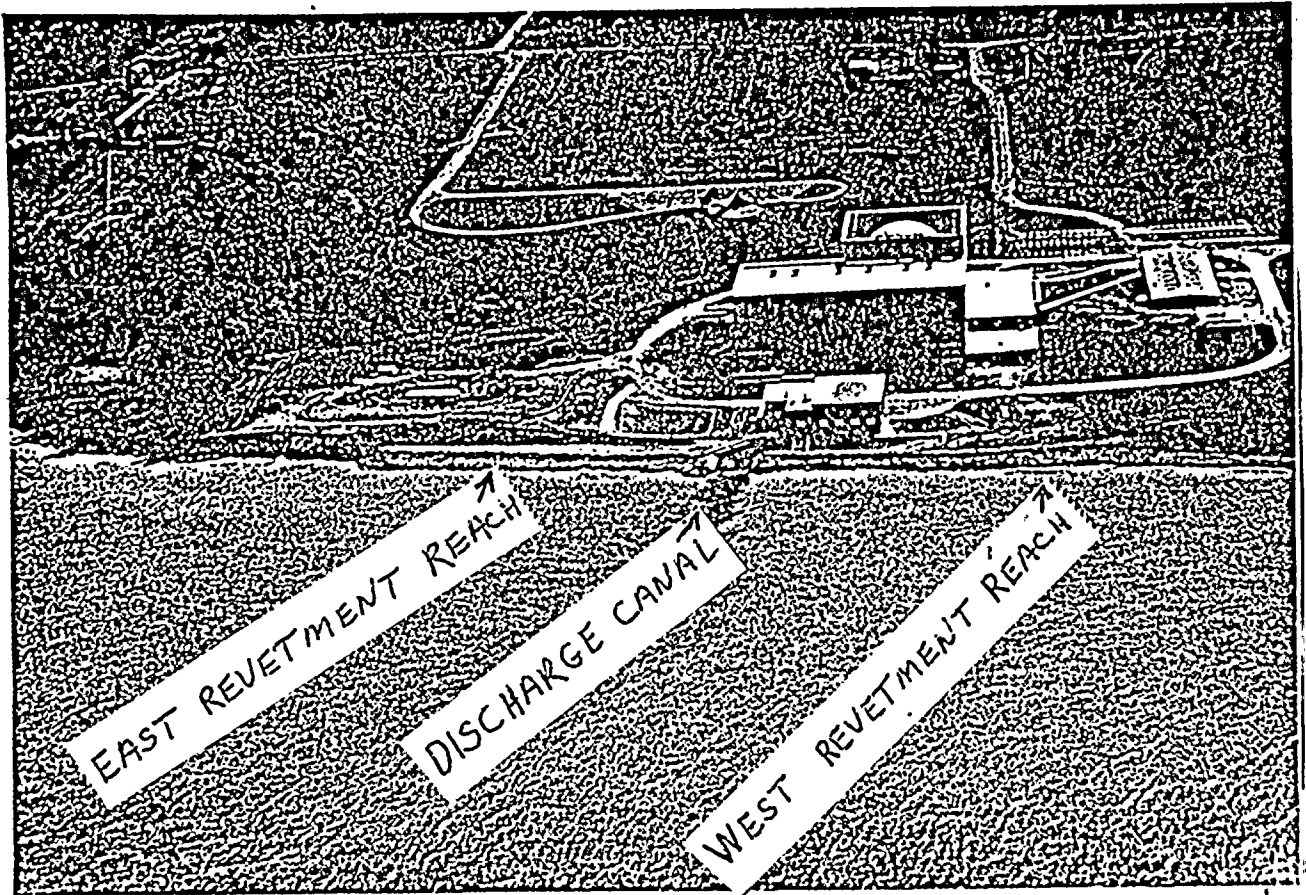
PLATE 1

6. The stone revetment was constructed in two reaches: an estimated 420-foot long west reach and an estimated 400-foot long east reach. The east and west stone revetment reaches are separated by a 20-foot wide discharge canal from the generating plant (see Plates 1 and 2). According to Section A-A and Section B-B on Drawing No. 33013-51E Reference 1f), the stone revetment was initially constructed in the 1960's with two layers of 5-ton minimum armor stones laid up on a 1.0 vertical on 1.5 horizontal sideslope to a minimum elevation of 257.0 (msl). Due to the high lake levels that were predicted for Lake Ontario during the early 1970's, the crest elevation of the revetment was raised to a minimum of 261.0 (msl) by placement of cap stone along the top of the revetment. Typical cross-sections of the east and west reaches of the stone revetment are shown on Plates 3 and 4.

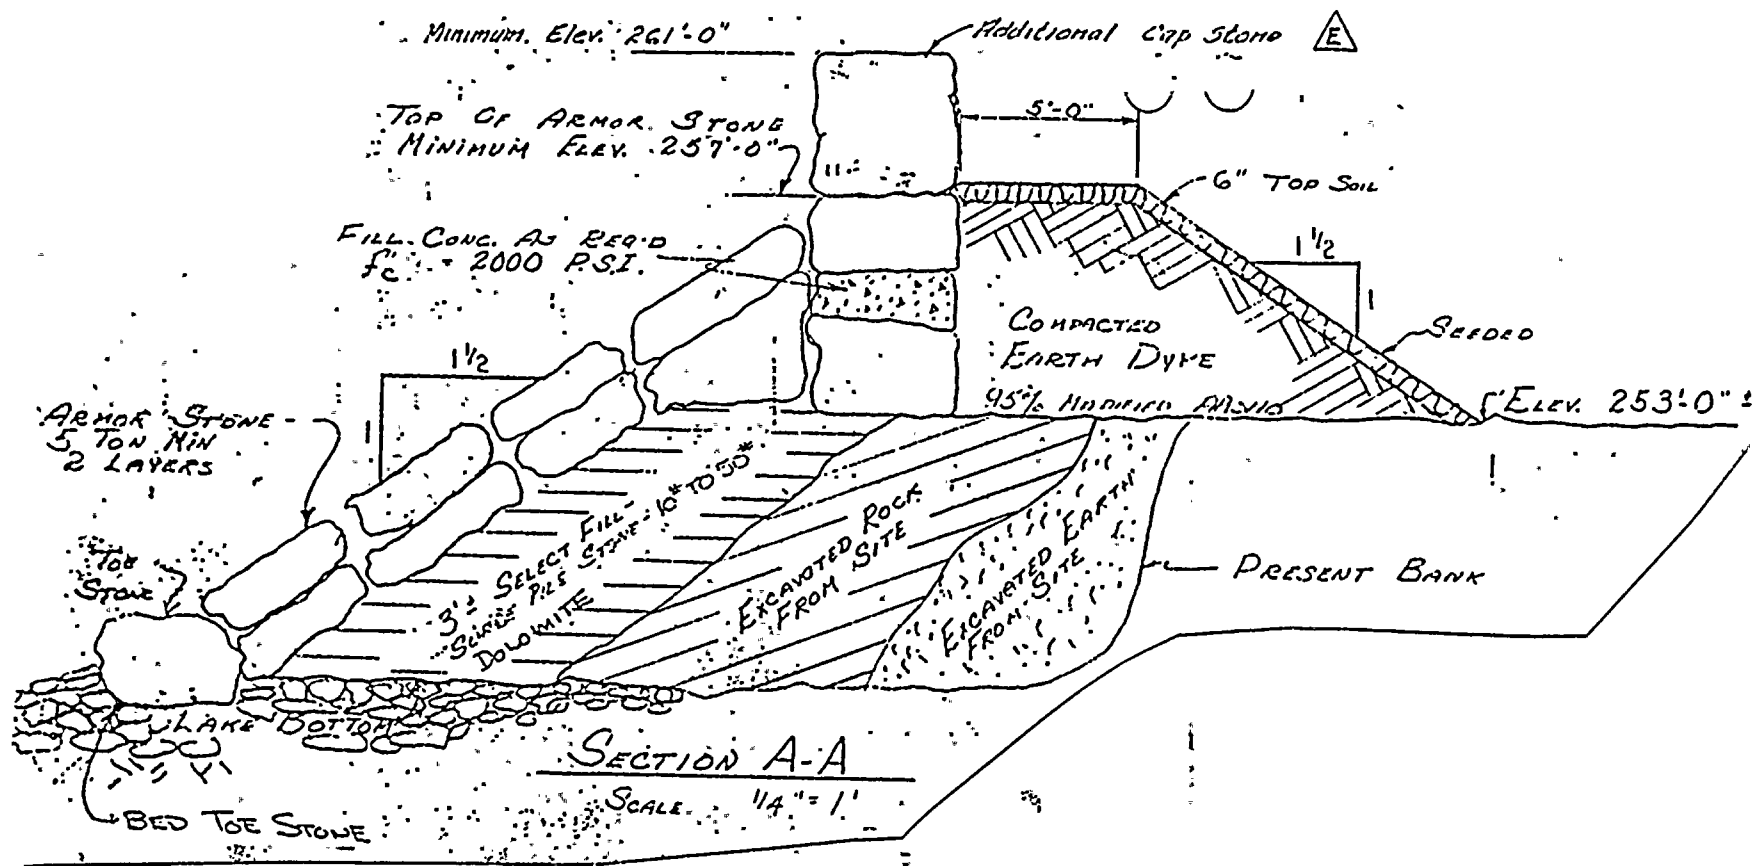
TYPICAL SECTION - EAST REVETMENT REACH

14. The large void on the east revetment reach which was observed during the 21 October 1981 inspection was reexamined during the 13 November 1981 inspection. The void is about 100 feet east of the west end of the east revetment and extends for about 25 to 30 feet directly under the cap stones which bridge the void with little rock-to-rock contact over the void. This void is apparently due to a construction oversight not a structural failure.

18. The east side of the revetment is in excellent condition, however, the large void should be filled with concrete or large enough stone such that they will not pass through the voids in the armor layer.

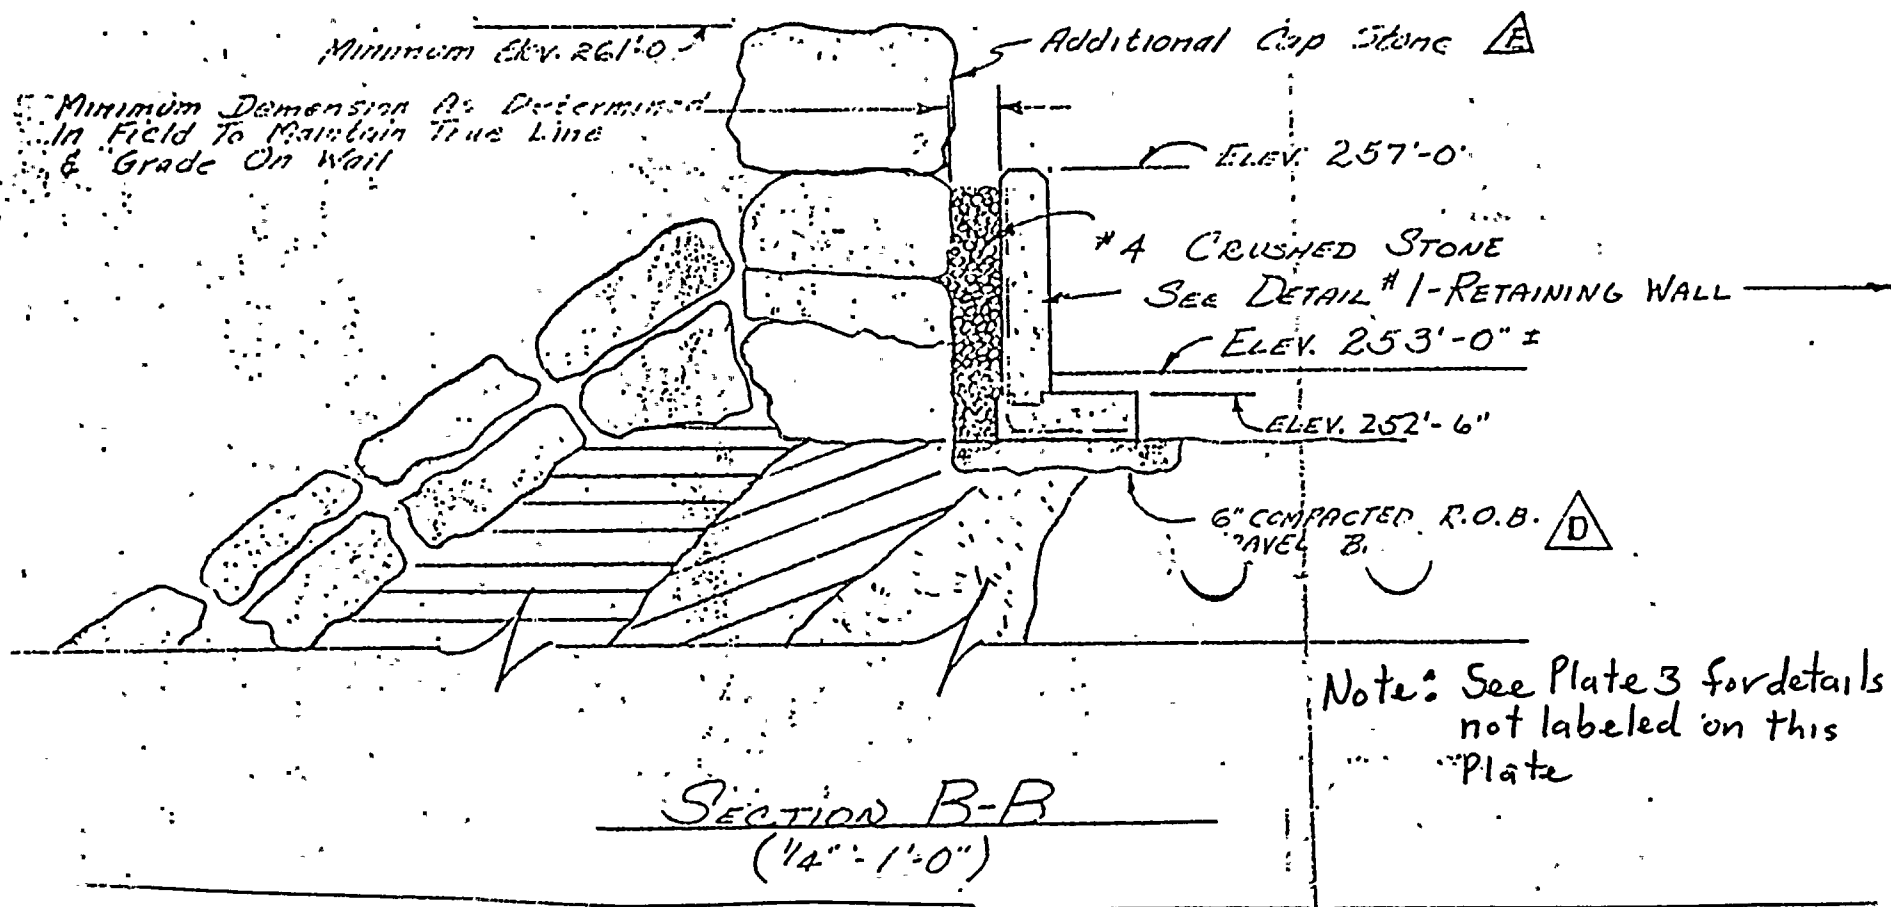
TYPICAL SECTION - WEST REVETMENT REACH

The licensee removed the small stones in two areas on the west end of the west reach of the revetment. Inspection of these two areas indicated that the double layer of armor stone is intact and that the small stone was not underlayer material as was suspected during the NRC Systematic Evaluation Program site visit. Further inspection of the west reach of the revetment disclosed an area, located approximately midway on the revetment, where there may have been minor movement of the armor stone layer. Discussions with Mr. Gary Goetz indicated that waste concrete had been dumped at this location and the toe stone could not be properly placed due to the concrete. The armor stone apparently slid on the concrete into what appears to be a stable position, thereby causing minor movement on the face of the revetment at this location.
