Steam Generator Evaluation
Ginna Steam Generator Tube Failure Incident
January 25, 1982
R. E. Ginna Nuclear Power Plant
Docket No. 50-244

At 9:25 a.m. on January 25, 1982, a tube ruptured in the B-Steam Generator at Ginna Station. A report summarizing the sequence of events, operator actions, emergency procedures, equipment performance, radiological assessment, and recommendations relative to the transient itself was submitted to the NRC by letter dated April 13, 1982. This report provides information specifically related to the tube failure. The work described in this report is a culmination of work performed by several organizations including Rochester Gas and Electric, Westinghouse, EPRI, and Combustion Engineering.

Shortly following the achievement of cold shutdown conditions on January 26, 1982, a comprehensive corrective action program was developed for the B-Steam Generator. The objectives established for this program were:

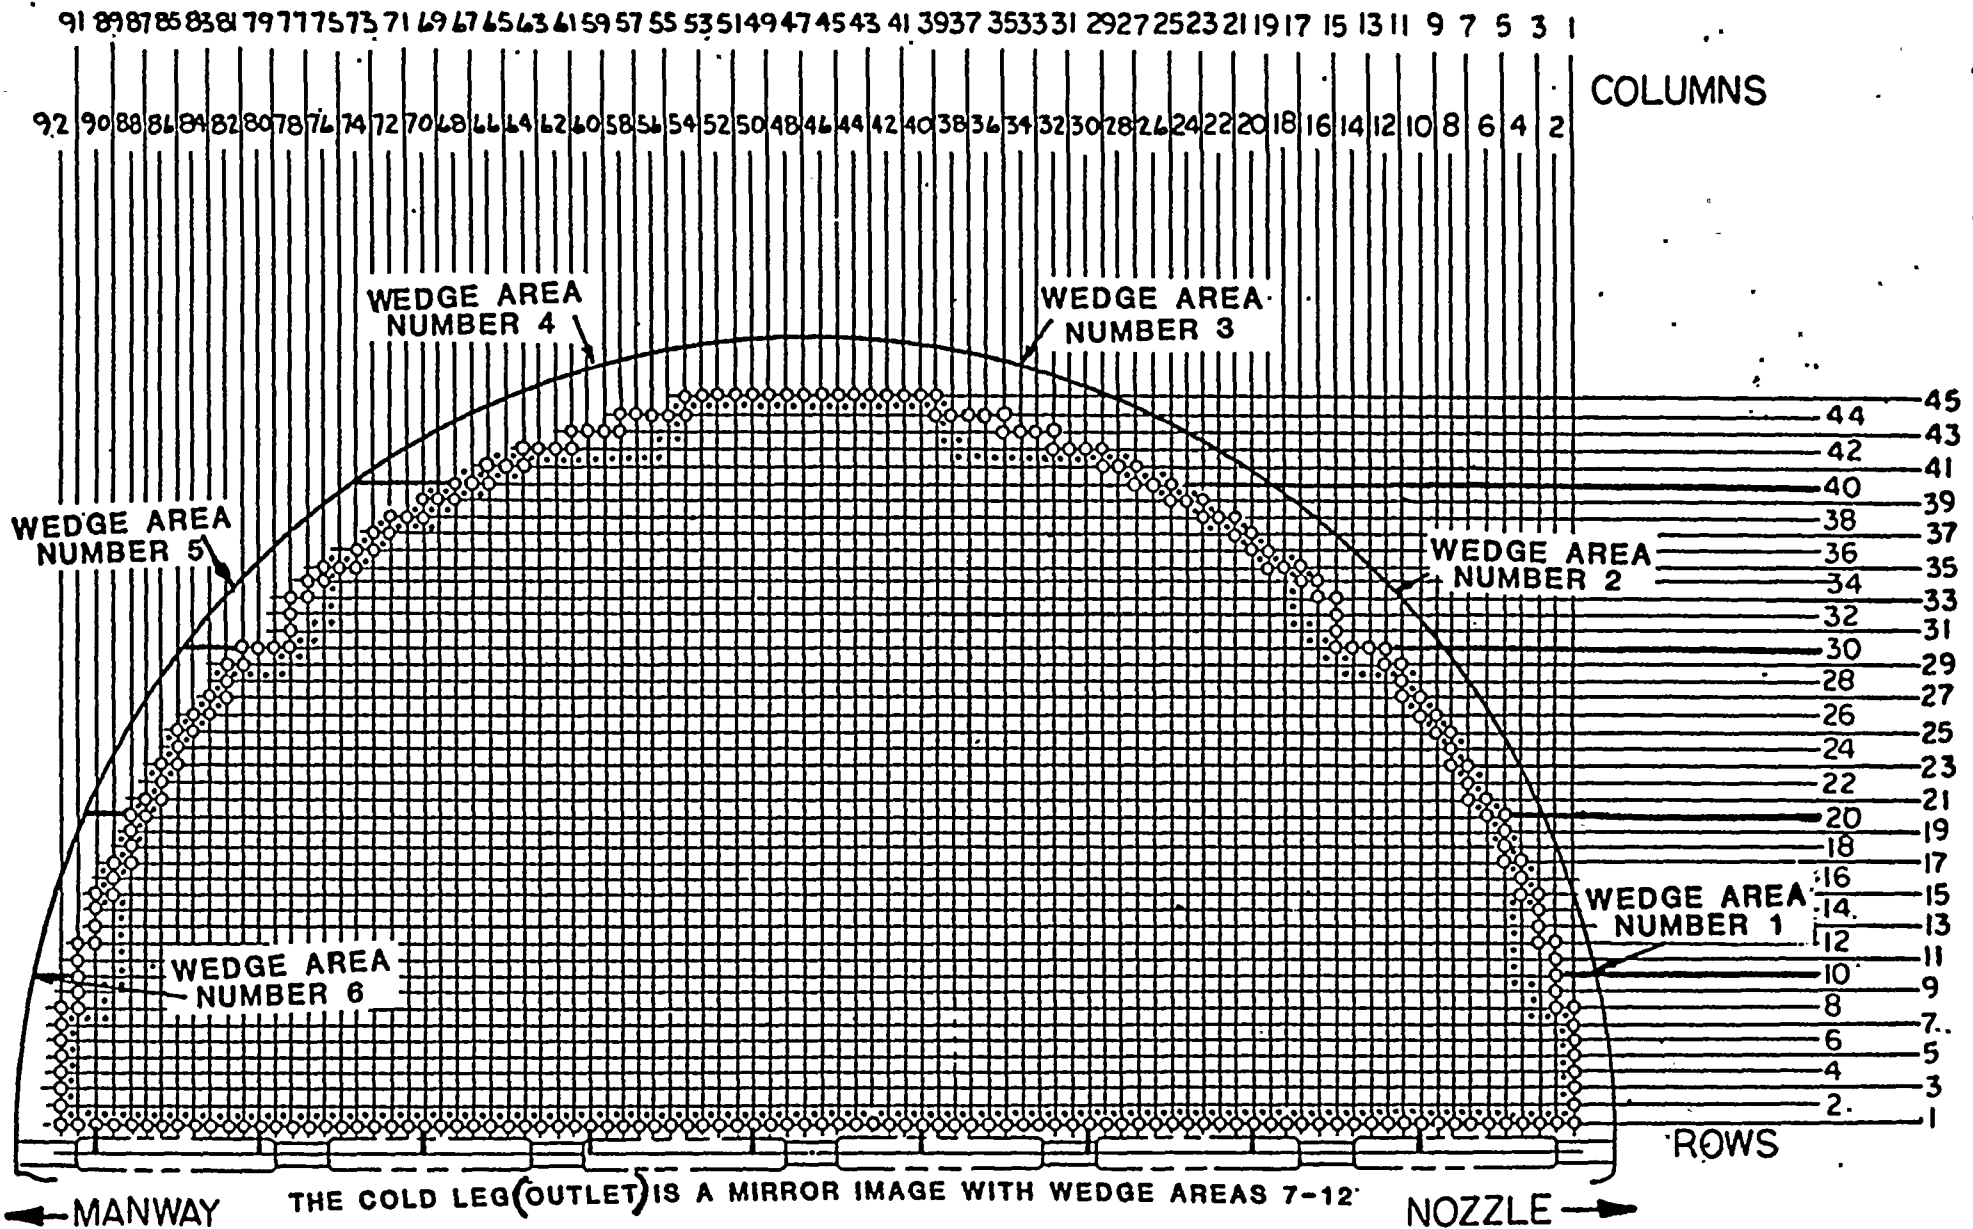
FIGURE 2.2

Ginna Station's first pluggable defects were identified in March 1974 by an eddy current examination of both steam generators. The pluggable defects were found only in the A-Steam Generator and were confirmed to be wastage of the Inconel 600 tubing. Within three years after conversion to the AVT water chemistry, the plugging of tubes in the A-Steam Generator for secondary side attack was essentially eliminated. See Table 2.1 and Fig. 2.3 for further definition of the A-Steam Generator tube plugging history.

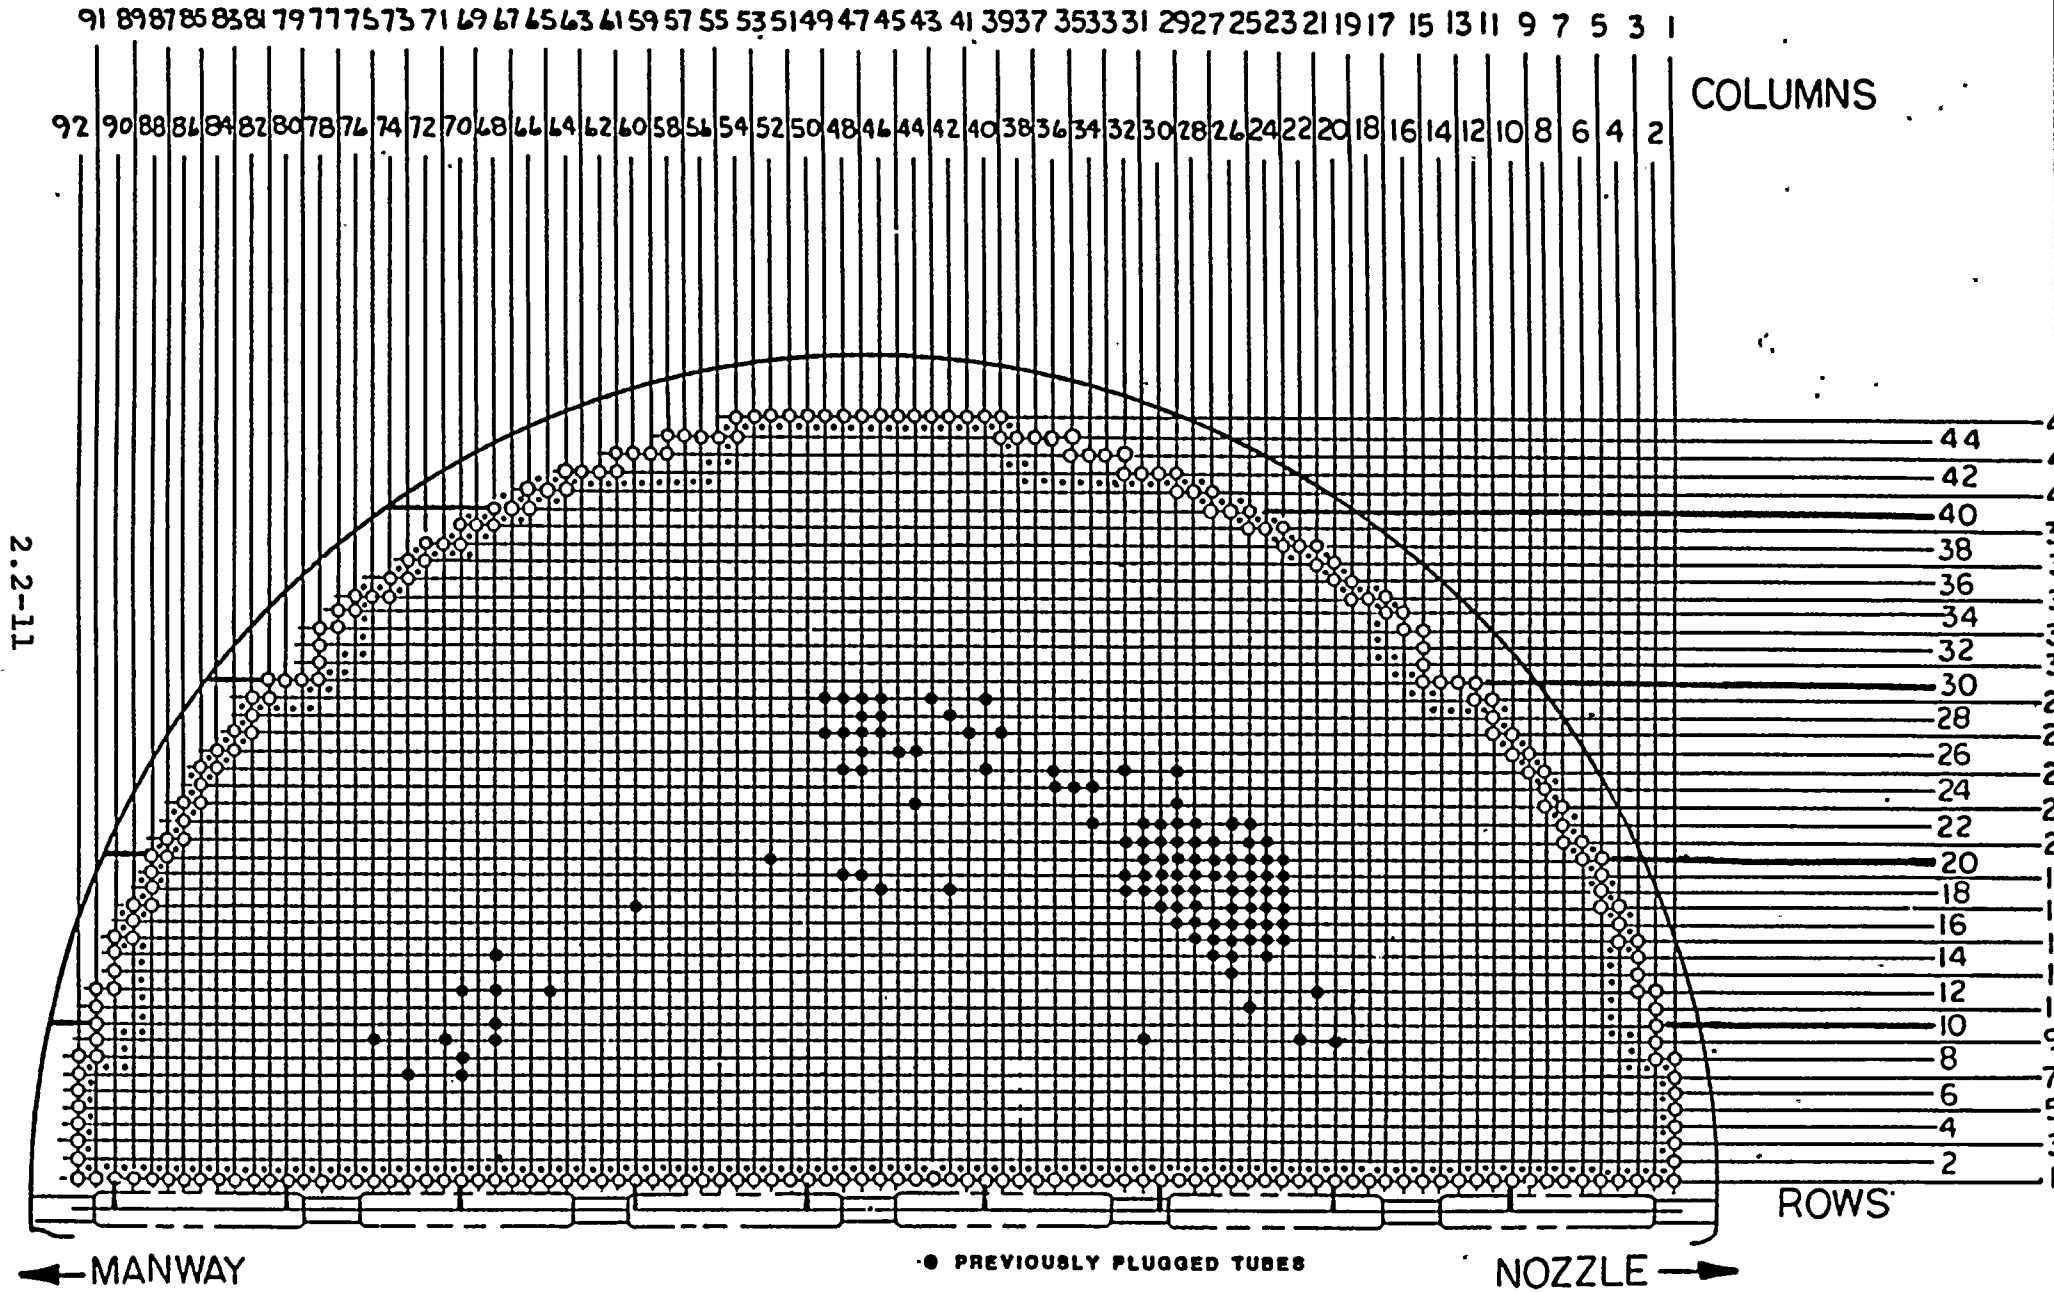
FIG. 2.3

The B-Steam Generator has had a different plugging history. Its first pluggable defect did not occur until after the AVT conversion. The first pluggable defects were identified in March 1975 and were characterized as stress corrosion cracking (SCC). SCC occurred because of the molar ratio shift (Na/PO_4) resulting in the sludge after conversion from phosphate control to the all volatile treatment (AVT) chemistry control. This shift resulted in a caustic environment being formed in previously phosphated

sludge since, on AVT, there is no addition of phosphate to buffer the sodium hydroxide. As with the A-Steam Generator, within a few years after AVT conversion, secondary side corrosion indications subsided. However, beginning in 1976, defects were found in the periphery area. These defects were mainly in the wedge areas (areas where the support plates are attached to the shell of the steam generator) within the first four (4) inches above the tube sheet. However, four (4) tubes adjacent to the Number 4 wedge area were found to have indications about 24 inches above the tube sheet. The majority of these defects were interpreted as internal diameter indications based on the eddy current signals.

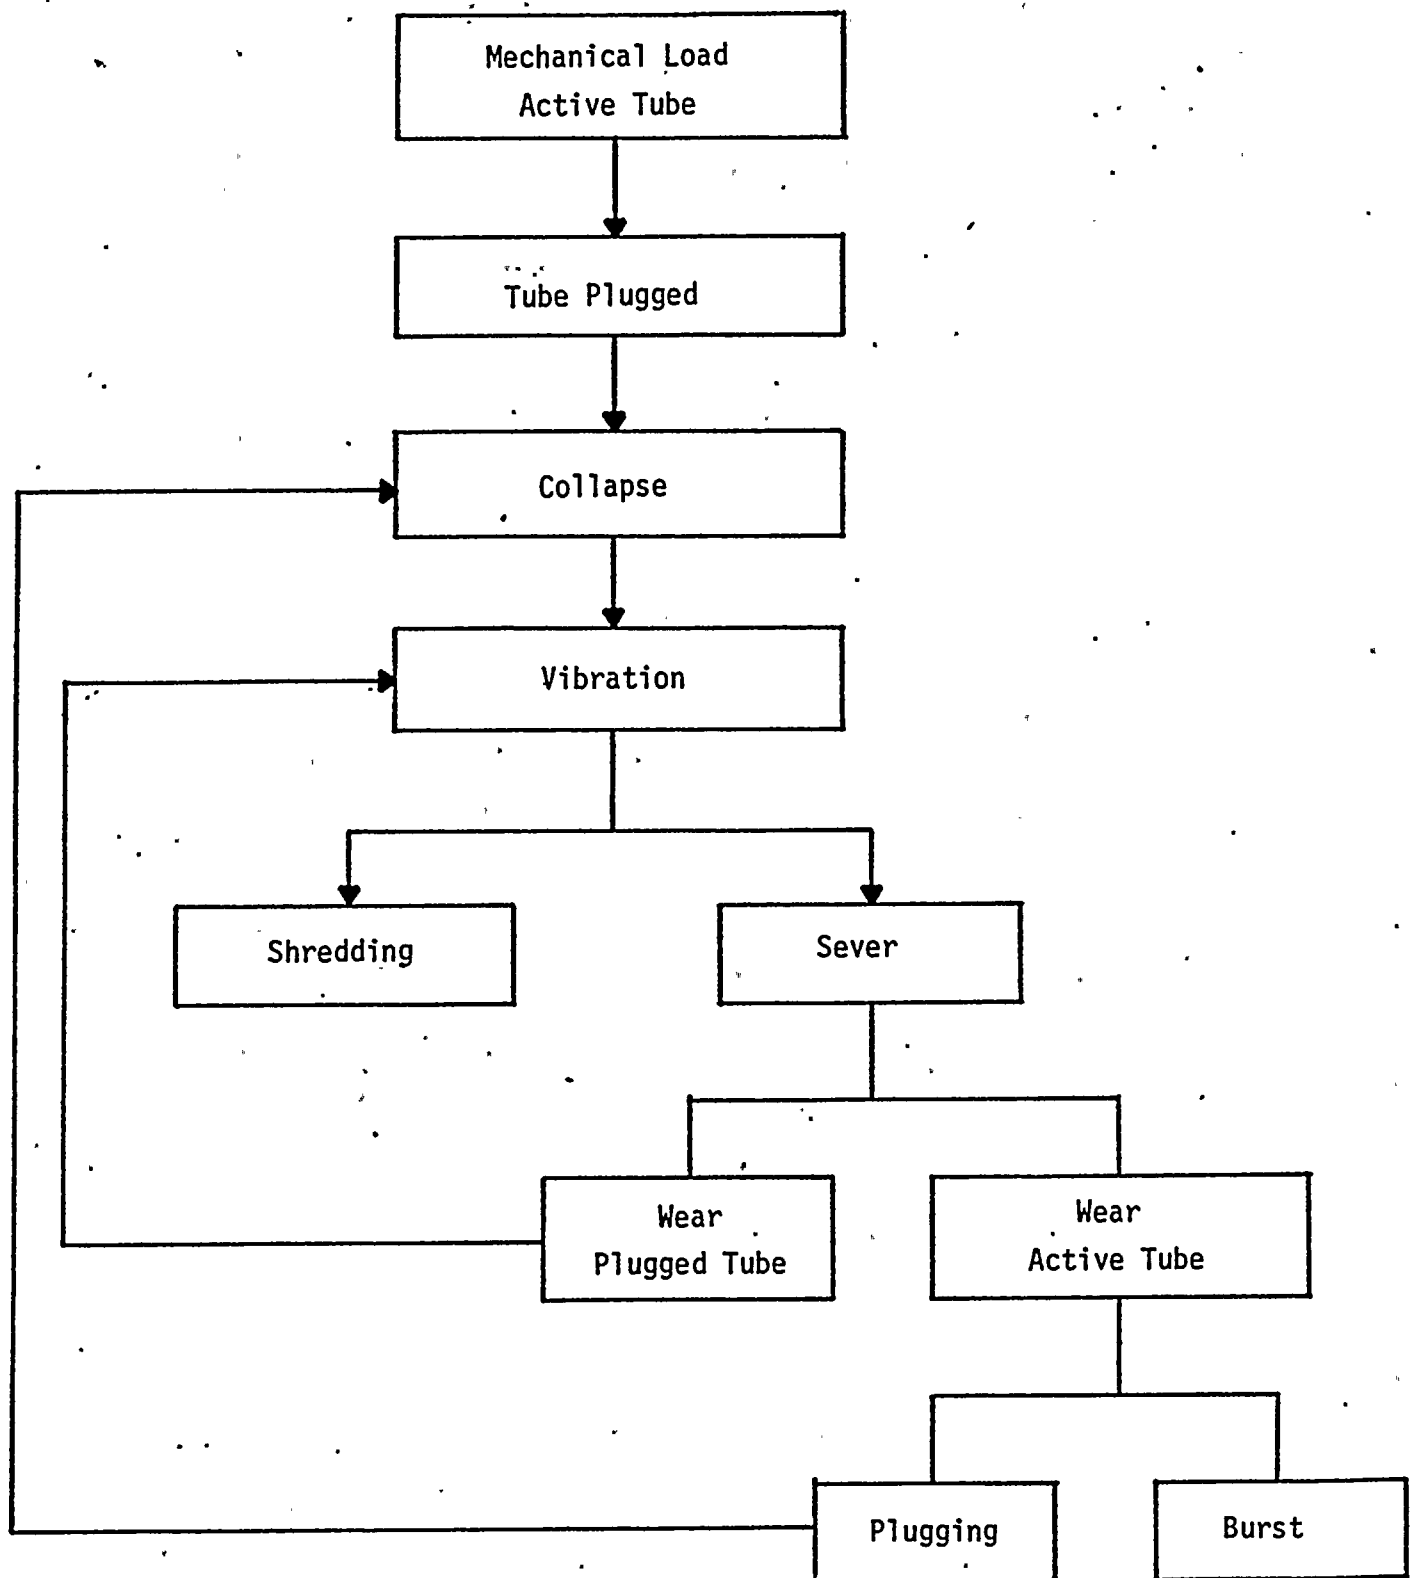
Figure 4.2-1
Postulated Failure Mechanism Sequence

Figure 4.2-1 illustrates the various failure mechanisms, and their sequence, which are postulated to have resulted in the rupture of R42 C55. A foreign object, axial loads, and pressure are postulated to have combined in leading to a sequence of events which led to plugging of many tubes on the B-Steam Generator periphery, and eventually to the rupture of one of them. The intermediate steps leading to the rupture appear to have included collapse, severing, and wear. Most of this intermediate tube degradation occurred subsequent to plugging and, therefore, could not be detected by eddy current examination. The analyses and tests which are described in the following sections have been performed to substantiate the postulated failure mechanisms described here.

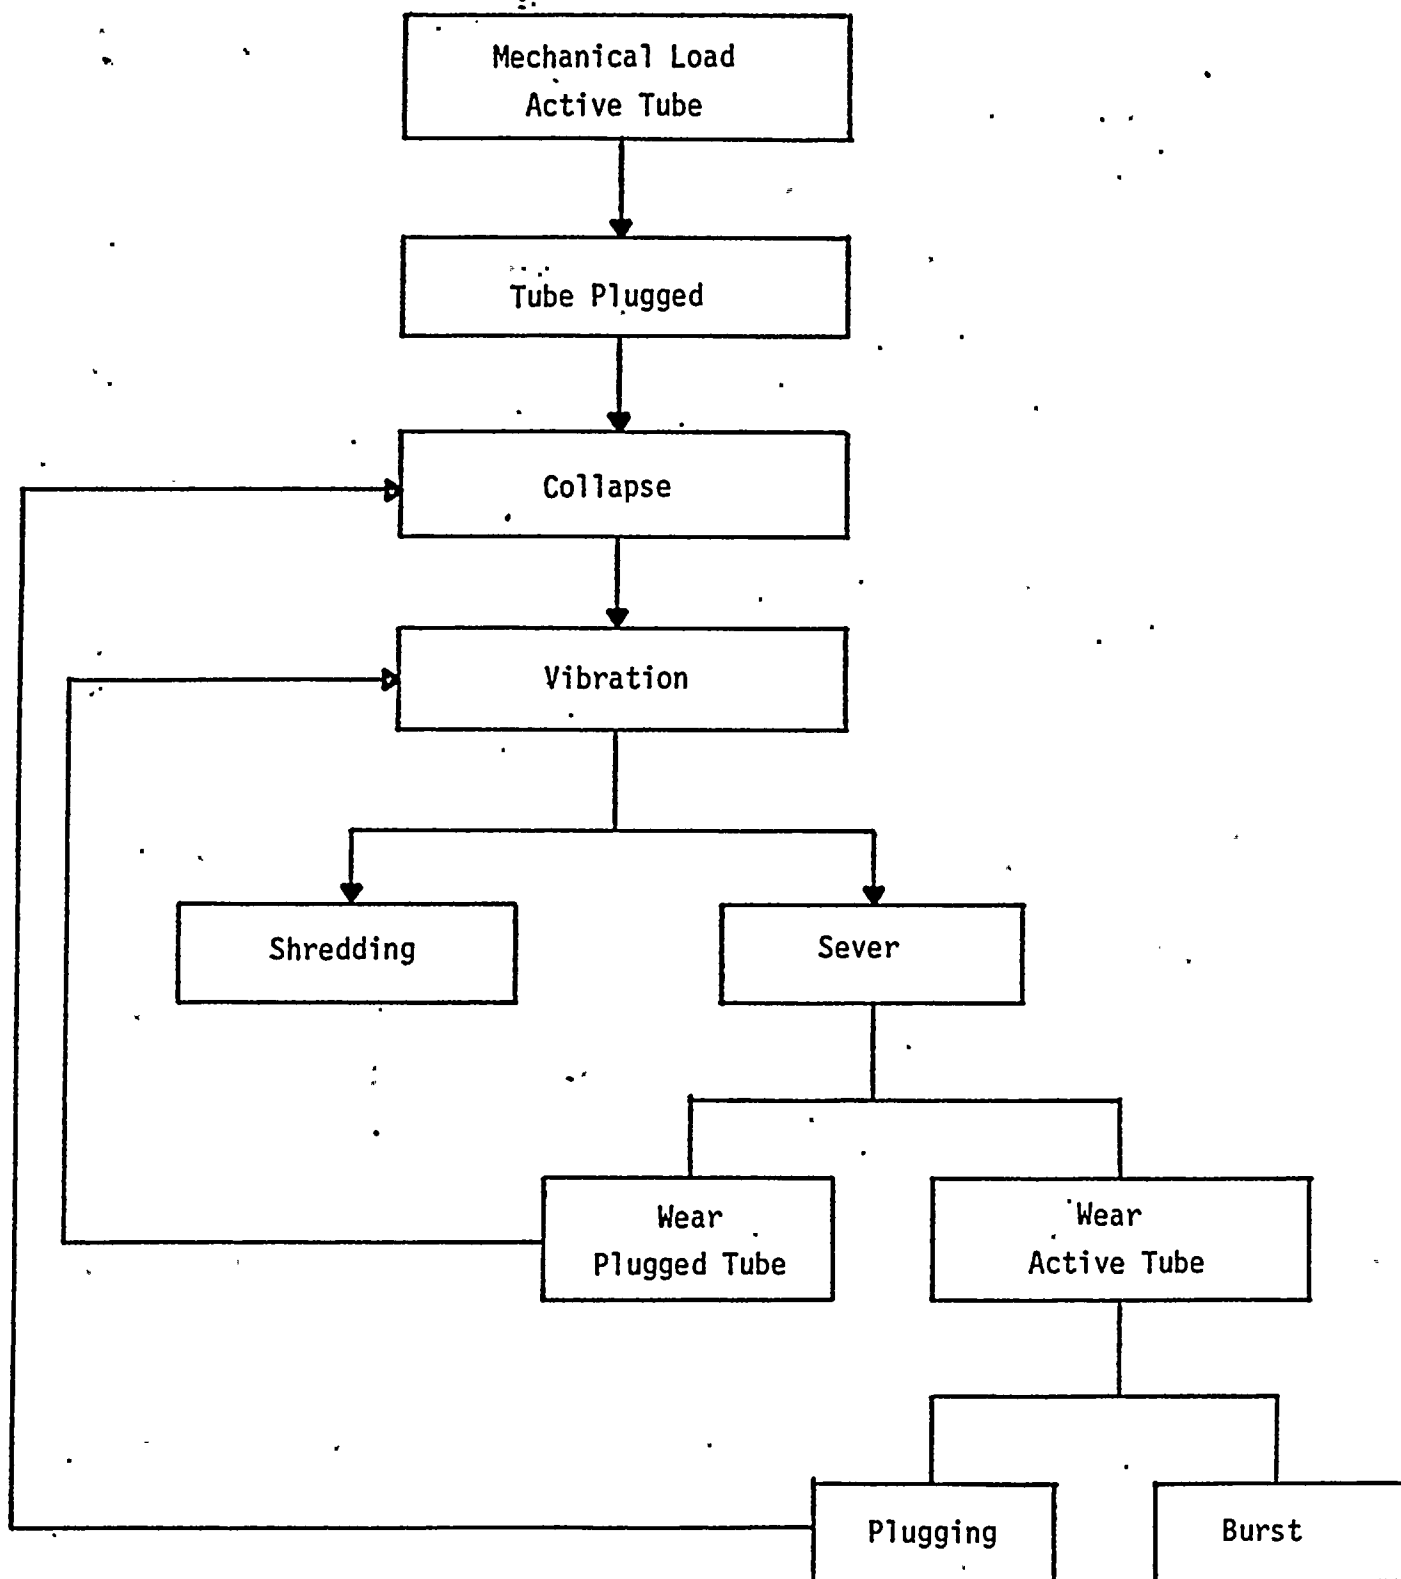
Figure 4.8-1
Postulated Failure Mechanism Sequence

Tube bursting occurred as a result of wear and is consistent with analytical predictions.

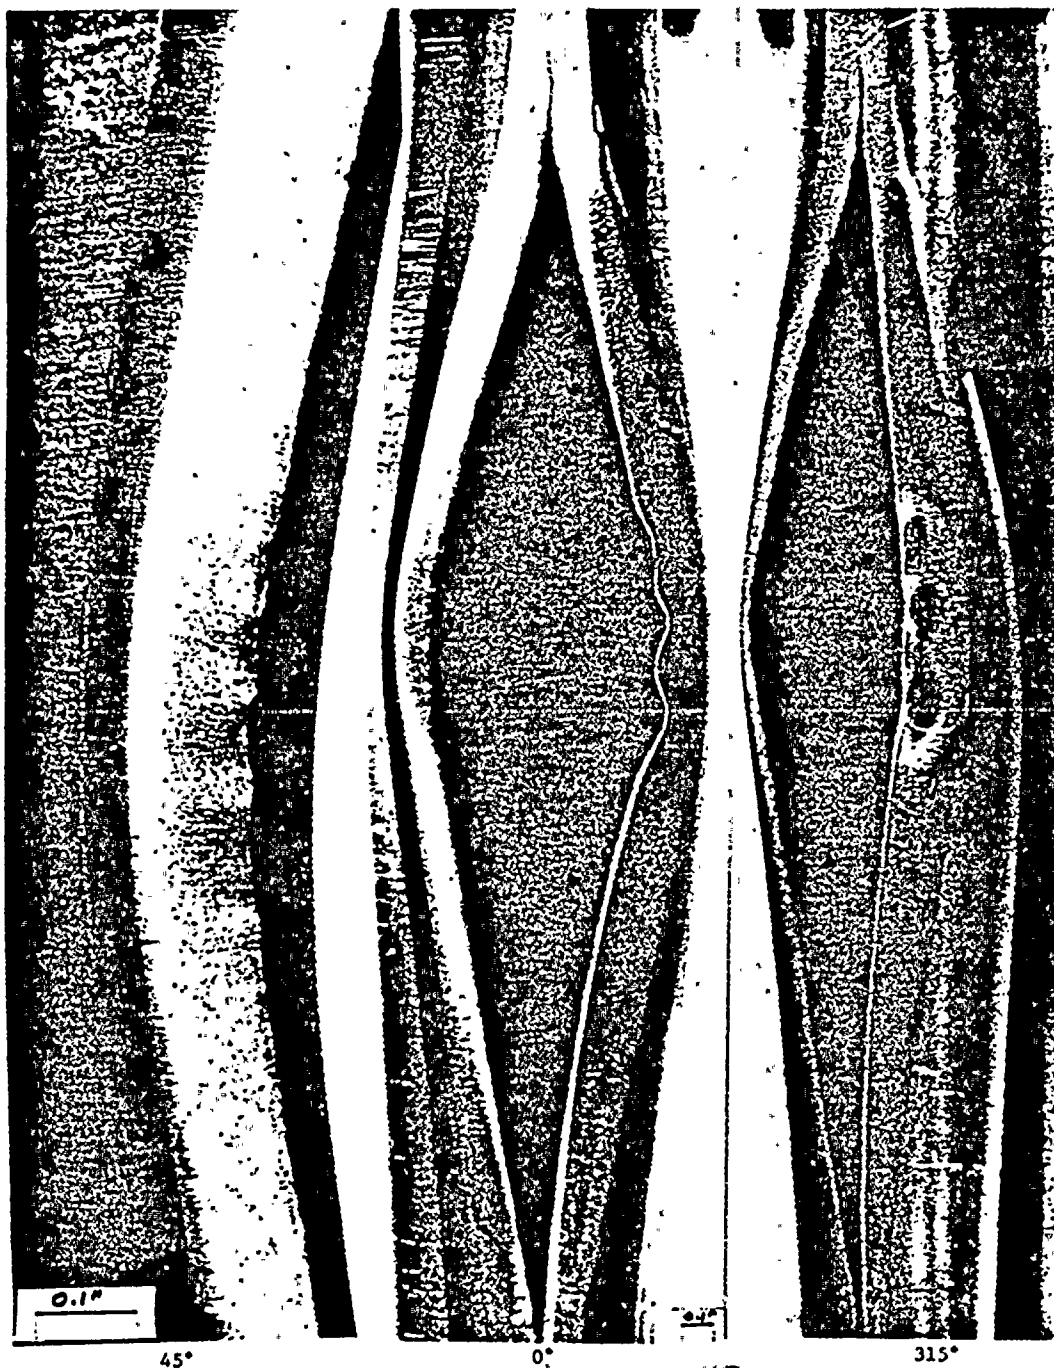
Fig. 2-1. Fish mouth crack at near 0° on Tube R42-C55 from RGE (GINNA), SGB, hot leg

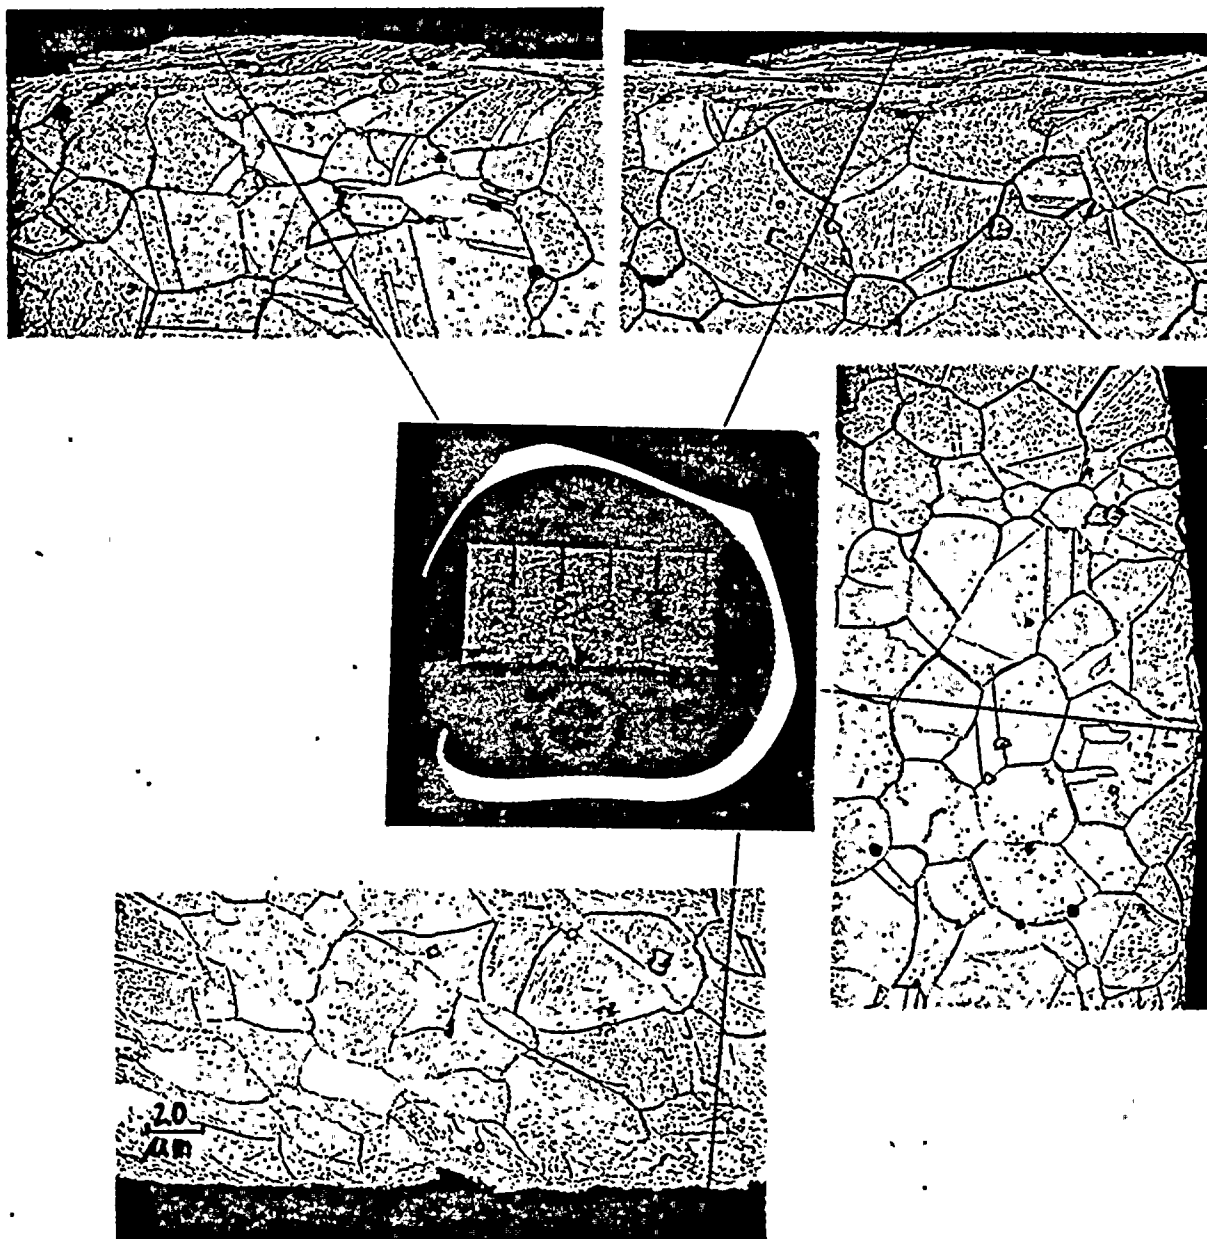
Fig. 3-8. Metallography on transverse cross-section down 6" from top of top portion of Tube R44-C55. Similar results were observed after polishing an additional 24 mils.

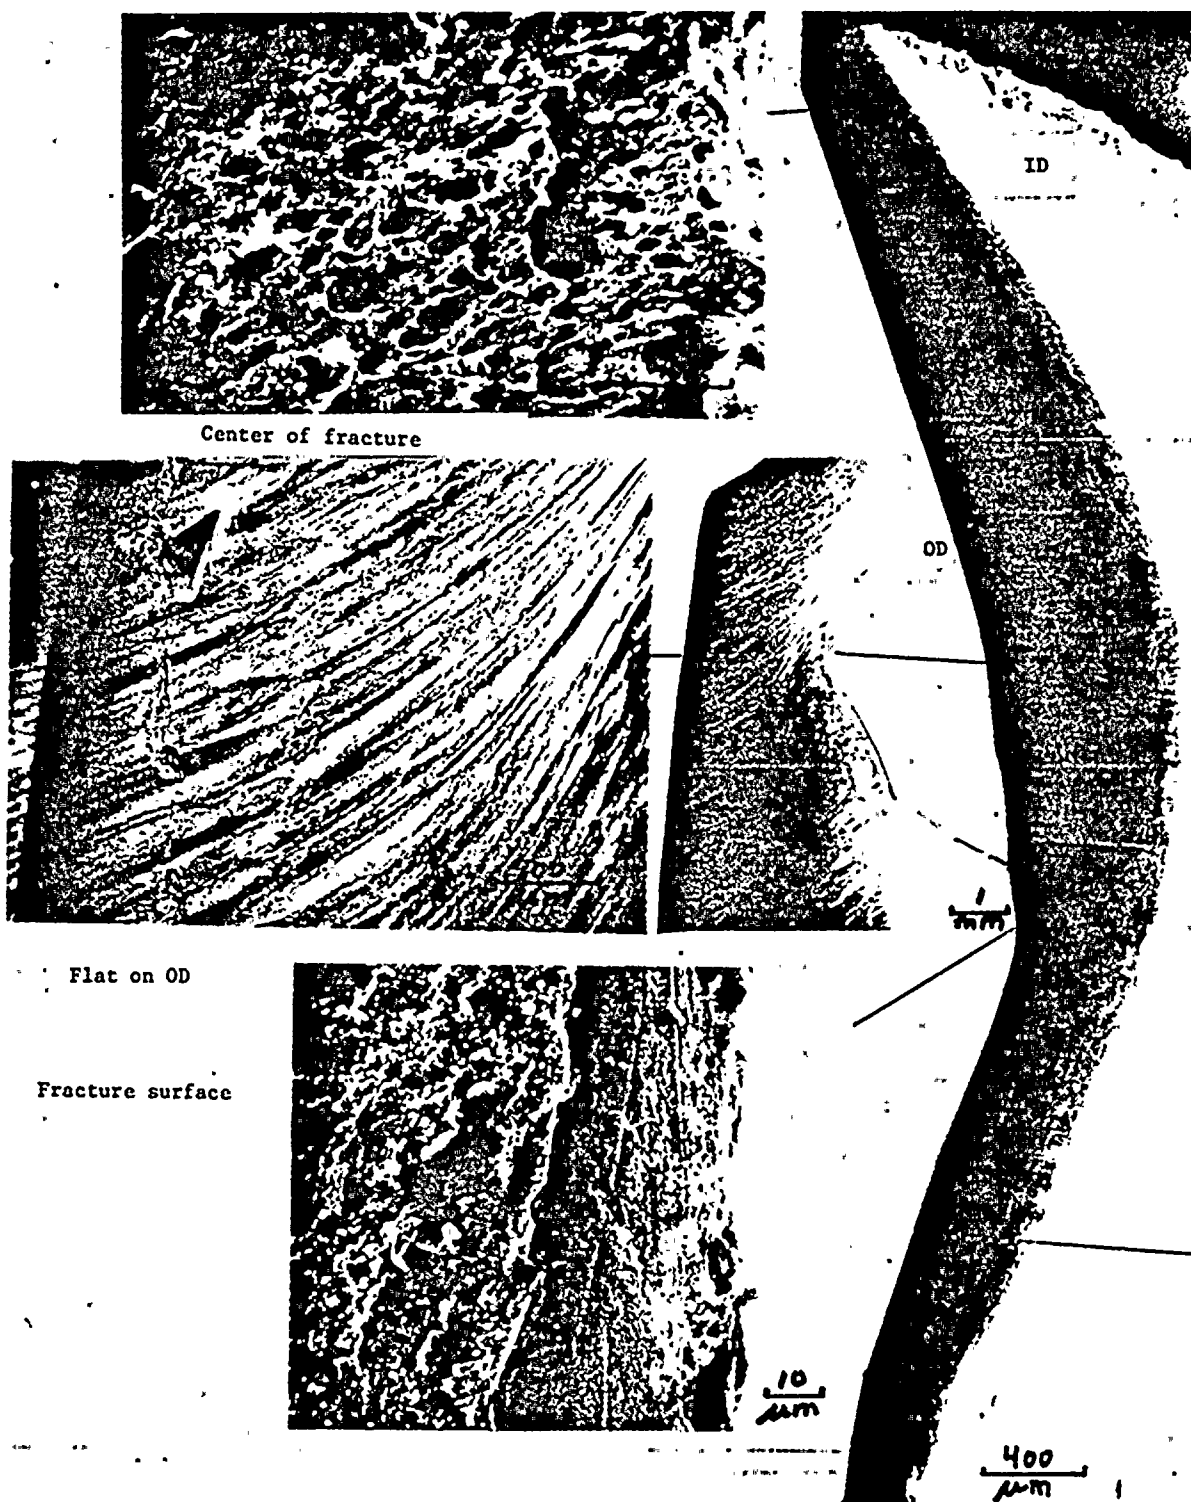
Fig. 4-2 SEM's of flat and fracture surface at center of fish mouth crack on Tube R42-C55

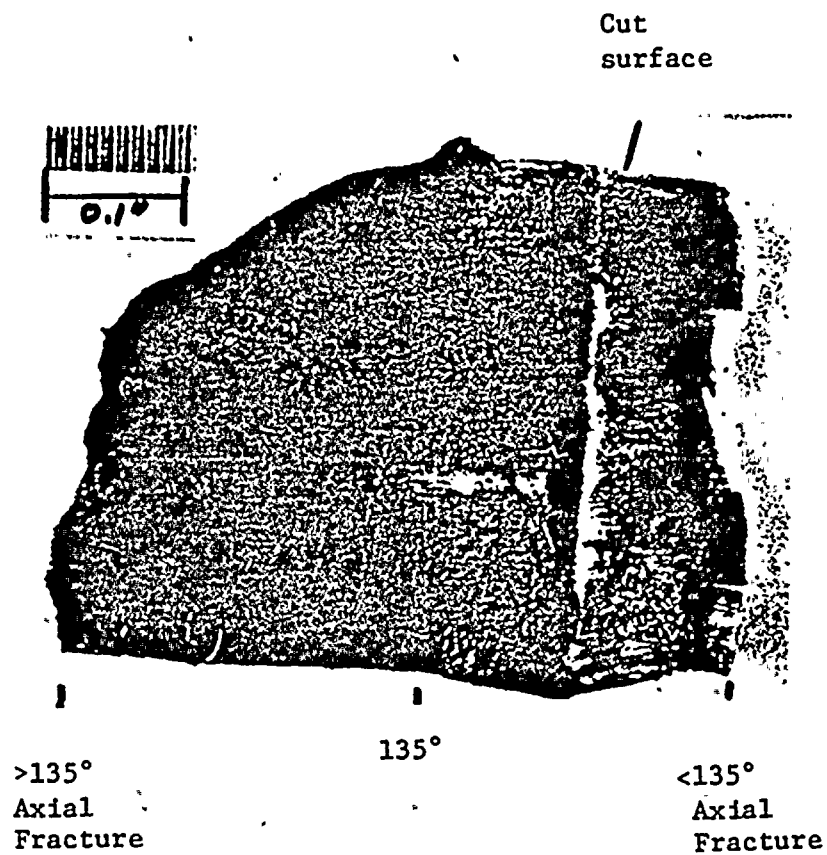
Fig. 4-6. Fractography was performed on two axial fracture surfaces 1-1/2" from the bottom of the top portion of Tube R44-C55

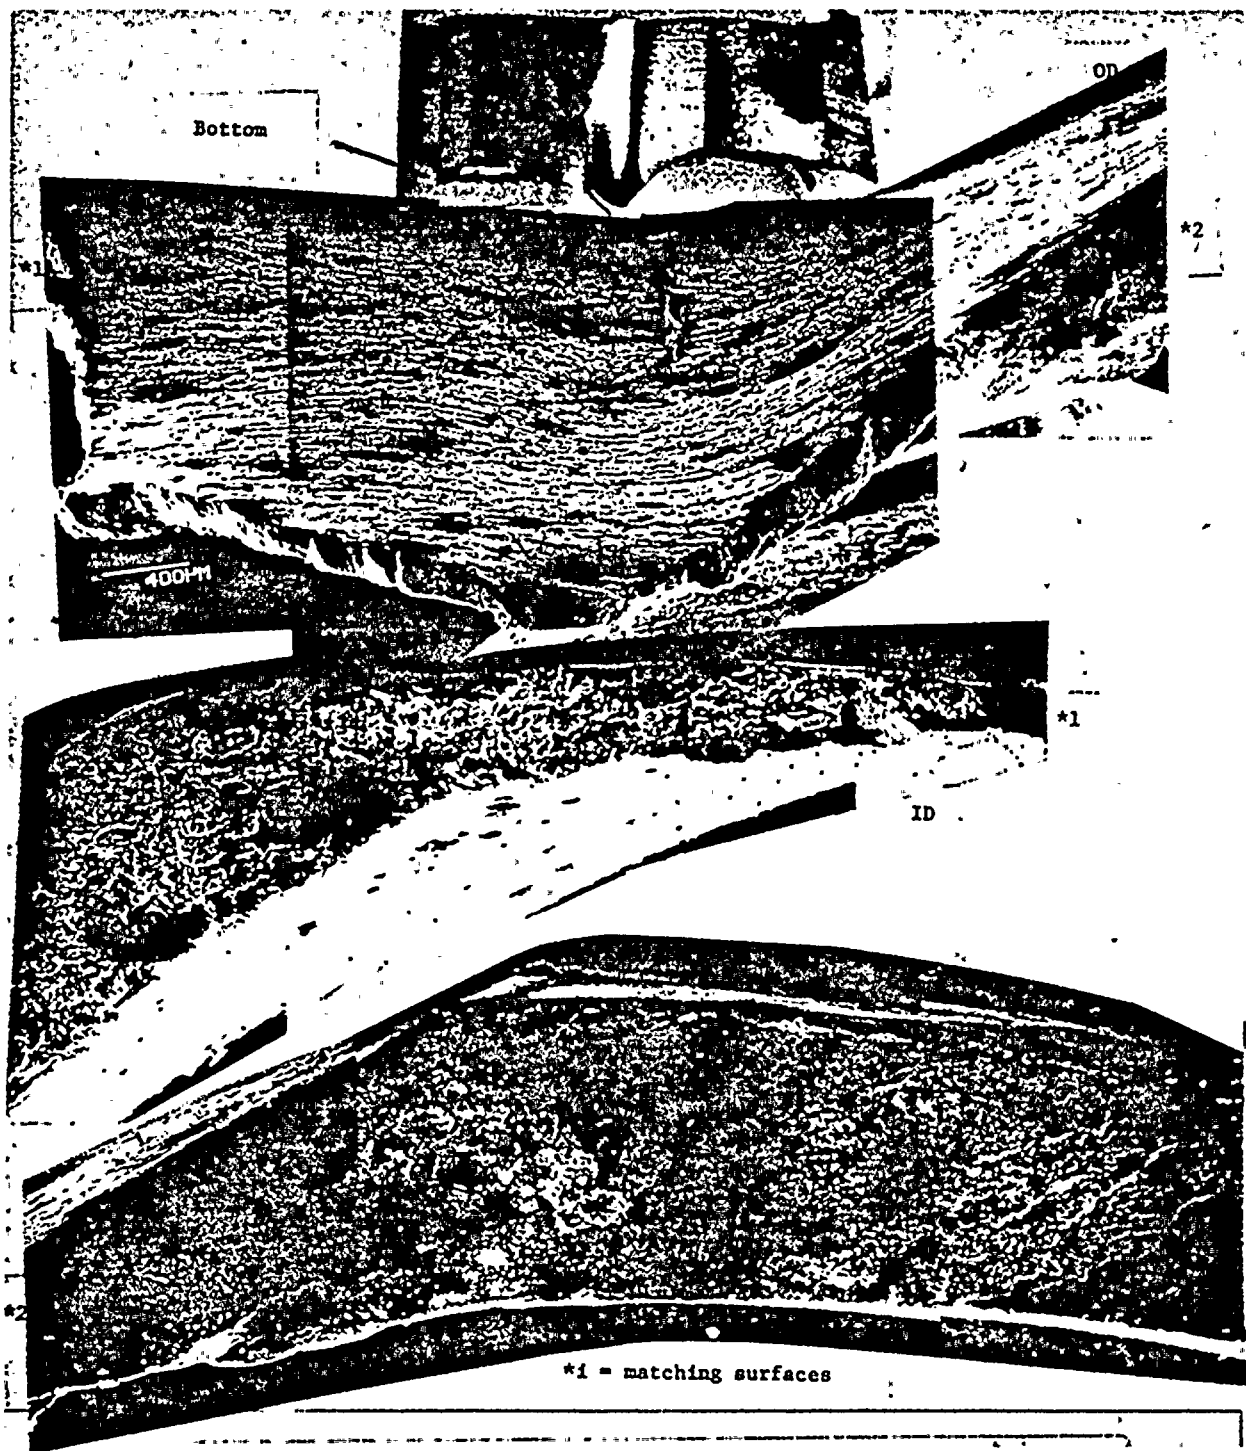
Fig. 4-10. 180° view of ring at bottom of Tube R44-C54 (Top) and fractography on bottom fracture surface showing areas studied in more detail

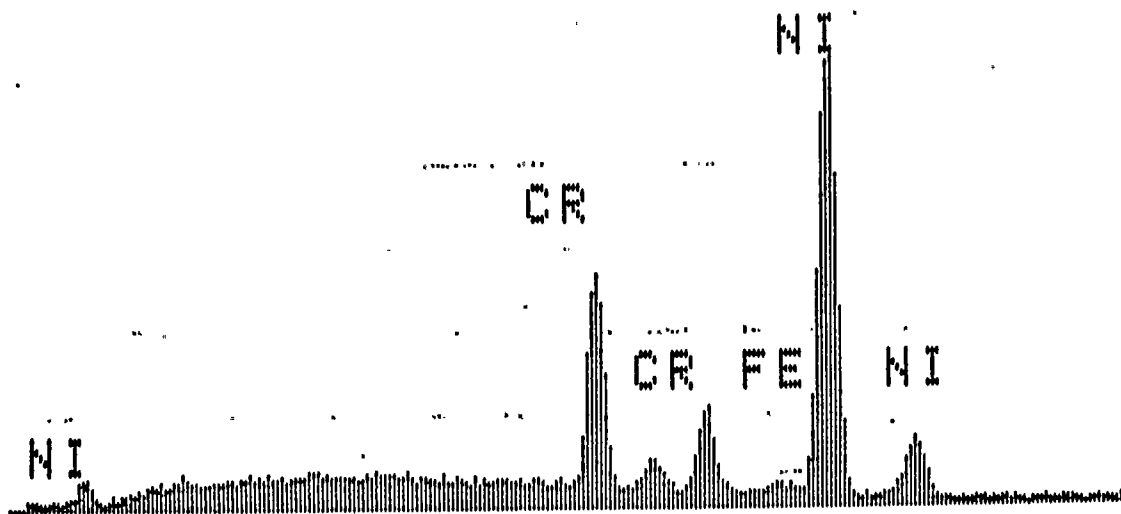
Fig. 5-1. EDS spectrum and analysis for principal elements on Section 1A from Tube R44-C55 (Included are ASTM specifications).
