Subject: Response to NRC Generic Letter 97-06, dated December 30, 1997;
SUBJECT: DEGRADATION OF STEAM GENERATOR INTERNALS
R. E. Ginna Nuclear Power Plant
Docket No. 50-244

Rochester Gas and Electric Corporation
Ginna Station

1997 Refueling Outage
Replacement Steam Generator Secondary Internals Inspection Report
(Issued February 20, 1998)

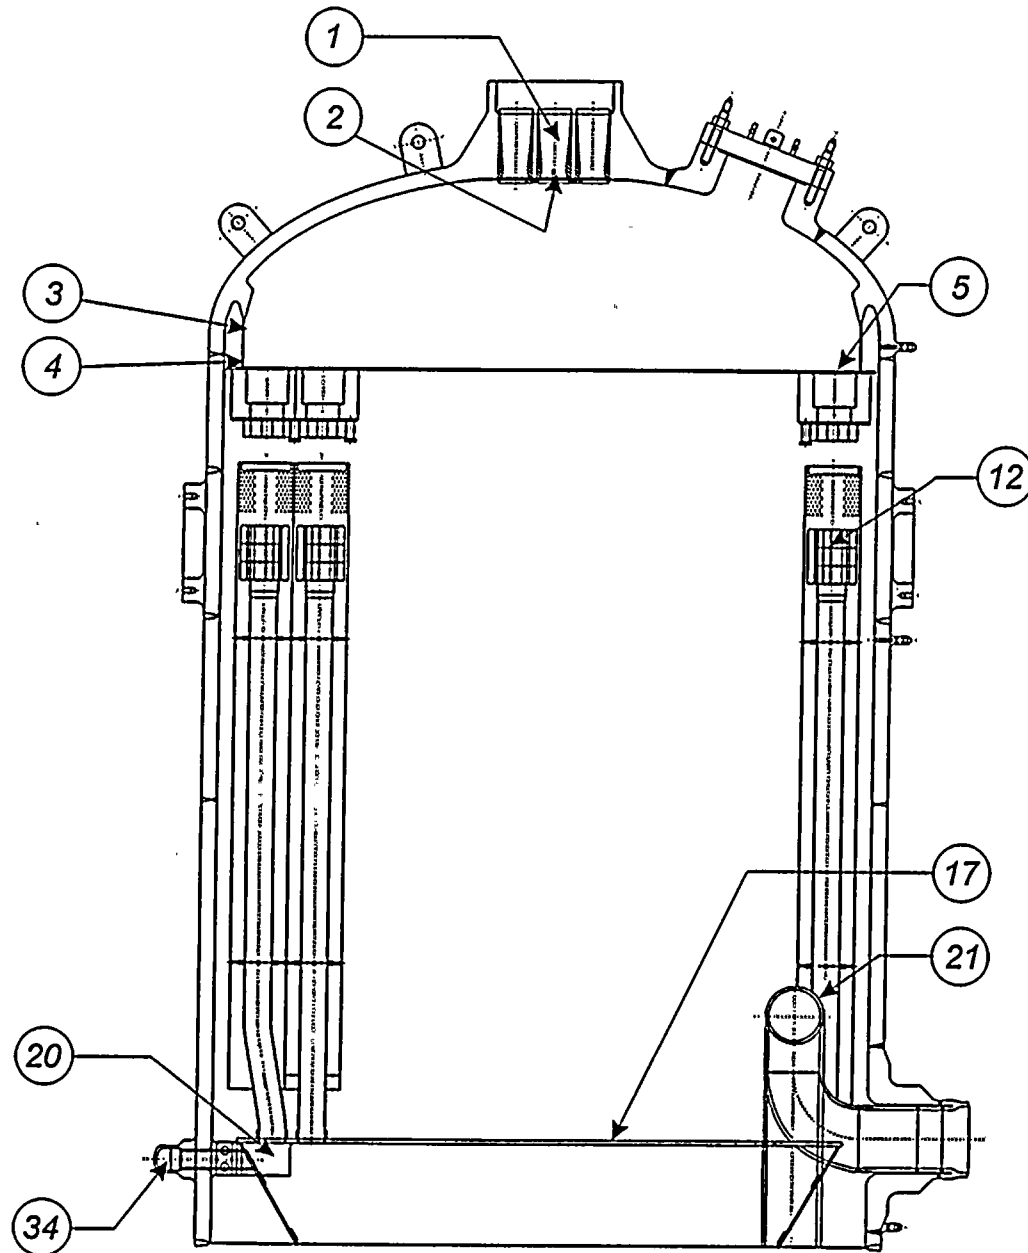
Figure 1
Steam Drum

The seven steam outlet venturis were fabricated from stainless steel. Although the moisture carryover of the Ginna RSGs was measured to be a very low 0.015%, the velocity at the throat of these venturis is extremely high ($\sim 380 \text{ fps}^3$). No erosion damage was visible on the venturis and the welds on the venturi retention plate were intact.

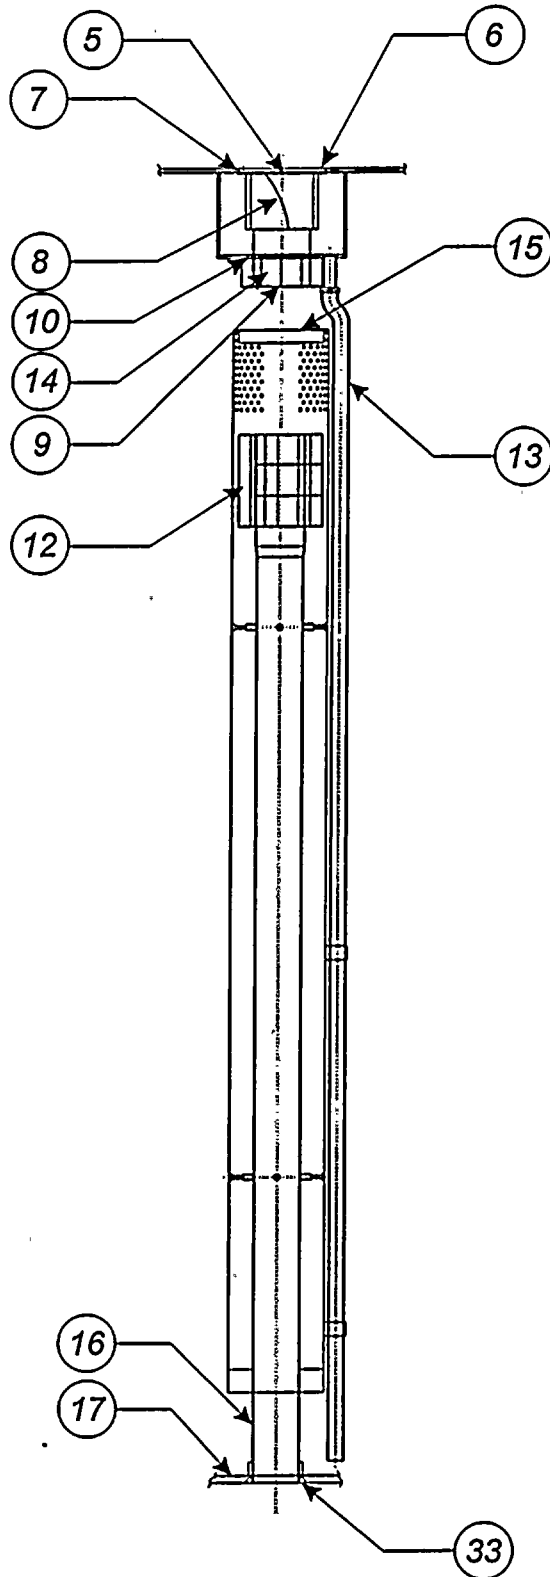
Figure 2

A subset of the secondary separators are visible from the tunnel, allowing some of the swirl vane to separator bottom plate and separator body welds to be inspected. No degradation of these welds was visible, and direct visual inspection of the inlet swirl vanes confirmed that no erosion damage had occurred. No problems were experienced with the visible secondary separator drain tubes or the associated attachment hardware.

The primary separator outer cylinders and riser tubes visible from the tunnel were inspected and found to be intact with no signs of degradation.

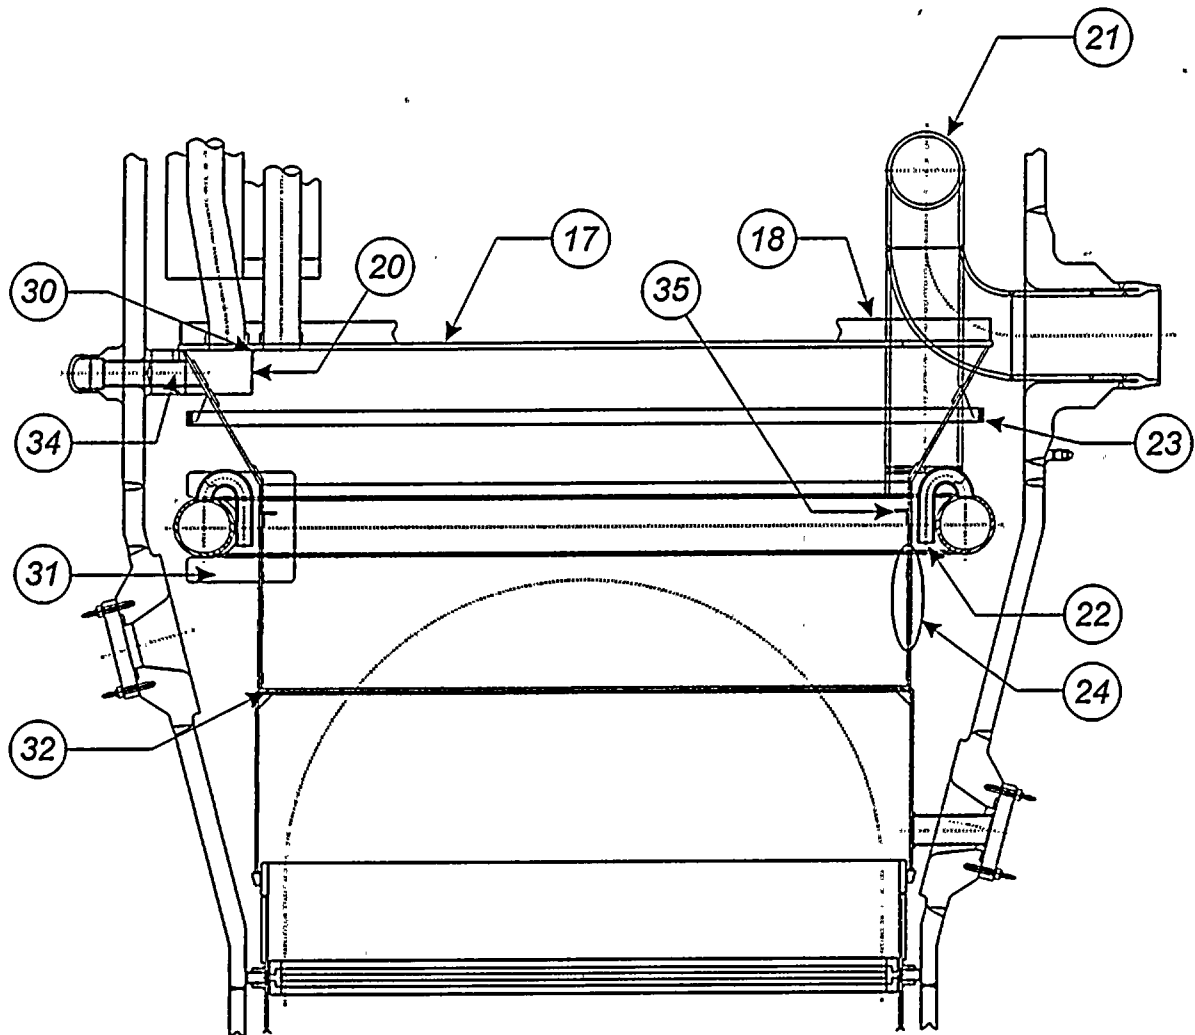
Figure 3
Feedwater Header Region (Elevation)

Access to the feedwater header was gained by crawling beneath the feedwater piping "gooseneck". This allowed several of the J-tubes closest to the tee to be inspected. Excellent views of the J-tube welds were obtained and no degradation was evident. One primary deck support lug was observed and was intact. The camera access track, installed in case more detailed feedwater header inspections are required in the future, was observed to be intact.

The original plan called for inspection of the area where the feedwater exits the J-tube in close proximity to the shroud. Shroud thinning had been observed at Diablo Canyon under similar geometric conditions, although none was expected at Ginna since J-tube exit velocities are lower by design. However, the stick camera intended for this inspection was too large to gain access between the feedwater header and shroud.

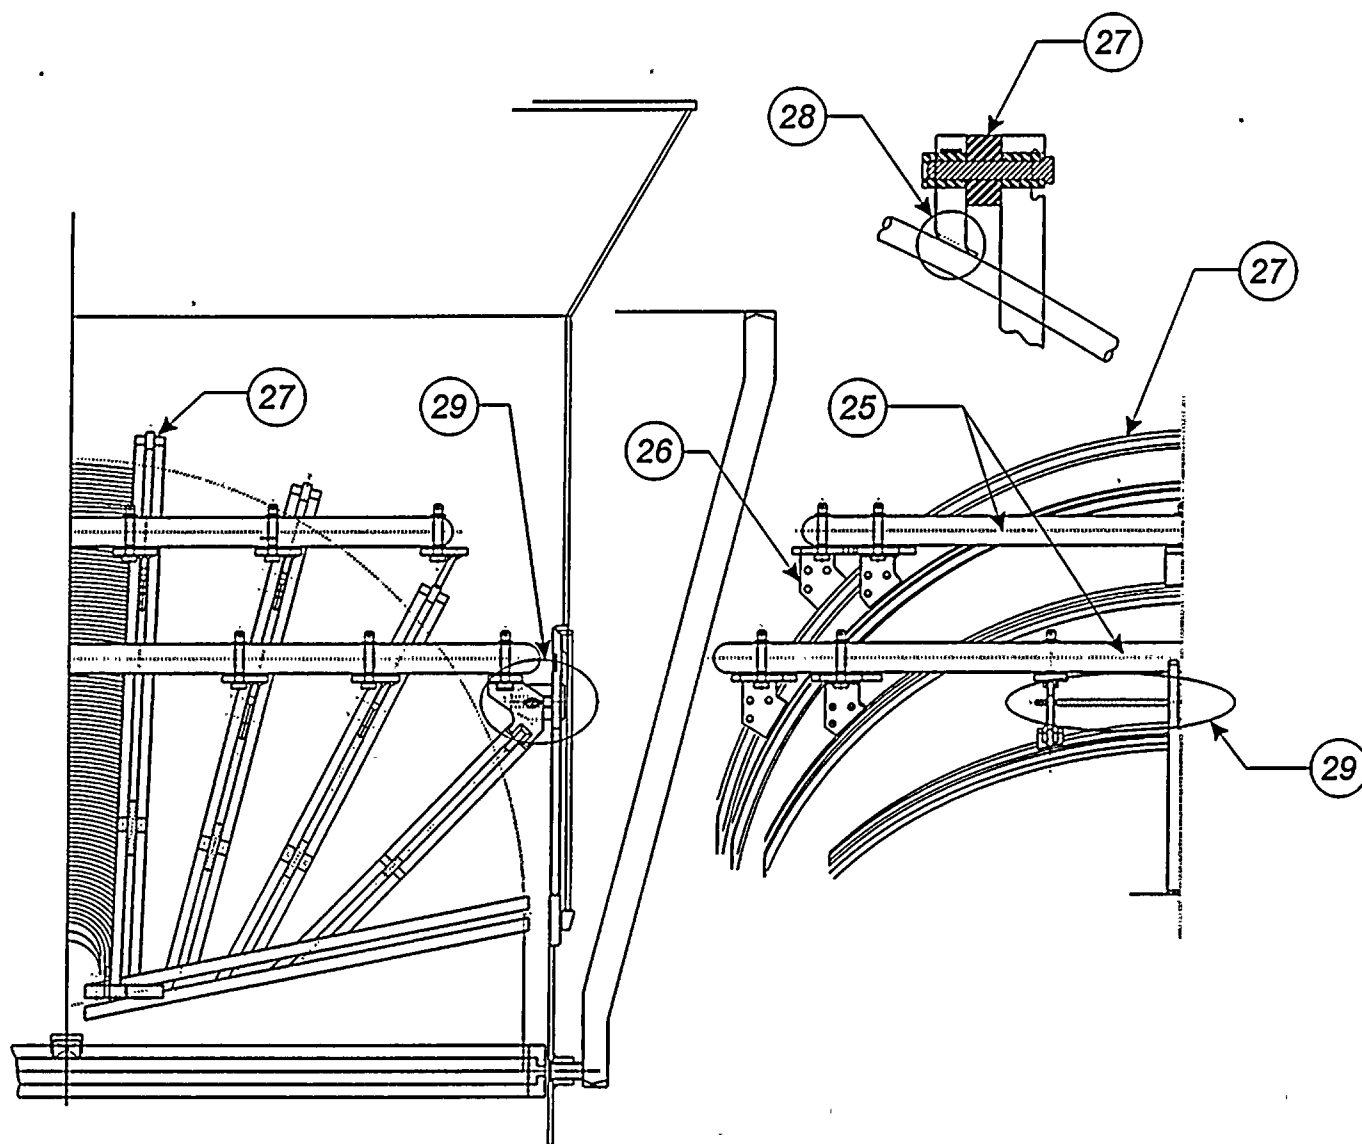
Figure 5
U-Bend Supports

Close-in inspection of the J-tab to tube contact areas revealed gaps at the edges of the J-tab lands. Subsequent review of the fabrication drawings revealed this to be normal; the land is curved to allow the J-tab to seat properly against the tube. There may have been slight deposit buildup at the J-tab to tube contact point although this was hard to confirm on the videotape.

No degradation of any items in the U-bend region was observed, and tube deposits were light.

U-bend gap measurements were completed in both RSGs as indicated in Table 2. Four of five U-bend gaps identified by ECT were measured in SG B. One of five U-bend proximity indications was measured in SG A. The other tubes identified by ECT in SG A were in the vicinity of the collector bar and lowest fan bar and would have been very difficult to reach; they were not attempted since dose rates were high and the existence of the gap proximity problem had already been verified in SG B.

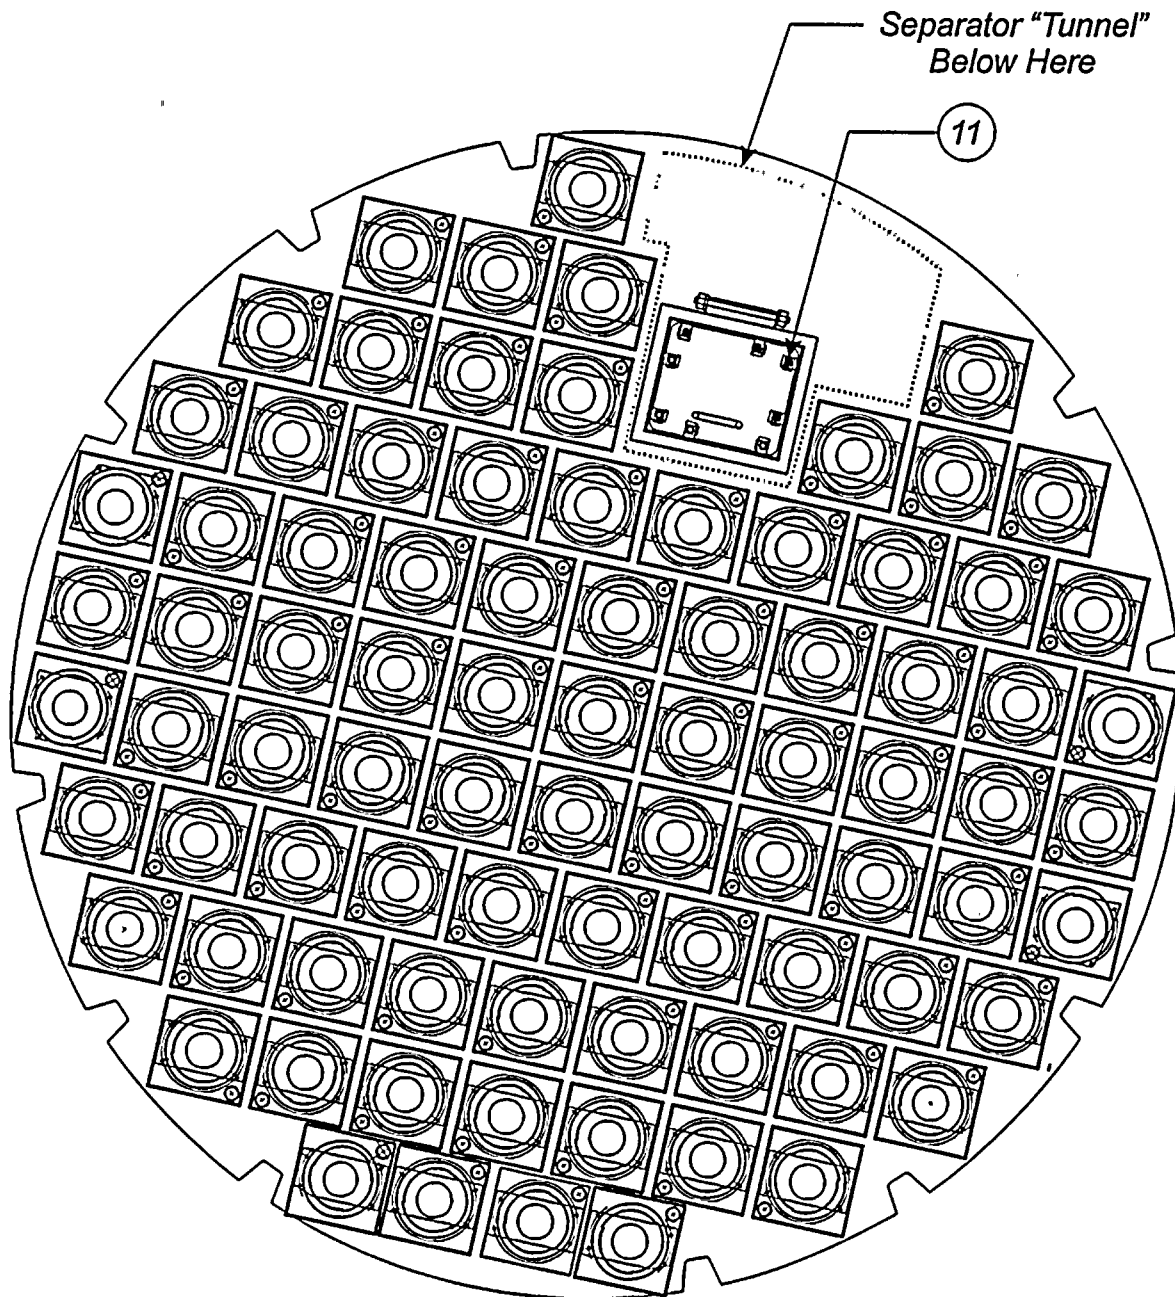
Figure 6
Secondary Deck and Separator Layout

No degradation of the deck door hardware or seal skirt welds was seen.

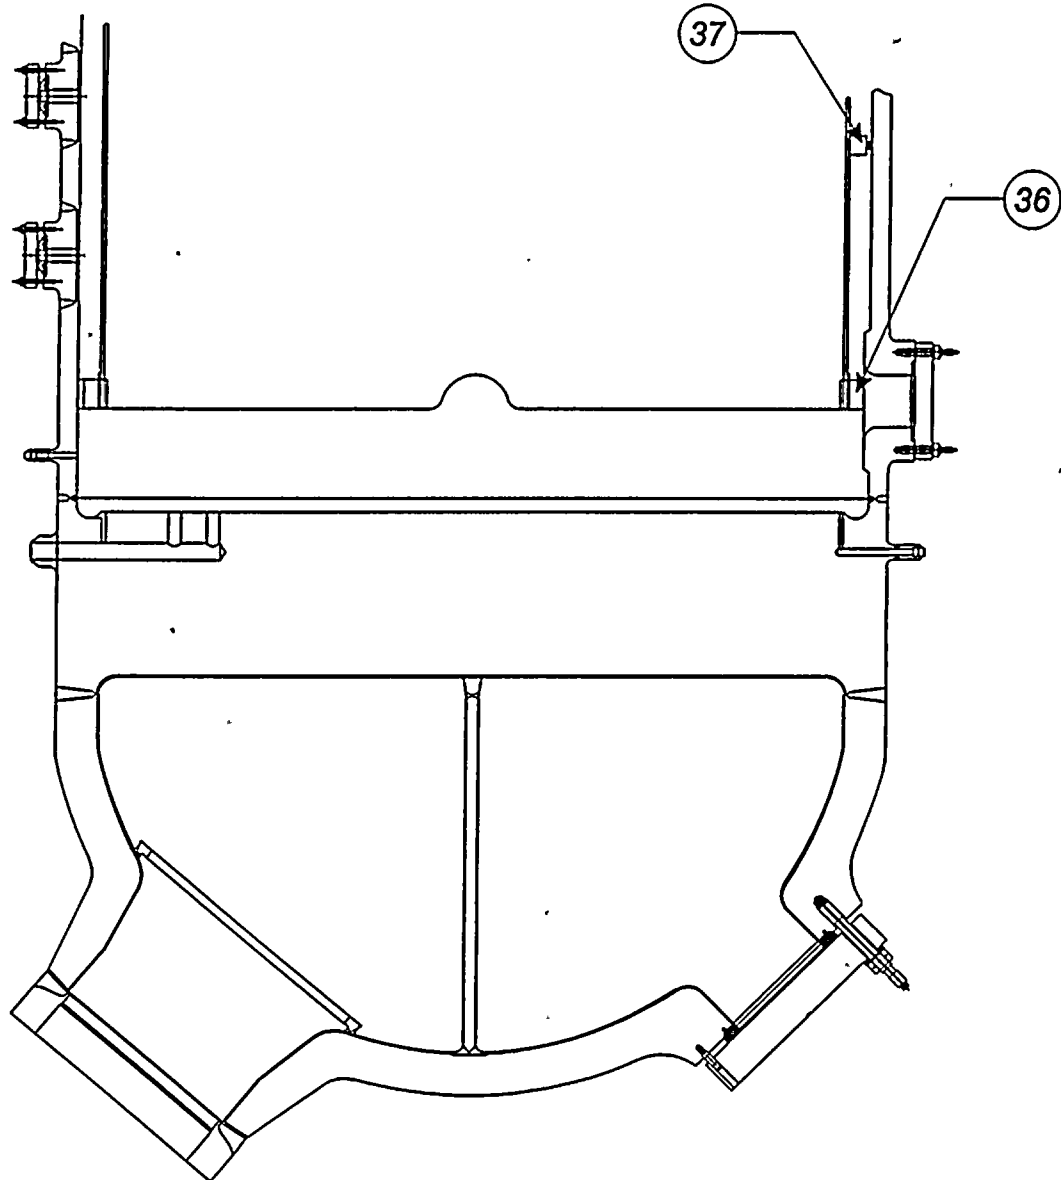
Figure 7

No problems were observed with the full penetration shroud support lug welds. Several shroud pins were observed and were not degraded. The lower lattice grid bars were not fouled.

Two foreign objects were found in SG B. A 4 1/4" long x 3/8" OD hex-head bolt and matching nut were found near the center of the no-tube lane and removed. No tube damage was observed by ECT. Subsequent investigation revealed that the bolt and nut were not native to the steam generator⁵.
