OAK RIDGE NATIONAL LABORATORYOPERATED BY MARTIN MARIETTA ENERGY SYSTEMS, INC.
FOR THE U.S. DEPARTMENT OF ENERGYPOST OFFICE BOX 2008
OAK RIDGE, TENNESSEE 37831-8168

June 4, 1993

On Tuesday, May 4, I traveled to the Palo Verde Nuclear Power Plant, near Phoenix Arizona, to review their eddy-current inspection of their steam generators. This plant has three identical units, each producing about 1250 MW of power, and each having two Combustion Engineering System 80 steam generators. Unit 2 experienced a tube rupture in Steam Generator 2 on March 14, that resulted in leakage of about 250 gallons/min. from the primary to the secondary loop. The plant was safely brought to shutdown and the steam generators opened and examined. The ruptured tube was determined to be due to a long axial defect in the free span of the tube, between the 8th and 9th egg-crate support plates of tube R117 C144 in steam generator 2.

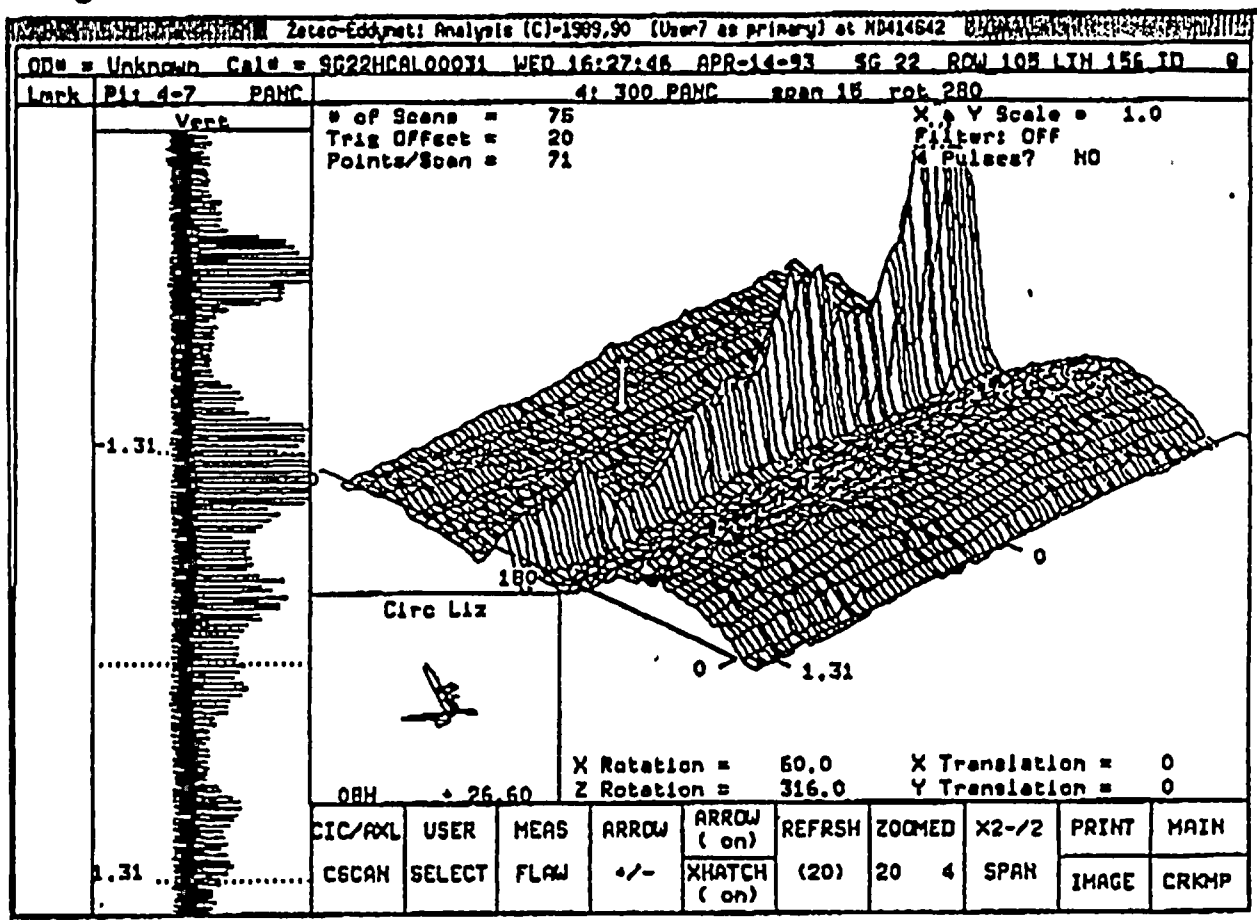
The ruptured tube (R117 C144 of steam generator 2) revealed a crack in the free span about 9 in. long. Another tube (R105, C156 of steam generator 2), had a crack almost

as large that was over 2 1/2 in. long and over 80% deep. This tube probably would have ruptured soon, or if there was a transient. A rotating pancake scan of this tube is shown in Figure 1.

Figure 1 Rotating pancake scan of tube R105 C156 of steam generator 2, made in April of 1993.

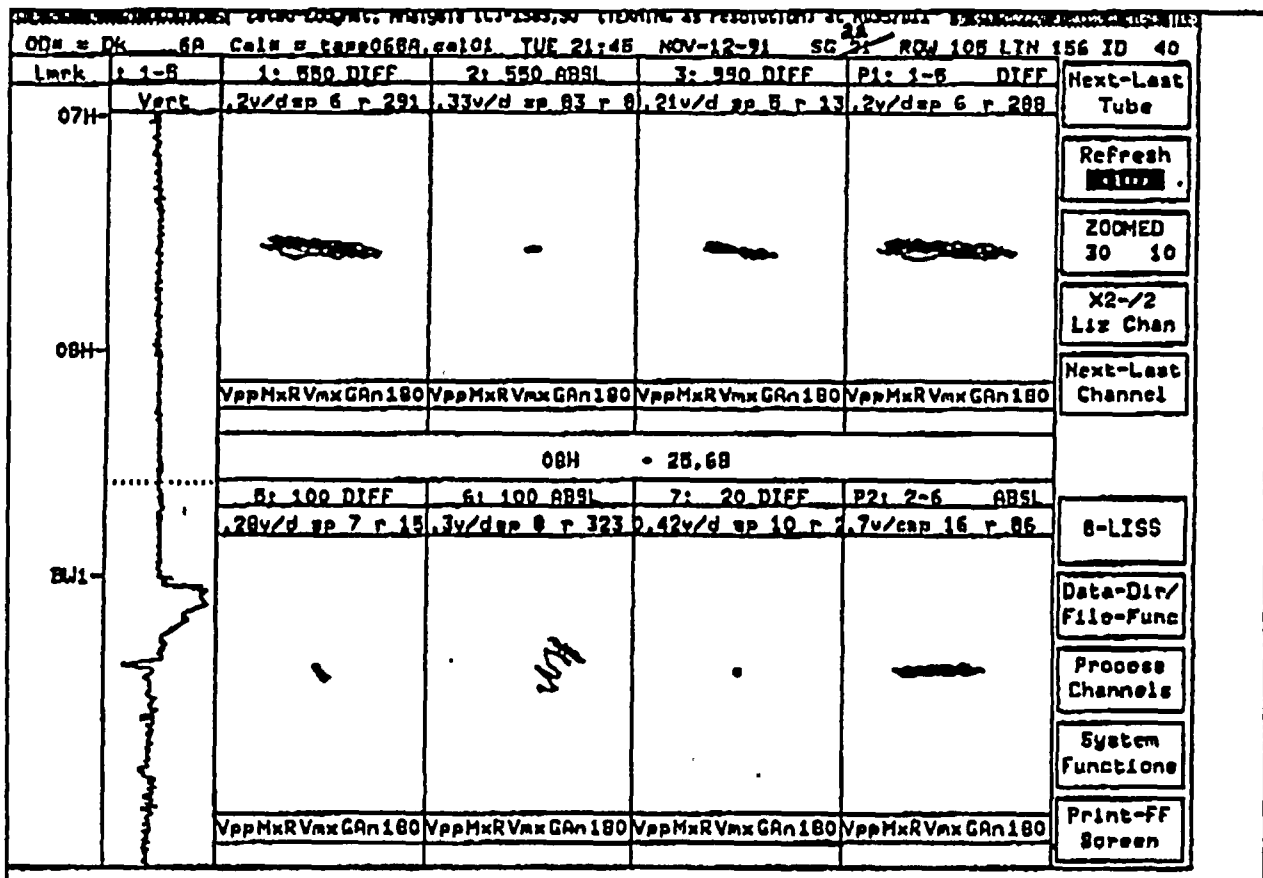
This tube had been inspected at the prior outage in November of 1991 using the bobbin probe. A bobbin coil plot of the tube at this location is shown in Figure 2. There is no indication at this location on any of the 8 lissajous plots. There is some small drift on the 100 KHz absolute channel, but this is normal for this type of tube scan. When the location of the defect is well known, a more sensitive examination of a particular region can be made, and the pilgering noise is less of a factor. This tube does not show even any "noise signals" that may be the start of a defect on the bobbin coil scan.

Figure 2 Bobbin coil scan made of tube R105 C156 of steam generator 2 in November of 1991.

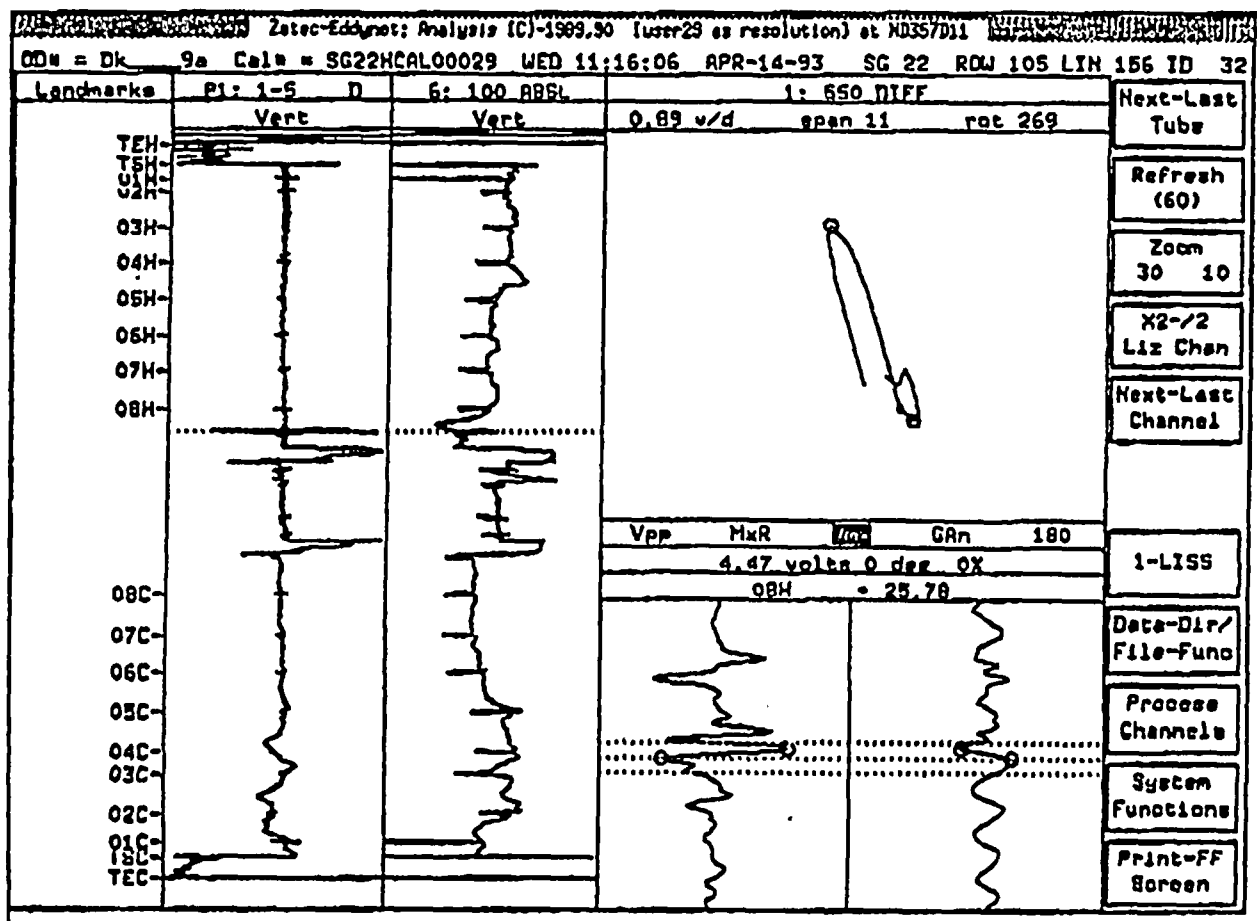
The scan in Figure 2 can be compared to the scan in Figure 3. Figure 3 is the bobbin coil scan of the same tube made in April of 1993. The defect is clearly visible in the 550 KHz differential channel, with a signal level of 4.47 volts. The expanded horizontal channel, (the right hand chart under the lissajous) shows the defect and the "sine wave" effect of pilgering, which is somewhat greater than a volt. The expanded vertical channel (the left hand chart under the lissajous) shows several vertical signals. This relatively long defect gave several "hits" on the differential channel, indicating that the defect was irregular, with stopping and starting points. The defect depth, which is measured from the angle of the lissajous figure, was reported as 80% at this point, and 84% at another. Since the pilgering noise has a direct effect on the phase angle (by varying the horizontal position of the signal) there can be considerable error in the depth measurement, particularly when the horizontal variation is greater than the vertical defect signal. However, from the amplitude of this signal, the length of the indication, the RPC scan

of the defect, and considering the measured depth on several of the bobbin "hits", the defect is probably in excess of 80% in places.

Figure 3 Bobbin scan of tube R105 C156 of steam generator 2 in April of 1993

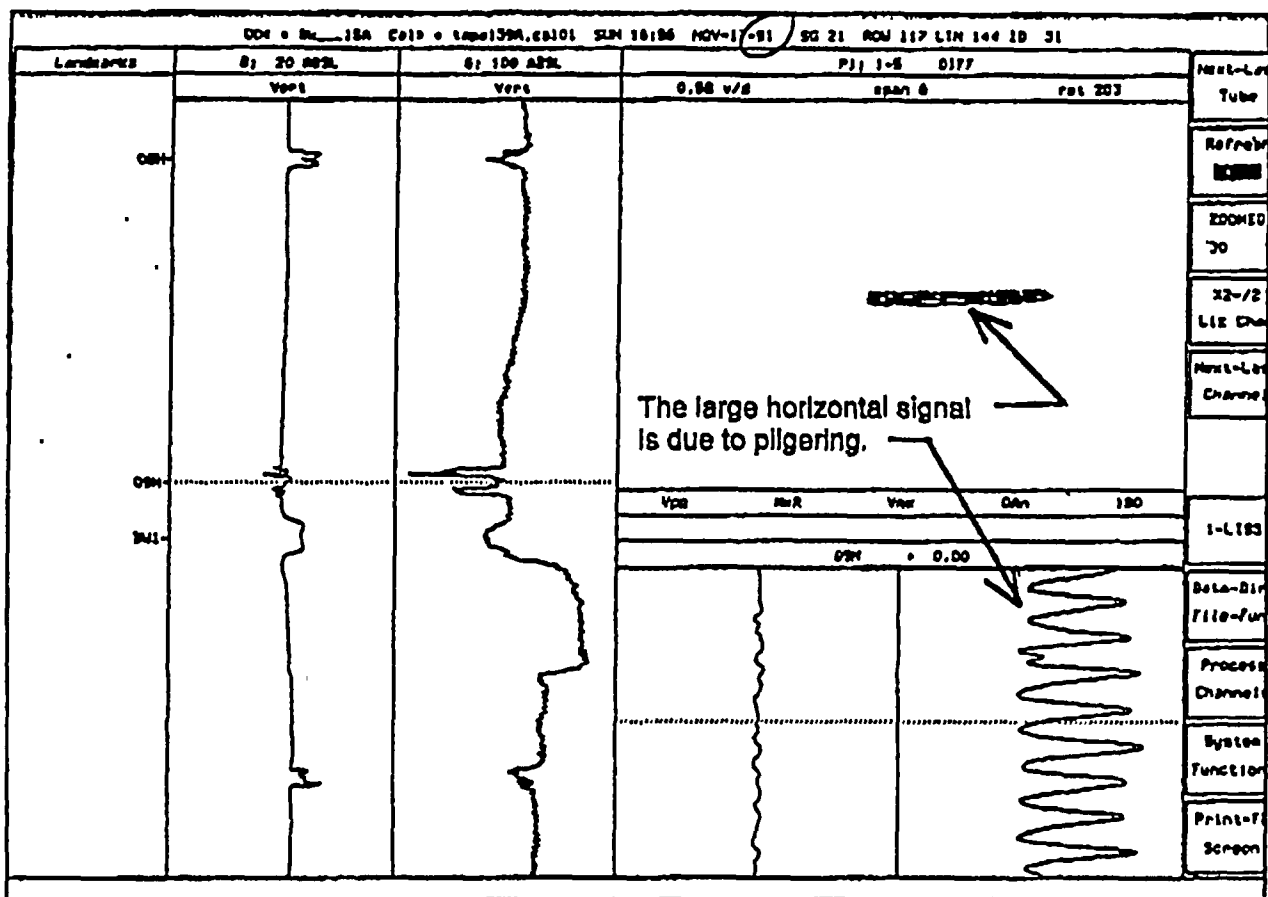
In Figure 4 we show the bobbin trace of the ruptured tube made in November of 1991. The sensitivity of this plot is much larger than the former plot, and the pilgering noise is showing up much greater on the horizontal channel. There is essentially no vertical signal in the region of the defect.

Neither of these tubes had any trace of a bobbin coil signal in the prior outage, indicating that the cracks were quite fast growing. While the pilgering noise can reduce the detection level of the bobbin probe, if the analyst knows the exact spot to examine, the reduction in sensitivity is not as large. However, there was no bobbin indication at all on these scans. Since this tube did rupture, we can conclude that with the current bobbin

Figure 4 Bobbin probe scan of tube R117 C144 (ruptured tube) made in November of 1991

inspection methods, defects can grow from not detectable to rupture during one cycle. It should be noted that one free span defect of this type was found and plugged in the generators in the 1991 outage, but no special (i.e., RPC) inspection program was initiated.
