SUBJECT: LER 93-005-00:on 930628,identified that redundant trains of  
safe shutdown equipment could be rendered inoperable by  
single fire.Fire watches manned in any area not already  
under compensatory fire watch.W/930715 ltr.

Subject: Palo Verde Nuclear Generating Station (PVNGS)  
Unit 1  
Docket No. STN 50-528 (License No. NPF-41)  
Licensee Event Report 93-005-00  
File: 93-020-404

TITLE (4)  
**Loss of Redundant Trains of Safe Shutdown Equipment Due to a Single Fire**

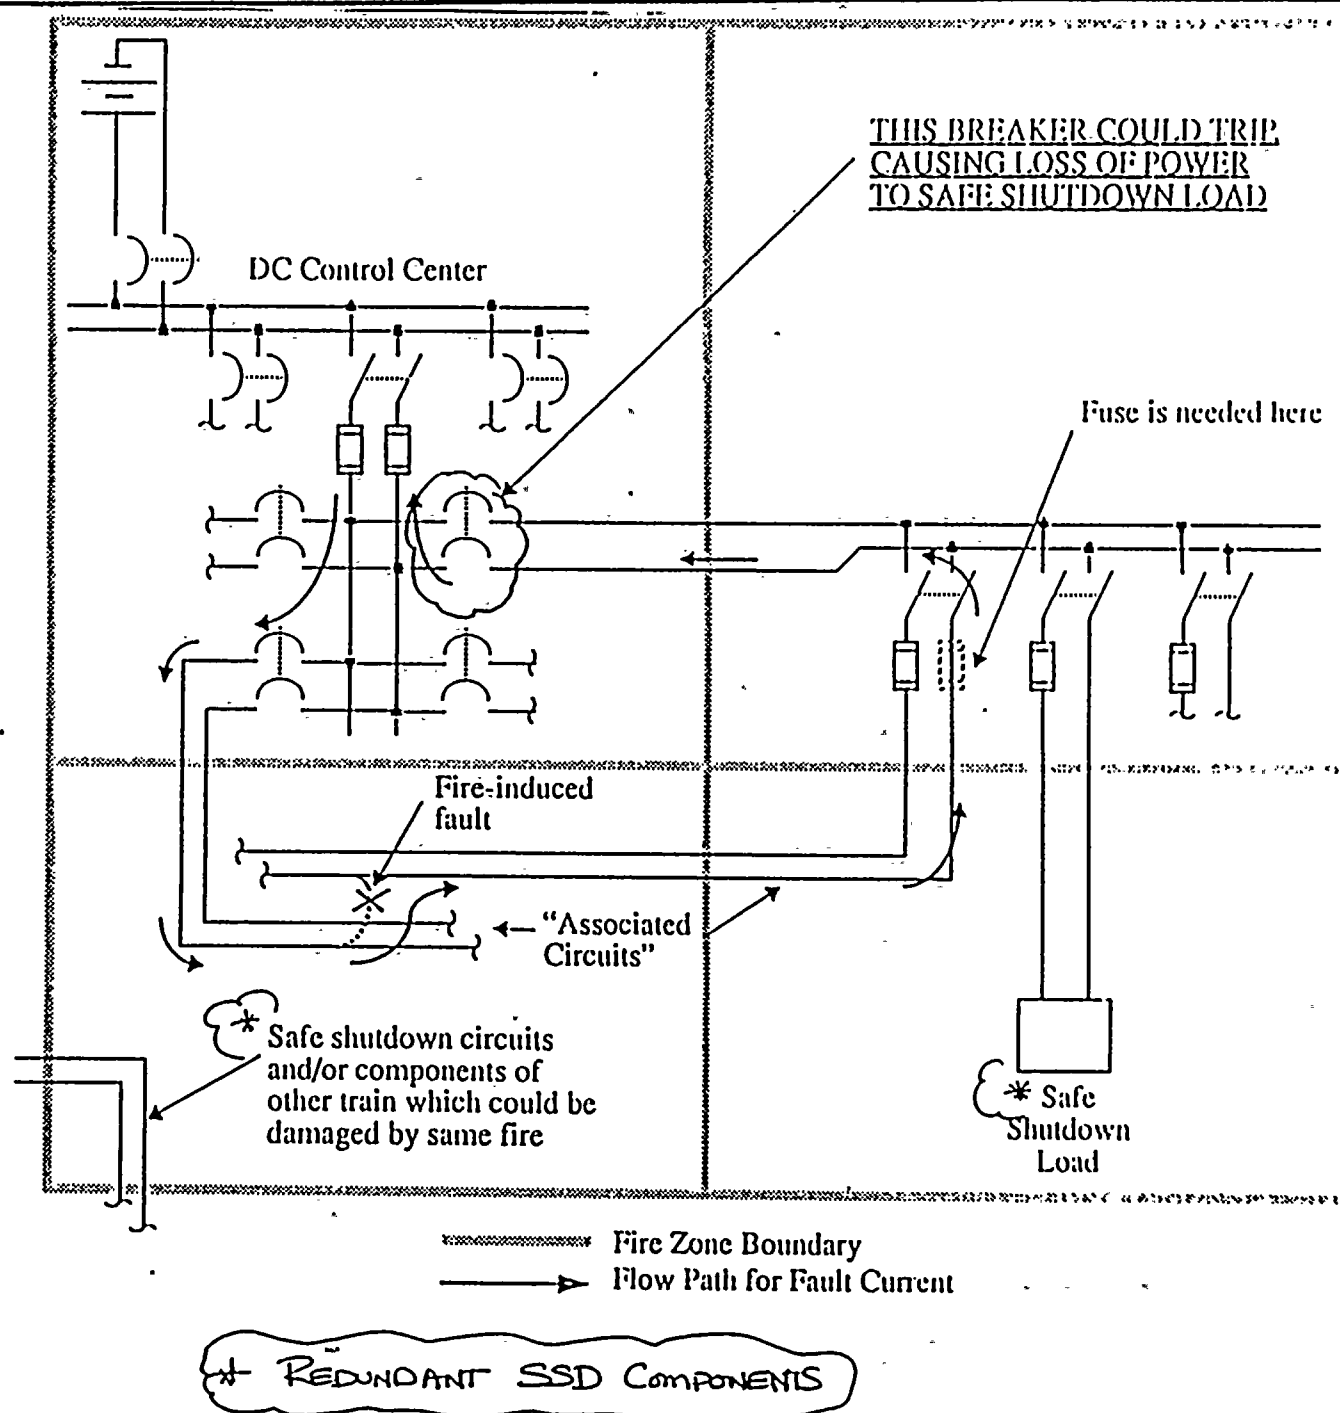
- have only one circuit leg electrically protected by coordinated relays, fuses, or circuit breakers,
- are powered from the same power supply as SSD equipment, and
- have not been verified to meet the requirements of 10CFR50 Appendix R Section III.G.2 and 3.

It was postulated that a fire induced fault in an associated circuit would cause current flow in the unfused leg. This current could trip the common power supply breaker causing a loss of power to the SSD load. Section V, "Additional Information" Figure 1 illustrates this condition.

Final corrective actions consists of a Plant Change Request to provide additional fusing in circuits with an unprotected leg. Plant Change Request (PCR) 93-13-ZZ-001 was approved by the Plant Modification Committee on June 29, 1993. The implementation of the modification has been scheduled in accordance with PVNGS Long Range Planning and is currently planned for refueling outages 1R5, 2R6, and 3R5.
